## EVALUATION AND FORMATION MECHANISM OF SURFACE CONTAMINANTS AND STRATIFICATION ON THE ROCK PAINTINGS OF HUASHAN MOUNTAIN (GUANGXI, CHINA)

### Abstract

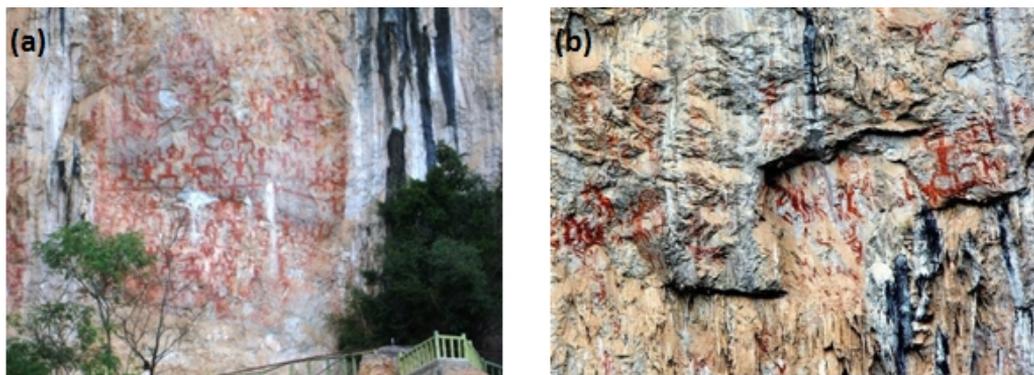
Overall, the rock paintings still present a momentum of grand, broad, and magnificent spectacular views at a first glance. Figure 1a and b shows panorama and partial view of the Rock Paintings of Huashan Mountain, respectively [6]. However, the degradation characteristics of these artifacts are significant after they were aged for thousands of years. A survey carried out in 2008 showed that there are seven main types of diseases that could result in the spallations and falling-offs of the rock paintings [7]. In addition to the geological factors that caused the instability of the limestone substrate [8, 9], main degradation characteristics include the peeling-off of the pigment layers from weathered rock, the fading of the petroglyphs pigments, water erosion, contaminants and stratification on the surface of the rock paintings, and biological attacking, etc.

**Fig. 1.** The Rock Paintings of Huashan Mountain:  
a. panorama view; b. partial view
