A SCIENTIFIC APPROACH TO PRESERVATION OF CULTURAL HERITAGE - SIB SAGAR (ASSAM) CENTRALLY PROTECTED MONUMENT

Archaeological Survey of India, Science Branch, Patna Zone, Patna-1, India

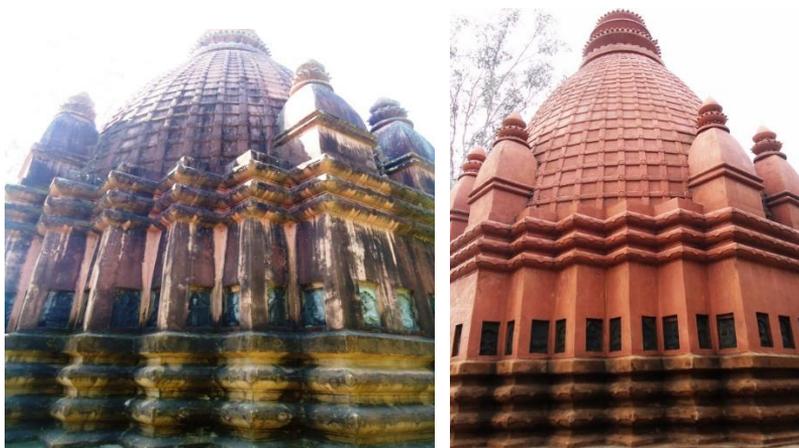
Fig. 4. Before treatment (left) and after treatment (right) of Bishnudol temple

Bishnudol and Devidol temple was suffered from several deteriorating problems due to effect of environment and heavy rainfall during the year. It was not affected aesthetic value only of the monuments but also building materials. So, to minimize these problems and intervention it was essential to chemical treatment and preservation because deteriorated materials make the monument surface more porous and increase the retention time of water which was increase the deterioration rate. The scientific treatment and preservation of monuments shows the best results (Fig. 4).

After treatment, monuments maintain not only its aesthetic value but also reduced the environmental effect to the monuments surface. Our scientific preservation approach is based on using wet chemical cleaning methods. Liquid Ammonia, non-ionic liquid detergent and de-ionized water are used as cleaning agents. In this treatment Sodium pentachlorophenate is used as a biocidal. Silicone based Silane/siloxane water repellent shows the excellent results of monument surface (Fig. 5). Results of the scientific treatment and preservation are making the monuments surface fully water resistance and hinder the regrowth of spores of micro- and macro- vegetation. So an account of this remedy, the monument will be long life to not only present generation but also future generation to known our incredible history and historical research.

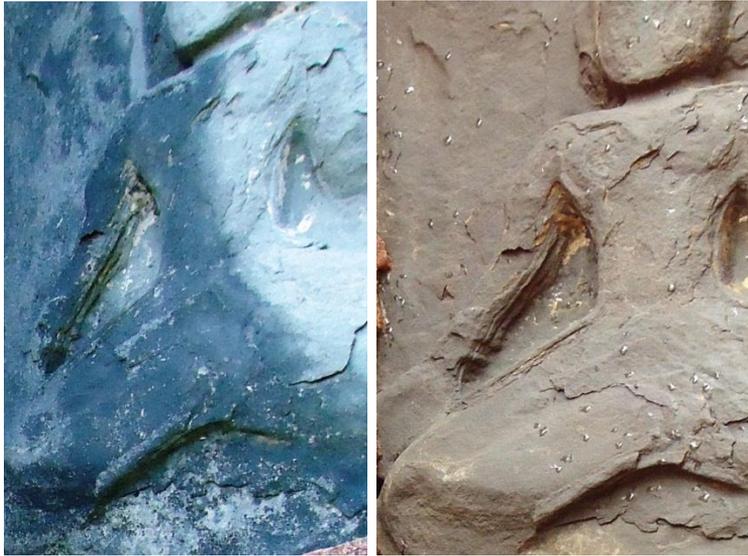
Fig. 5. After preservation of sand stone surface of Sculpture (right) imparting water repellence and un-preserved sandstone surface (left).

The completely dried surface area was subjected to dilute solution of silicone based on silane/siloxane (Wacker BS-290) in organic solvent of Mineral Turpentine Oil (MTO) (ratio of Wacker BS 290: MTO was 1:14 W/V) by the help of different size and type paint brushes to

make the surface suitable for imparting water repellency (fig. 5). Physical data of silicone based on silane/siloxane are [16-17]:

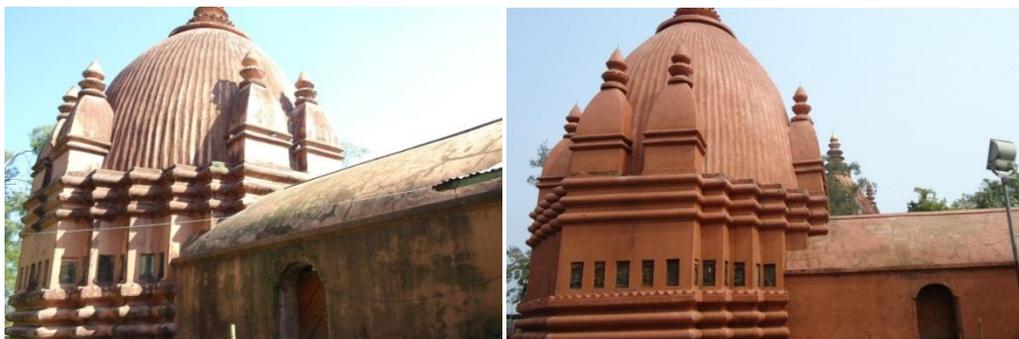
Fig 6. Before treatment (left) and after treatment (right) of Devidol temple at Sibsagar,

After biocidal treatment, the surface of monuments kept completely dried to further action. Actually water-repellent agents used for the hydrophobic treatment from silicone based silane/siloxane of monument surface. Nearly all water-repellent agents used for the hydrophobic treatment of stone form silicone resin films as a final product. After application, SILRES[®] BS 290 reacts with the atmospheric moisture or pore water in the substrate, thereby generating the active ingredient while liberating alcohol. The active ingredient greatly lowers the water absorbency of the substrate. Since neither pores nor capillaries are clogged, the substrate retains a very high degree of water vapors permeability. Silane/siloxane acts as consolidation and good as well as water proofing agent finally looks object in good preservation state (Fig. 6).
