## ASSESSMENT OF PHYSICAL AND MECHANICAL CHARACTERISTICS OF MASONRY BUILDING MATERIALS IN HISTORIC MILITARY TOWERS IN ALEXANDRIA-EGYPT: A CASE STUDY

Mohamed Kamal KHALAF, Mohamed Mostafa ABDELMEGEED \*

Faculty of Archaeology, Conservation Department, Fayoum University, Egypt

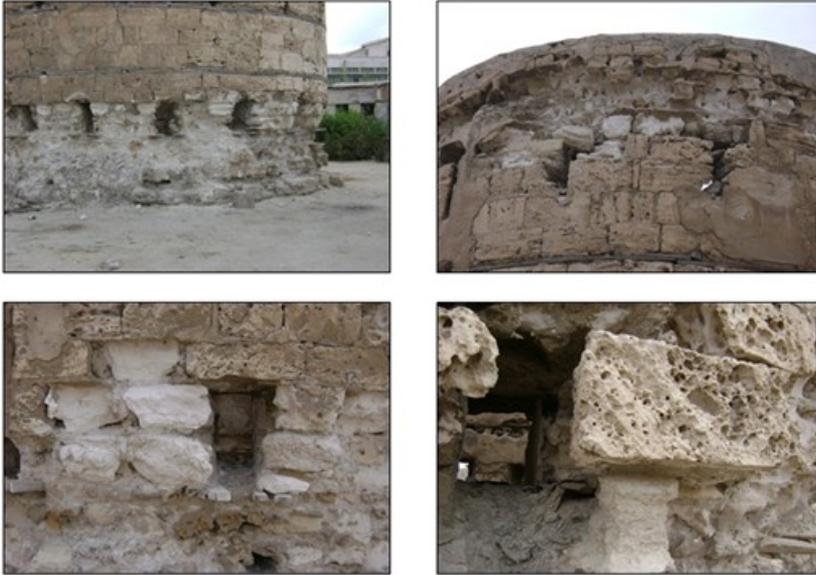
Fig. 2. Examples of deterioration phenomena in the military tower

Due to the effect of environmental or surrounding factors limestone in the tower and room beside has exposure to dissolution, bleeding and erosion phenomena as shown in figures 2 and 7. As a result of previous mentioned deterioration phenomena, the compressive strength values of limestone are insufficient manner ( $110 \text{ kg/cm}^2$ ).

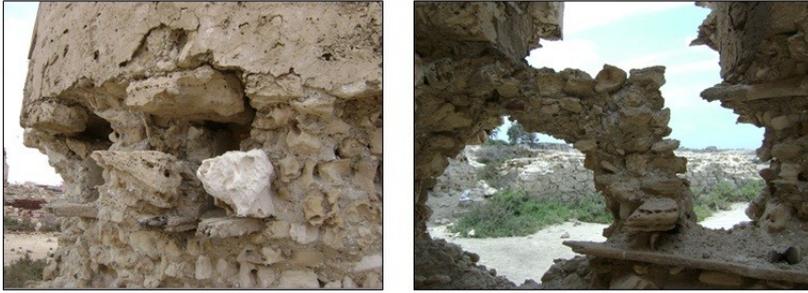
**Fig. 8.** Rapid decay to limestone blocks and collapse of whole sections of the wall

Surface dissolution decay in limestone as shown in figures 7 and 8 may begin with limited and localized surface missing parts through granular disaggregation (honeycomb weathering). By the time and with the long-term of weathering acts the small hollows of limestone honeycombing can amalgamate to form larger cavernous hollows, distinctive bedding and multiple flaking. Invariably this is associated with the near-surface presence of salts crystalline crusts.

The result of such actions due to the salt weathering to *Oolitic limestone* used in the construction of historical military construction in Alexandria there is alarm visual evidence that individual blocks and ultimately, whole sections of the wall can become prone to rapid decay and, eventually, localized collapse (Fig 8).

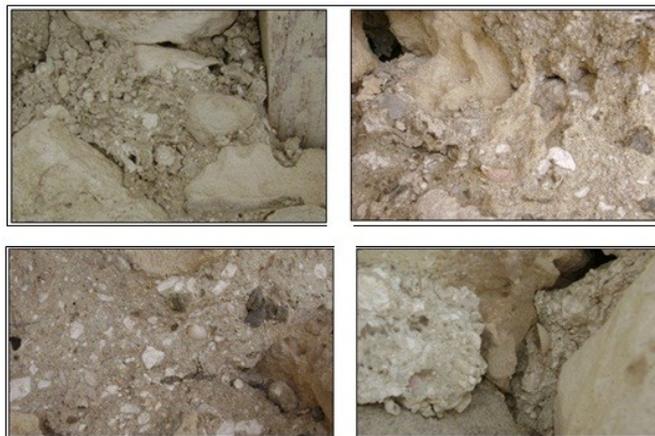
The mortar used in the construction of the tower and the adjacent room in the bad condition, it suffer significant damage phenomena due to some external and internal factors. From visual observation and survey the mortar is in bad current situation due to many cases (Fig. 9).

**Fig. 9.** Show decay of the mortar used

The harmful of deterioration surrounding factors and the poor composition of the mortar are the main factors lead to mortar loss and bleeding leaving stone courses without in-between mortar [15, 16].

One the other hand construction defects play an important role in mortar decay as the builder used the marine or beach sand which contain in its composition shells and various shaped of gravels as shown in Fig 9. In the long-term with the weathering actions shells and gravels fall down. As sequences mortar began to bleeding and form larger hollows in it. And the result is fragmentation of masonry mortar and missing the binder-based mortar layer between limestone blocks courses leading to localized collapse in the building.
