USING NANO-MATERIALS IN SUPPORTING THE SUBSTRATE OF AN EGYPTIAN COPTIC FRESCO PAINTING

Abstract

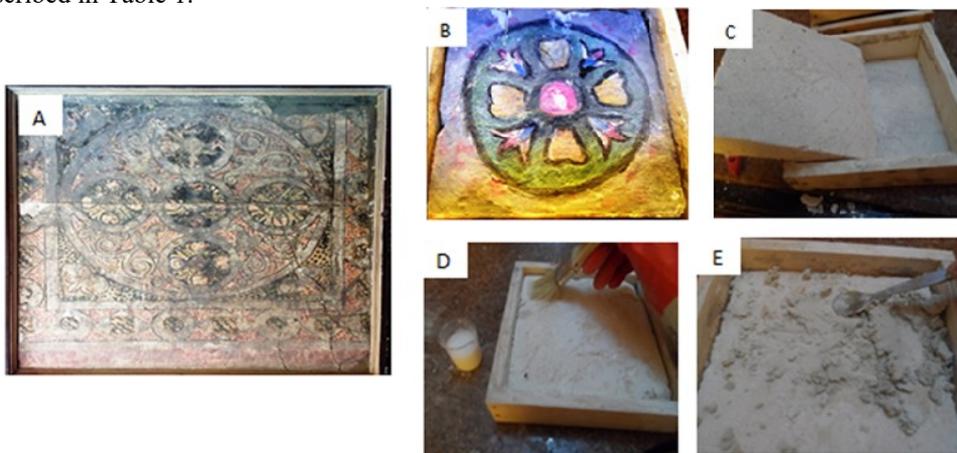
Fig. 1. Egyptian Coptic fresco painting: A. the original; B. one of the model; C. the backside substrate of the model which treated with normal CaCO₃ and the four nano-materials; D. applying the nano-materials with brush on the backside; applying the calcium carbonate with spatula

The pictorial layer suffered from severe loss and color change around the lost areas [9] and the whole fresco painting suffered from weakness as there were a vital cracks (Fig. 1A). The four models of Egyptian Coptic fresco were exposed to artificial aging to create a similar circumstances for the original fresco painting then they were treated with three different system described in Table 1.

The surface of current fresco painting has a gypsum spots and a black crust as shown in figure 1 [10] and the whole fresco painting suffered from weakness as there were a vital cracks. The models of Egyptian Coptic fresco were exposed to artificial aging to create similar circumstances for the original fresco painting which kept in the storage of national museum of

The models of Coptic fresco paintings were treated with the previous components using brushes (Fig. 1D) [11] from the backside after turning them upside down as shown (Fig. 1C) and the model treated with nature calcium carbonate after mixture of calcium carbonate with water the mixture added with a spatula as a separate layer on the back side of the model (Fig. 1E). The models were subjected to different accelerated ageing test to simulate the most Common outdoor heritage deterioration processes due to weathering agents. so they were exposed to temperature 25°C for 12h then up gradually to 60°C for 8h then left them in room temperature for 24h this round repeated 10 times to define the state of models after exposing for changing in temperature [13].

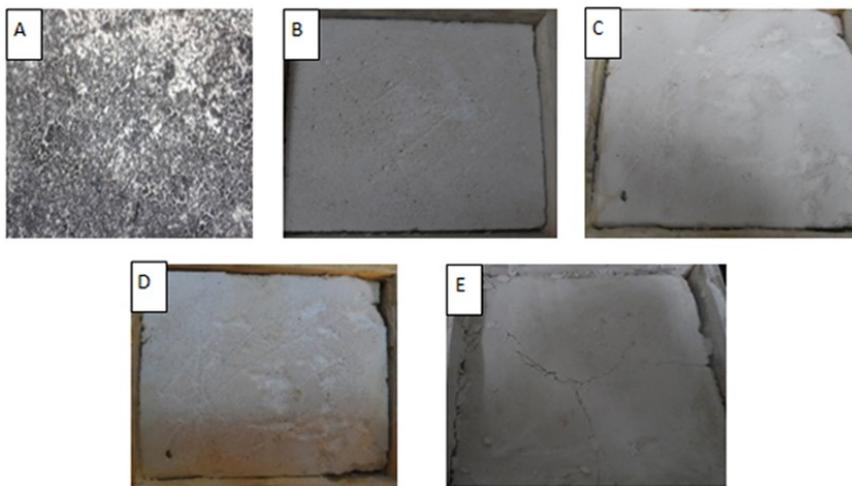
Fig. 2. The models substrate which treated with four nano materials: A. carbon nano tube; B. nano Ca(OH)₂; C. nano CaCO₃; D. nano SiO₂; E. the normal size calcium carbonate

The purpose of comparison the changes of visual colors of substrate which always white after treatment (Fig. 2A) the carbon nano tube caused darkening. The models after treatment figure 2B, C and D, with nano-materials in sequence nano Ca(OH)₂, nano CaCO₃, nano SiO₂ shown as white and figure 2E the new added layer of nature calcium carbonate cracked.

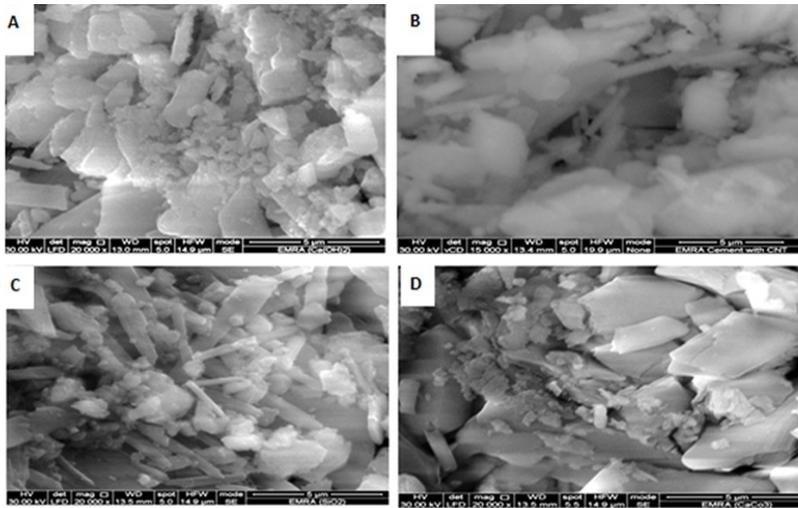
Fig. 3. SEM images of pure nano-materials:

- A. $\text{Ca}(\text{OH})_2$ during the carbonation process; B. carbon nano tube inside the substrate structure; C. nano-silica; D nano-calcium carbonate

Scanning Electron Microscope showing the results of consolidation as the nano-materials appeared inside the structure of the treated models as shown in figure 3.

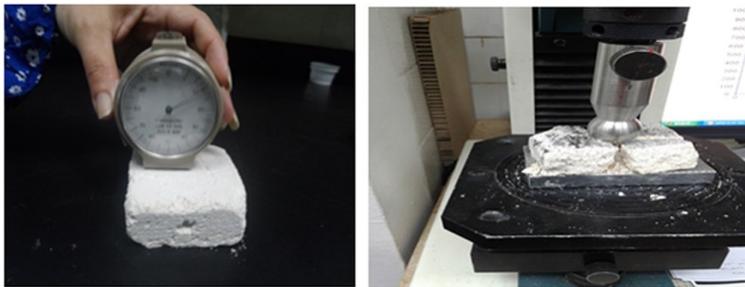
Fig. 4. Testing samples for Hardness using Shore D and bursting strength test using Tinuis Olsen

The Shore D scale is based on ASTM D2240. The test involves the use of a hardened steel rod 1.1 - 1.4mm diameter, with a 30° conical point, 0.1mm radius tip. This exerts 44.64N of force (Fig. 4) [17]. The measured hardness is determined by the penetration depth of the indenter under the load maximum penetration for each scale is 2.5-2.54mm, the amount of penetration is converted to hardness reading on scale of 100 units maximum hardness value 100 shore corresponds to zero penetration which can be converted in to Newton to be 44.45N [18]. Hardness tests for untreated model and treated models with the four nano-materials are presented in figure 4 and the treated model with nature calcium carbonate acts as a two layer connected together.

Bursting strength or compressive strength express the ability of samples to bear compressive strength to be broken (Fig. 4) [18, 19]. Bursting strength for untreated model and treated models with the four nano-materials are presented in Table 2. The results proved that there is an improvement happened in the five models in different values the traditional way in adding a layer of calcium carbonate separated as a single layer under pressure.
