## NANOSTRUCTURED MATERIALS FOR STRENGTHENING AND PRESERVATION OF HISTORIC STRUCTURAL MARBLE COLUMNS

Sayed HEMEDA<sup>1\*</sup>, Mervat KHALIL<sup>2</sup>, Ahmed SHOEB<sup>1</sup>, Ahmed Abd EL AZIZ<sup>3</sup>

<sup>1</sup>Conservation Department, Faculty of Archaeology, Cairo University, Giza, Egypt (P.O 12613).

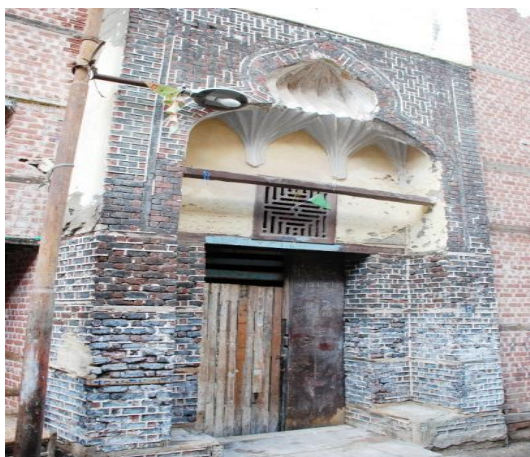
**Fig. 1.** The present state of preservation of the main entrances of Al Mahalli Mosque. rick disintegration due to the ground water rise and salt accumulation is obvious

Figure 1 show the present state of preservation of the main entrances of Al Mahalli Mosque. Figure 2 illustrate the effect of ground water on the marble columns inside Al Mahalli Mosque, and the observed in and out of plane deformations of the structural marble columns. Figure 3 illustrates the decomposition of marble building materials and the permanent deformation of the structural mortar between the column parts.

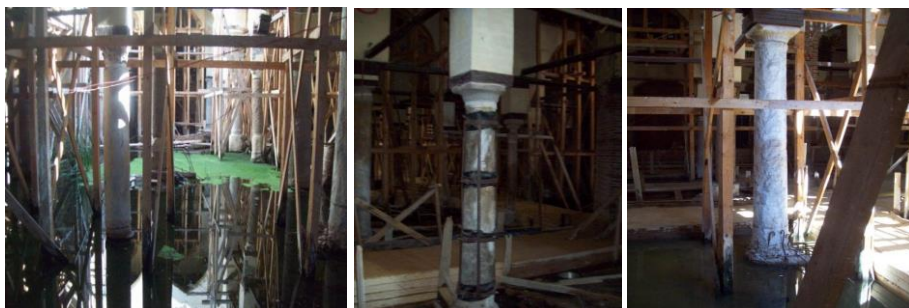
**Fig. 2.** Degradations and deteriorations of columns: *left* - ground water rising above the surface of the earth and the growth of algae within the mosque; *center* - staining and of soot layers cover some of the marble columns; *right* - intensive erosion of the surface layer

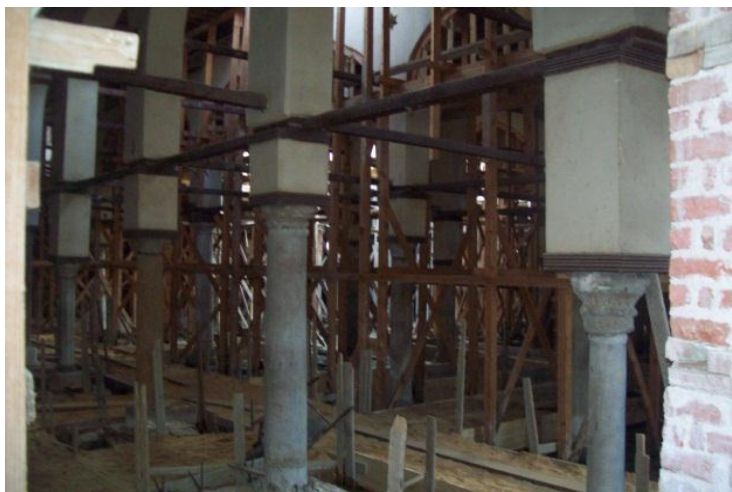
**Fig 3.** The pillars of the mosque and its abyss show signs of deterioration and imbalanced

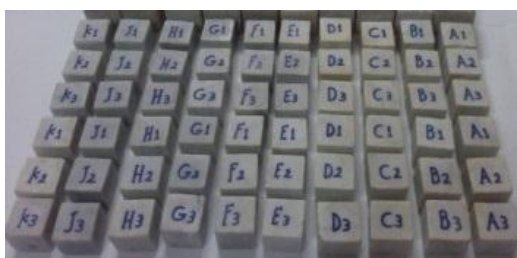
Fig. 8. The specimens with their code number after the consolidation treatment.

exposed to serve factors in this site was collected. The specimens were cut to cubes of 4×4×4cm, and then dried in electric oven for 24 hours at 100°C (+/- 5°C). Sixty specimens were prepared and divided into 11 groups, each group were composed of three specimens. Figure 7 and 8 shows the specimens with their code number before and after the consolidation processes.

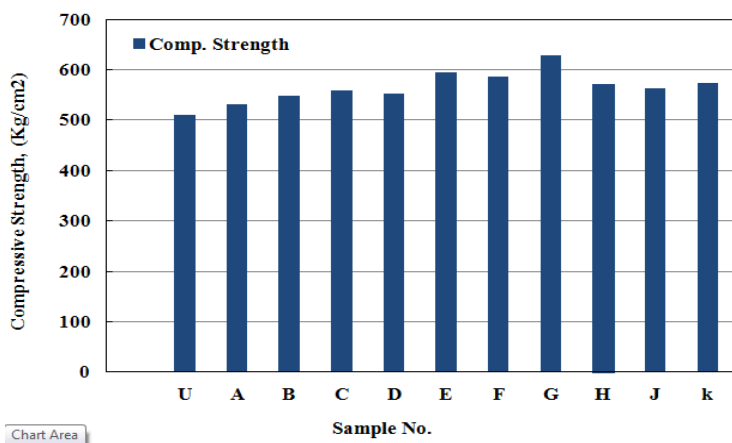
Figure 9 shows the average Compressive Strength for three samples for each treatment. The figure shows that sample with code number G treated with Nano restore with 50% and EucoColle materials with 50% concentration and diluted in water, gives the highest  $\sigma_c$ , where its value is  $629.23\text{kg/cm}^2$  which increase the control one by about 23.59% which give  $509.18\text{kg/cm}^2$ .

**Fig. 9.** The average compressive strength of samples after consolidation

Compressive strength for sample (G) after treatment with Nano restore with 50% with EucoColle materials with 50% gave the highest load of 629.23kg/cm<sup>2</sup> by an increase of 23.59% with respect to the control one which give a compressive strength of 509.12kg/cm<sup>2</sup>.

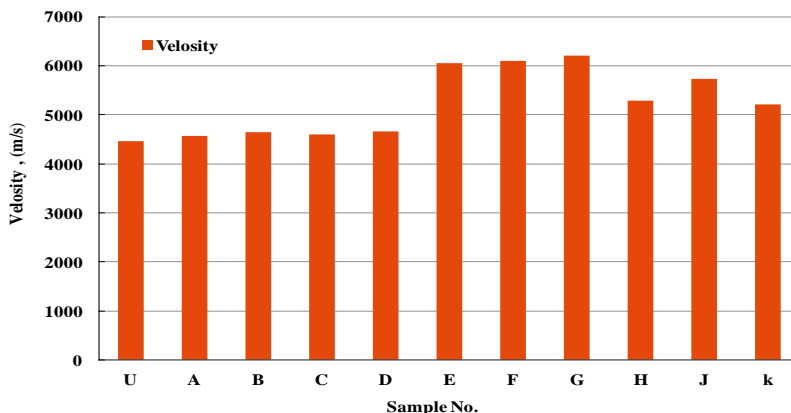
Figure 10 shows the average wave velocity for three samples for each group. The figure shows that sample with code sample with code number G treated with Nano restore with 50% with EucoColle materials with 50% concentration and diluted in water gives the highest velocity of 6252m/s which increase the control one by about 39.99% which is 4266m/s.

Fig. 10. The average wave velocity of samples after consolidation

Ultrasonic pulse velocity for sample (G) after treatment with Nano restore with 50% with EucoColle materials gave the highest velocity of 6252m/s with an increase of 39.99% of the control sample which give 4266m/s.

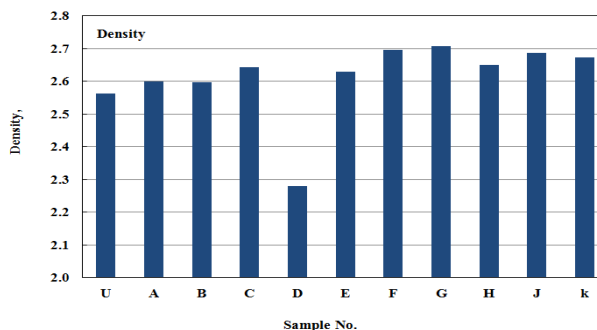
Fig. 11. The average bulk density of samples after consolidation

Figures 11 shows the physical properties of samples. Figure 12 shows the bulk density in which sample with code number G treated with Nano restore with 50% with EucoColle materials gives the highest bulk density of 2.7g/cm<sup>3</sup> which increase the control one by about 5.46% which is 2.56g/cm<sup>3</sup>.

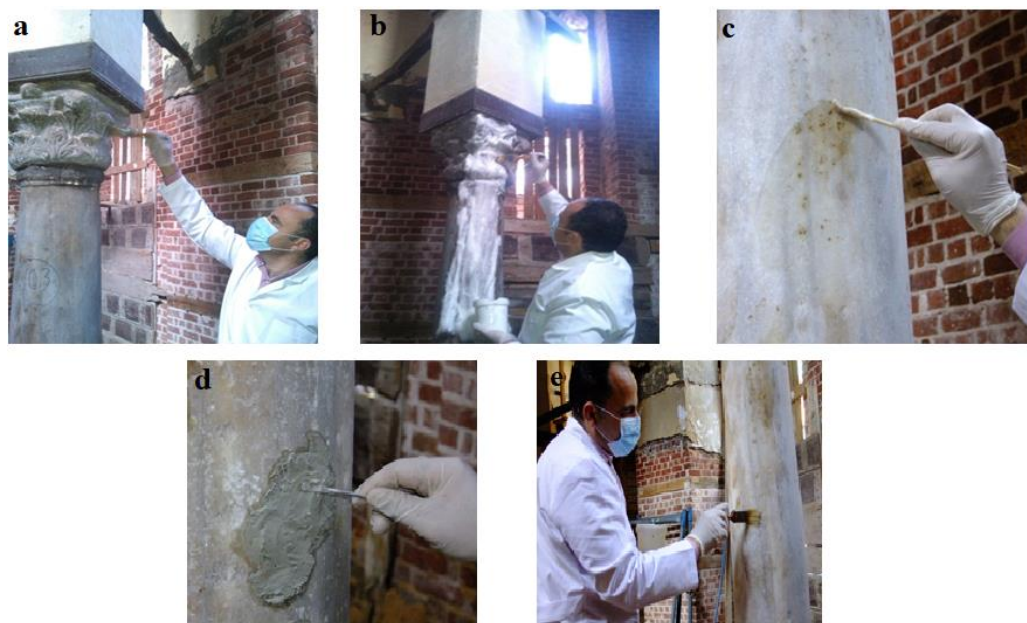
Marble columns were cleaned using the dry tools and mild detergents with a low-pressure (900psi) water rinse (Fig. 16).

**Fig. 16.** Cleaning and consolidating process process of the marble columns: **a** - dry cleaning; **b** - salts removal process using poultices saturated with mild detergents with a low-pressure (900 psi) water rinse; **c** - final step, staining removing with detergents; **d** - repointing of the pits and gaps inside the marble columns; **e** – consolidating with Nano restore with 50% with acrylic materials with 50% concentration and dilute in water by 1:1 ratio agent time

The challenge in cleaning these interior decorative components was to avoid damaging the adjacent highly stenciled surfaces. This was achieved by using carefully placed protection in these areas of interface. Cleaning and repointing of the pits and gaps was carefully executed to avoid contact with the leaded components.

Interior marble columns were carefully resurfaced and filled to produce smooth and uniform marble columns that are now capable of withstanding the abrasion of constant use.

Other marble columns were anchored and restored to preserve the exterior details of the facade. The final step of the restoration process included the consolidation and protection of the marble surfaces with Nano restore with 50% with acrylic materials.
