RESTORATION AND PRESERVATION PROCEDURE OF ARCHITECTURAL MONUMENTS. RAILWAY STATIONS WITH MONUMENTAL ART OF THE SOCIALIST PERIOD (ON THE EXAMPLES OF UKRAINE AND POLAND)

Keywords: Restoration and preservation procedure; Railway stations, Socialist period, Ukraine, Poland

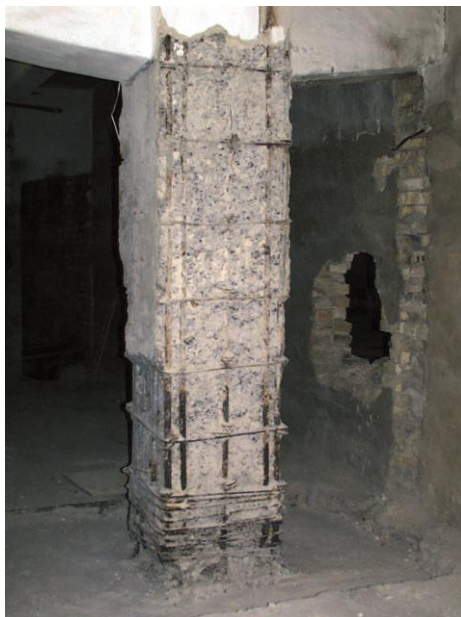
The main problem was related to the fact that the basement ceiling, as a result of the bombing of the station by the Germans, fell into the basement, and later, during the restoration of the station, they put the floor on top of it, and it reduced the height of the basement to 3 m. Besides, the destroyed ceiling lay on the bases of columns, and it led to corrosion of the reinforcement in the columns, a decrease in their loadbearing capacity and the emergency state of the columns in their lower part. It was necessary to dig out the basement, remove the destroyed ceiling and make two engineering collectors for plumbing and electrical communications. For this purpose, the basement ceiling marks were lowered by 2.5m by deepening the foundations, as a result of which the basement height increased to 4–5m. Digging out the columns proved almost complete corrosion of the reinforcement in their lower part and the loss of their loadbearing capacity (Fig. 1). Therefore, the works were carried out to strengthen the columns of the station using metal structures. In the lower supporting part of the columns, metal bases were welded to increase the bearing capacity of the columns; the body of the column itself was taken into metal straps, followed by reinforcement and concreting. They

made a new base of columns, which rest on the foundation, and transferred loads through the metal structures.

Fig. 1. Condition of the reinforced concrete column before renovation.
Photo from the funds of the Ukrrestavratsiia corporation, 2001

In the centre of the building, under the hall, a new basement ceiling made of metal structures with principal and secondary beams was installed under the old basement ceiling; the escalators were set up.

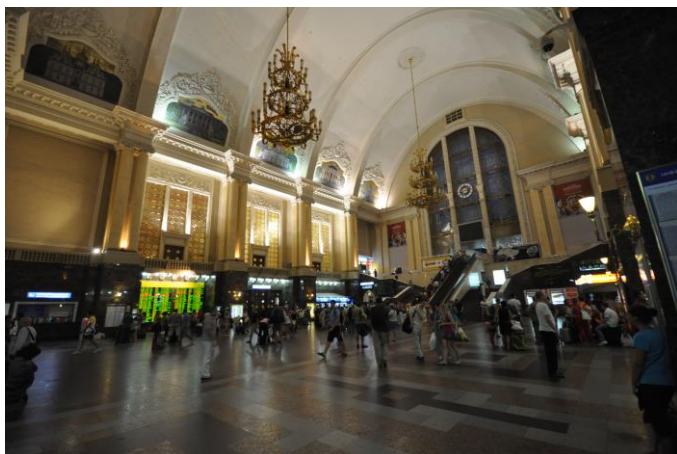
As a result, it was decided that the style of the Kyiv railway station had changed several times, so it is necessary to separately develop the style of the interior of each hall. In hall No. 1 of the former restaurant, it is required to fix the old painting and, if necessary, after additional examination, to restore. It was decided to remove the symbolic ideological images, and in their places to make picturesque landscapes in the style of existing ones. In hall No. 2, in cartouches, it was agreed to place landscape paintings, in the cartouches of the main hall – mosaics that represent Kyiv as fully as possible [15] (Fig. 2).

Fig. 2. Interior of the station building main hall after restoration.
Photo from the funds of the Ukrrestavratsiia corporation, 2020

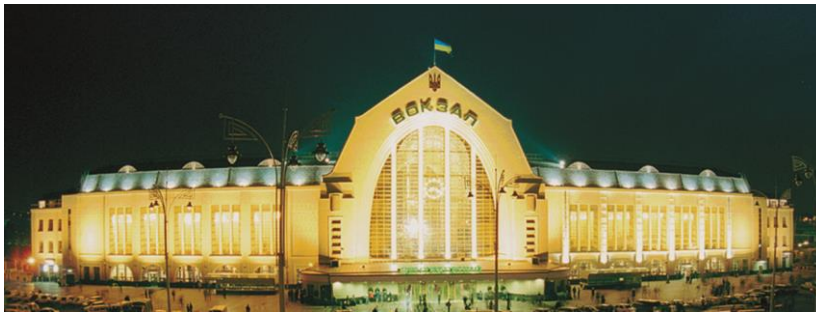
The station building was renovated in 2001 during seven months and equipped with modern technical equipment (Fig. 3). Escalators with access to the passage and underground storage rooms were installed in four halls.

Fig. 3. Main facade of the station building after restoration.
Photo from the funds of the Ukrrestavratsiia corporation, 2020

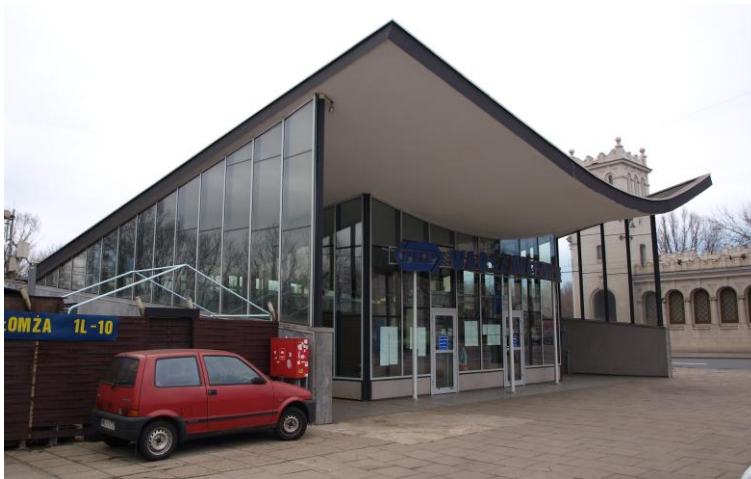
The topography of the area determined the design of the station that consisted of two pavilions – the upper one (in the upper part of the slope, Fig. 4) and the lower one (under the slope, Fig. 5). The architectural expression of the upper pavilion resembles the pavilion of the Warszawa Ochota railway station (also designed by the team of Romanowicz and Szymaniak following the proposal of Zalewski). However, there are many differences between the two pavilions, since the plan of the upper pavilion in Powiśle is in the shape of a parallelogram, not a rectangle. The double-conoid roof, further sloping down the stairs, flows smoothly from a downward curve to an upward curve. The lower pavilion has a roof in the shape of an inverted dome. Its glass walls run partly along the perimeter and partly along the chord of the roof. The authors' assumption was to contrast the pavilions with the historical form of the neighbouring Prince Józef Poniatowski Bridge [21].

Fig. 4. The upper pavilion

In 2008–2009, the upper pavilion was renovated according to the project of the architectural studio MAAS (architects: Henryk Łaguna, Dariusz Hyc, Anna Drozdowska, Przemysław Zalewski). As a result of these works, the original forms and elements were restored. Black and white mosaic tiles of the same size as originally (2x2cm) were used. Most of the surface was decorated in the same way – alternating horizontal stripes of black and white tiles (Fig. 3). There were also some differences. Instead of the original tiles with sharp edges, tiles with rounded edges were used. The original placement of mosaic tiles on larger panels, which were fixed to the walls and other elements, was abandoned. In the case of kiosks, instead of the original arrangement with walls at the bottom and glazing above, entire openings were used, closed by shutters.

The original design of glass partitions in the outer walls of the pavilion was restored. Besides, double glazing was used instead of single glazing. The stone floor and the back wall made of glass blocks were replaced with new ones [23]. In the summer of 2009, at the front wall of the pavilion, the inscription "Warszawa Powiśle" and the PKP (Polskie Koleje Państwowe – Polish National Railways) logo in navy blue, made of illuminated coffered letters and lines, was placed on the steel structure supported by three pillars. This solution was not included in the renovation project and was not agreed with the renovation architects. The stairs leading to the platforms from the sides of the upper pavilion were equipped with lifts moving along them for transporting disabled people in wheelchairs.

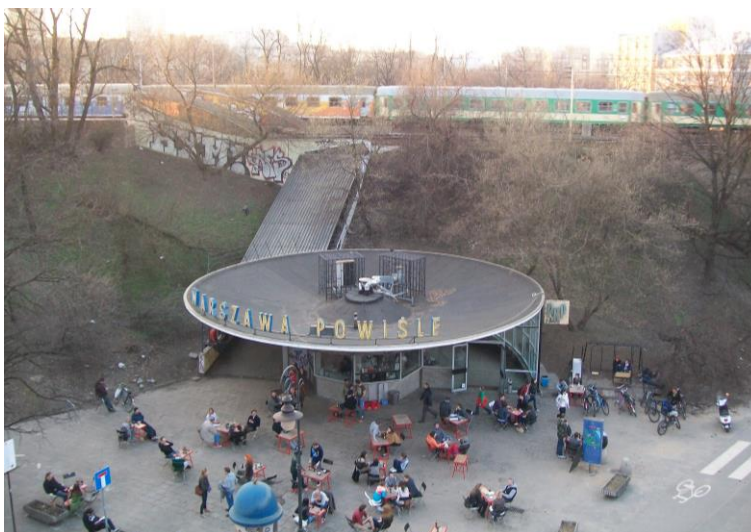
Fig. 5. The lower pavilion

During the second renovation in 2009, the lower pavilion of the Warszawa Powiśle station was adapted for the cafe-club. The renovation works were carried out according to the

The external glass curtain walls were replaced. In the interior, the existing floor was preserved as well as white and black 2x2 cm mosaic tiles arranged on the walls in horizontal stripes, one tile wide. The tiles removed from the disassembled elements were used to fill the defects in the remaining mosaics. The inscription "Warszawa Powiśle" on the roof was preserved and renovated. The name of the station was used as the name of the cafe-club.

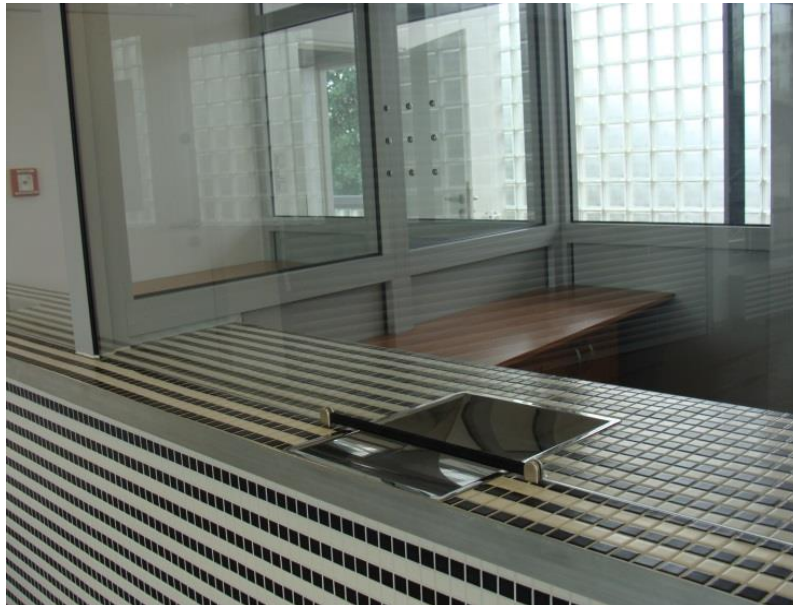
Fig. 6. Mosaics in the upper pavilion

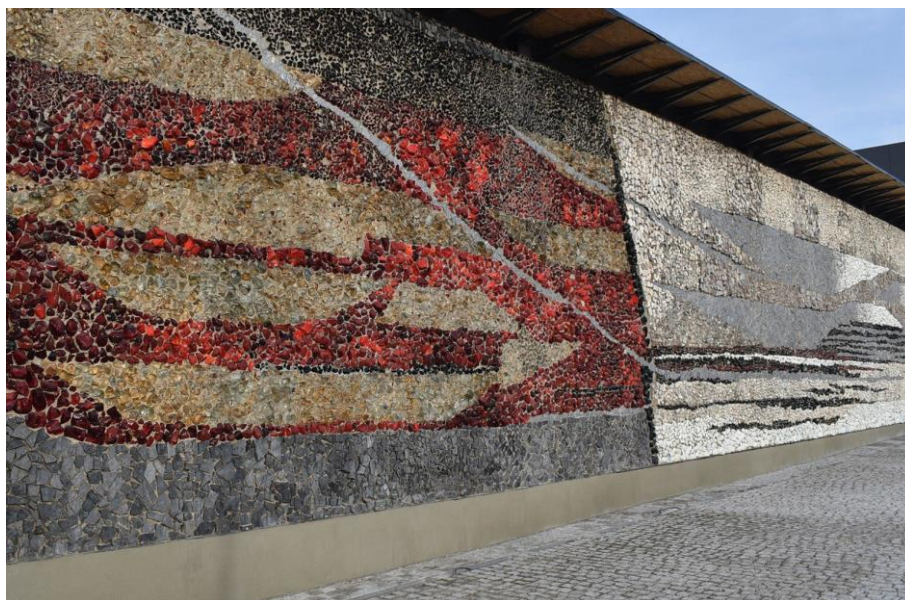
The mosaic in Oświęcim is 24 metres wide and 4.6 metres high. It weighs 100 tonnes [28]. The mosaic consists of two parts: on the left side red and ochre colours with brown accents dominate; on the longer right-side beige and white with small black accents were used. Mosaic elements were mounted directly on a brick wall with the use of cement mortar. After the demolition of the old station, the mosaic, which is of historical and artistic value, was preserved and transferred to the main facade of the station, becoming its main focus (Fig.7).

Fig. 7. The mosaic on the main facade of the Oświęcim station building

The transfer of the mosaic was very difficult and required high precision. It began by preparing detailed documentation of the mosaic using a 3D scan of the surface. The next stage involved carrying out conservation analyses. They showed that the mosaic could only be transferred using the “stacco a massello” method (with the entire base). The mosaic was divided into four sections. Each section, six metres wide, was well protected before it was mounted anew on the elevation of the new railway station. The wall with the mosaic had to be set up on a new foundation (the wall was added to the south elevation of the new railway station), and specialist conservation treatment had to be applied, as a result of which the mosaic regained its original colouring [28].
