TECHNICAL EXAMINATION AND STATE OF CONSERVATION OF WALL PAINTING AT THE THEBAN TOMB TT15 AT DRA' ABU EL-NAGA NECROPOLIS, WESTERN THEBES, LUXOR, EGYPT

Abstract

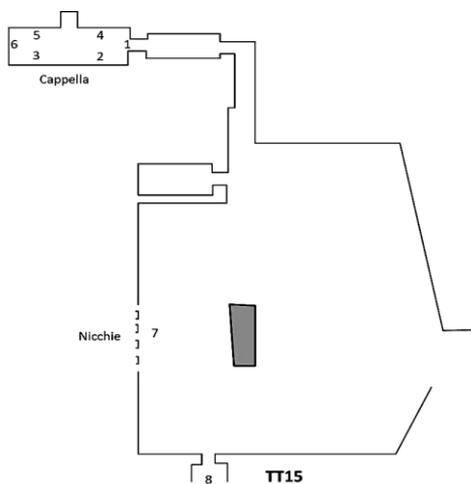
Fig. 1. Floor plan of the tomb TT15 at Dra' Abu El-Naga Necropolis

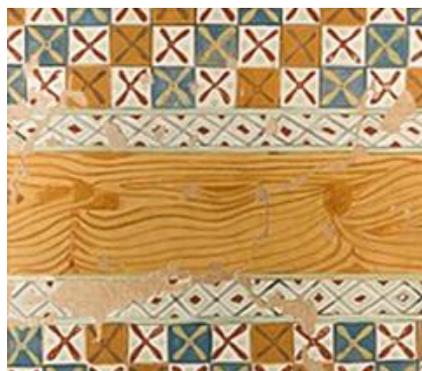
Fig. 2. Geometric decorations and the shape of the bark of wood decoration at the ceiling of the tomb TT15

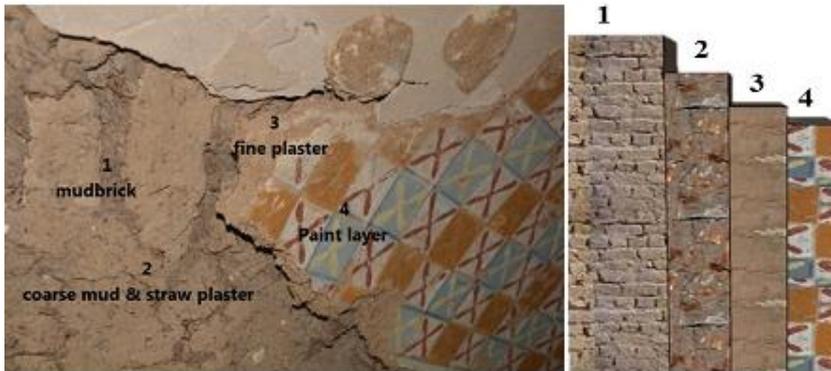
Fig. 3. The stratigraphy of mural painting at TeTiky tomb:
 a. portion of the image of the tomb, the stratigraphy of the preparation can be seen in the damaged portions of the painting; b. The stratigraphy of the mural painting at TeTiky tomb;
 1. mudbrick support; 2. coarse mud and straw plaster; 3. fine mud plaster;
 4. The upper plaster carries a polychrome painting

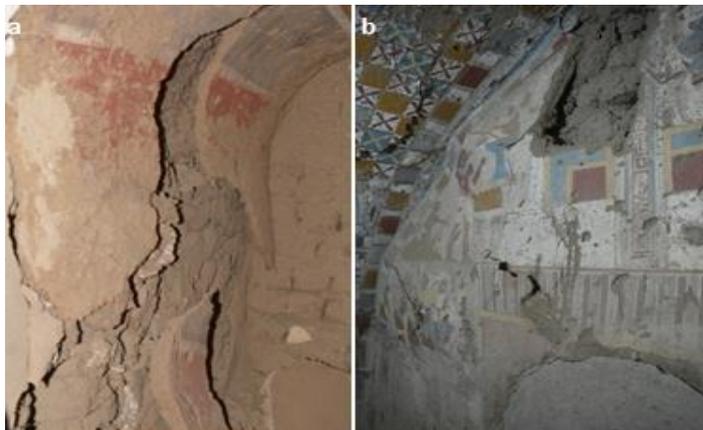
- Displacement, leaning, collapse in the lower part of the wall and moderate cracks are found along the tomb walls (Fig. 4a), also bulges of the upper wall of the niche (Fig. 4b) due to subflorescence in between plaster layers.
- Network of microcracks (Fig. 5a) and missing parts of wall painting in different parts of the wall of the tomb were clearly noted which affect the tomb's integrity (Fig. 5b).

Fig. 4. a - Displacement, leaning of the wall:
b - bulges or swelling of the upper wall of the niche the TeTiky tomb

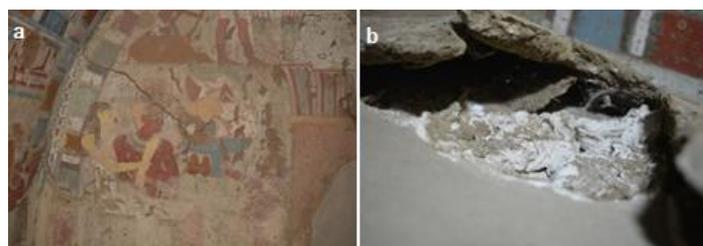
Fig. 5. a - Network of micro cracks associated with detachments of the mud plaster;
b - missing part of wall painting which affects their integrity

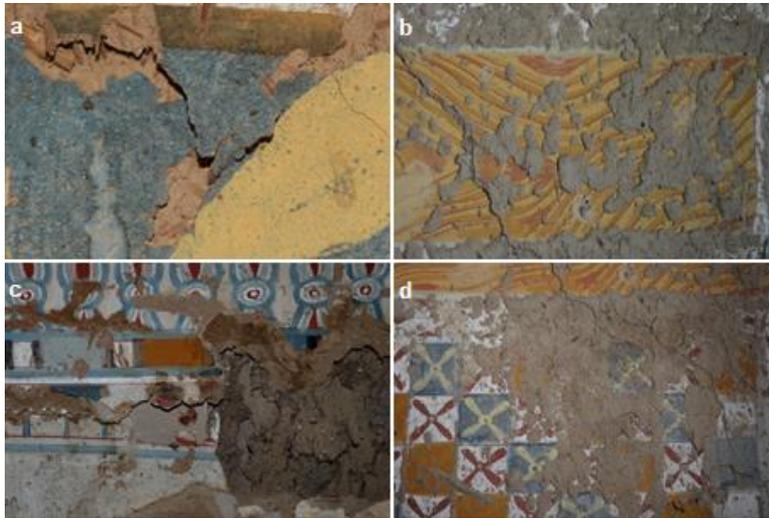
- The most common types of deterioration observed on wall paintings in the tomb is detachments of the mud plaster from mudbrick support (peeling) (Fig. 6a), abrasion of the paint layer (Fig. 6b), crumbling, surface erosion and failure of the plaster (Fig. 6c) and the brittle plaster collapsed and was crushed (Fig. 6d).
- Salt efflorescence was clearly observed at the surface, and crypto efflorescence salts were observed between the mud plaster and mudbrick support, which deteriorated the wall plaster in various degrees from one area to another. Separation of the wall plaster layers, partially or completely, is caused by the crystallization of the salts (Fig. 7a and b).

Fig. 6. a - peeling of the paint layer; b - abrasion of the paint layer; c - crumbling of the mud plaster; d - the brittle plaster collapsed and was crushed

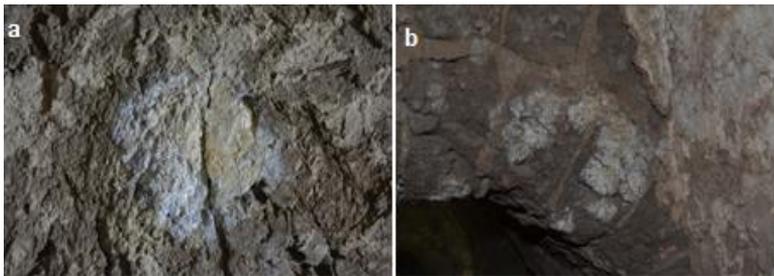
Fig. 7 a, b - accumulation of soluble salts at the mudbrick

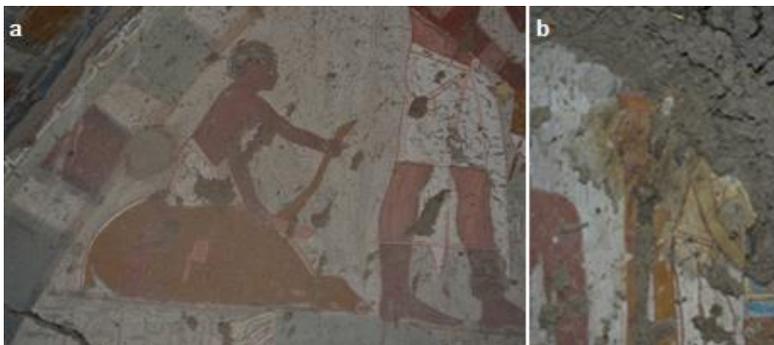
- Chromatic alterations are widely distributed in the mural painting in the tomb, essentially greyish in color, which ascribed to the deposition of debris, dust, and other fine particulates at the surface (Fig. 8a and b).

Fig. 8. a, b - The accumulation of dirt on a surface leading to discoloration

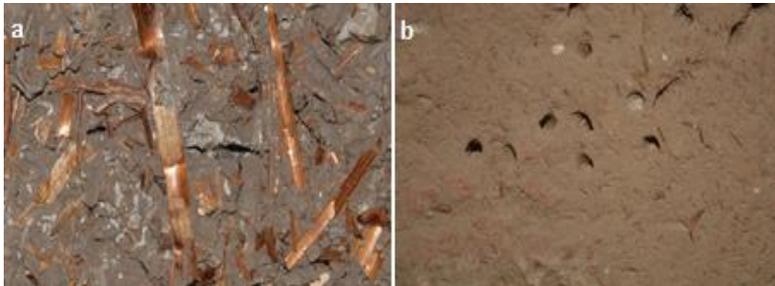
- Mural paintings in tombs are exposed to deterioration due to the composition of these paintings, it was well established that mud plaster containing organic materials such as chopped straw (Fig. 9a) provides a rich and suitable food source for insects, so many areas

show extensive holes and gaps in the ground layer (Fig. 9b) due to the insect attack, which feeds on the chopped vegetable matter at the mud plaster and mudbrick support.

Fig.9. a - straw in mud plaster; b - extensive holes and gaps due to the insect attack

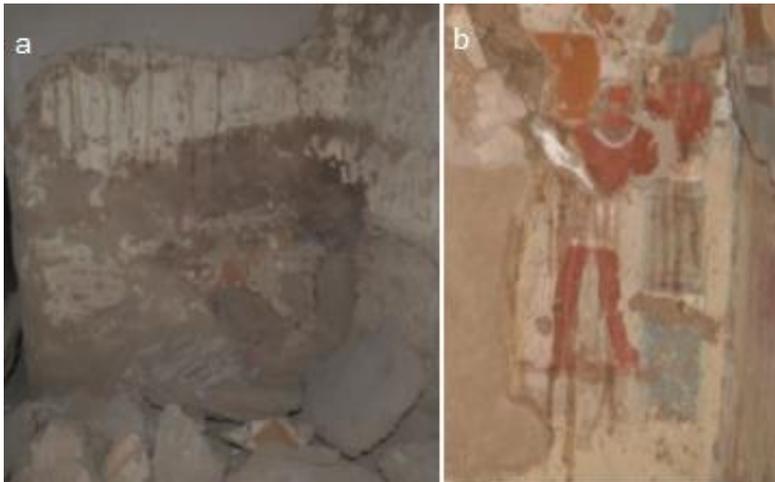
- Infiltration of rain and wastewater (from sewage leakage from sewage septic tanks installed by the people at the top of the tombs) within joints and cracks of the ceiling of the tomb cause dissolving clay and gypsum in gray opaque encrustations that hidden paintings (Fig. 10a), also the wall paintings in the tomb present visible discoloration in appearance (Fig. 10b) due to the prolonged action of microorganisms [9].

Fig. 10 a - infiltration of rain and wastewater by ingress through cracks; b - discoloration in appearance due to the prolonged action of microorganisms

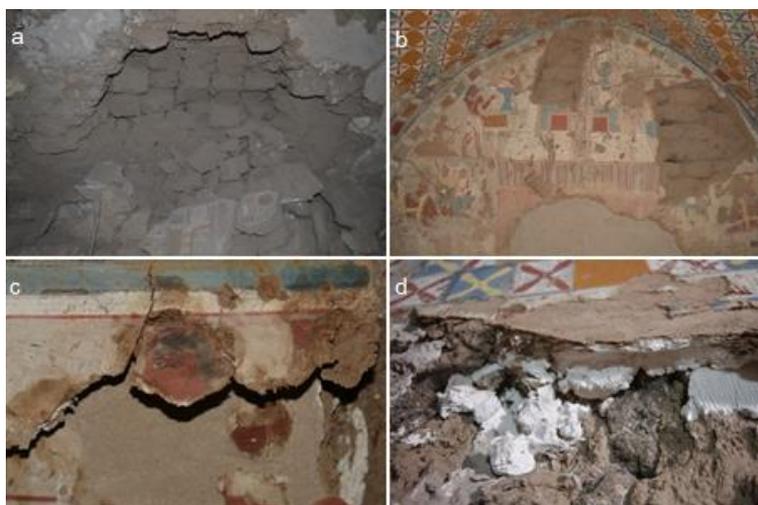
- Damage caused by deliberate or unintentional human acts were represented in the tomb of TeTany in different features as; desolation of many parts of the tomb during the demolition of houses in the old Qurna (Fig. 11a), also many wall painting parts at TeTiky tomb has been damaged due to looting, theft and demolition, the thieves cut off some parts of the mural in the tomb (Fig. 11b) for trafficking and the Louvre have recently returned several decorated sections from the tomb [10]. In addition, using inappropriate materials through ignorance of mudbrick techniques and the incompatibility of materials trying to protect the tomb by using cement, linen with gypsum mortar and organic binders which affected by biodeterioration (Fig. 11c and d).

Fig. 11. a- desolation of many parts of the tomb during the demolition of houses in the old Qurn:
 a and b - some parts of the mural were cutting off in the tomb for trafficking;
 c - Portland cement and organic binders affected by biodeterioration; d - Gypsum mortar with linen

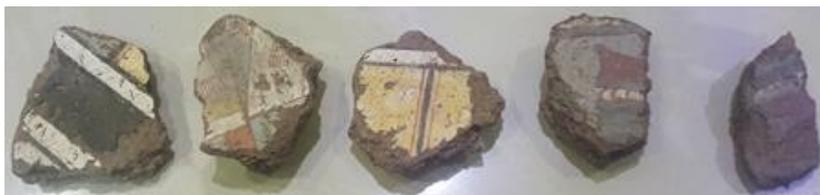
Fig. 12. Fragment of plaster with different pigments from TeTiky tomb, white, black, red, yellow, dark blue and grey

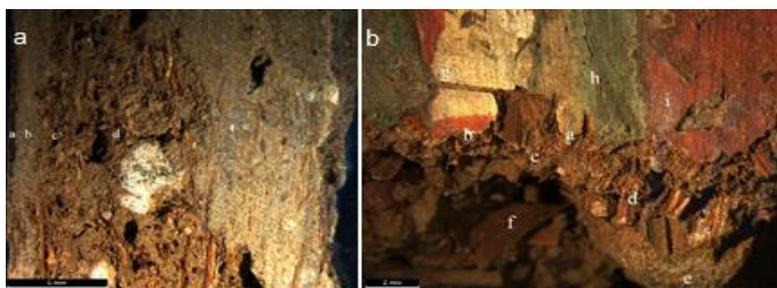
LOM photos of the cross-section sample from TeTiky tomb pointed out that, the underlying stratigraphy of the wall painting consists of coarse mud and straw plaster that was applied on the mudbrick walls in a layer approximately 1:2cm thickness, followed by a layer of a finer plaster containing fine clay and sand supplemented with a variety of chopped vegetable matter, the outer layer of fine gypsum plaster that functions as pigments support carrying the white ground color and other pigments (Fig. 13a and b). The photos revealed a network of gaps, missing parts, microcracks in the plaster and paint layer, and accumulation of extraneous material as dust, bird droppings on a surface leading to discoloration. The investigation of the yellow pigment sample shows the canary hue of the pigment which is applied in form of a single layer on the plaster layer, acclimation of extraction of insects and salts coated the yellow paint layer (Fig.14a and b). The investigation of the white pigment sample shows the presence of extensive holes and gaps in the ground layer resulted from Insect's attack (Fig. 15a). The investigation of the green pigment sample shows pale hue tends to gray, in addition to the weakness of the pigment (Fig. 15b and c). The investigation of the red pigment sample shows a thick layer of the paint layer with dark grains embedded in the layer and hairline crack observed clearly (Fig. 15d).

Fig. 13. Optical microphotographs of wall painting sample from **TeTiky tomb**, showing, the stratigraphy of wall painting: a - paint layer; b - gypsum preparation layer; c - mud fine plaster; d - mud coarse plaster; e - mud brick support; f - straw mixed with mud mouratr and plaster; g - white pigment, h-green pigment; i - red pigment

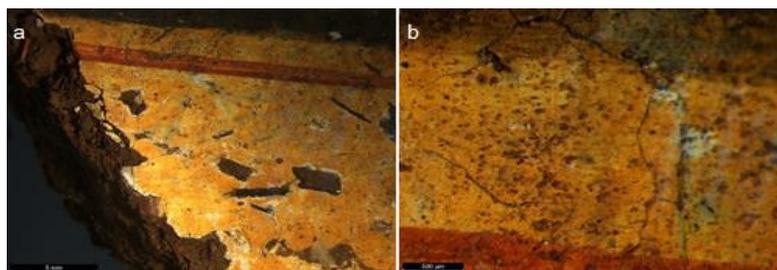
Fig. 14. Optical microphotographs of yellow pigment sample from TeTiky tomb, showing network of cracks, accumulation of extraneous material as dust, bird droppings on a surface

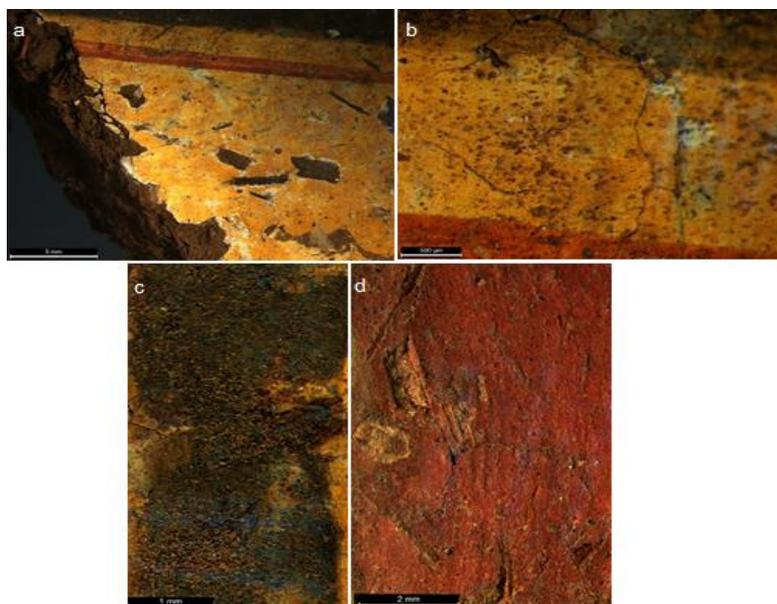
Fig. 15. Optical microphotographs of different pigments sample from TeTiky tomb, showing deterioration phenomena as network of microcracks, extensive holes, gaps and missing part of wall painting which affects their integrity, salt crystals on the surface

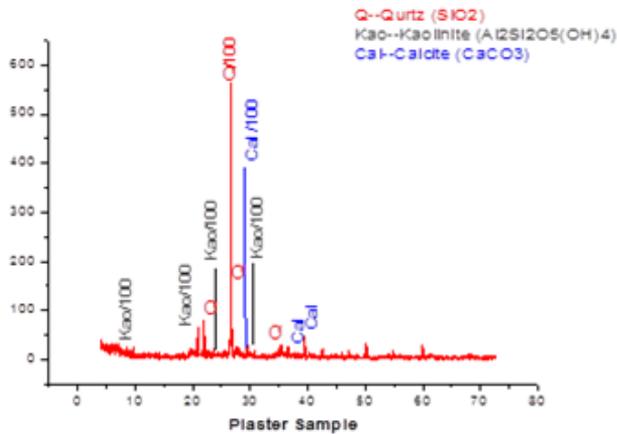
Mineralogical composition data of the wall painting samples is shown in figure 16. XRD data of the clay plaster (Figs. 16 and 17) indicates that quartz (SiO_2), calcite (CaCO_3), phyllosilicates and kaolinite - $\text{Al}_2(\text{OH})_4\text{Si}_2\text{O}_5$ compose mainly the ground layer. Most of the

Fig. 16. XRD pattern of mud plaster from TT15 tomb

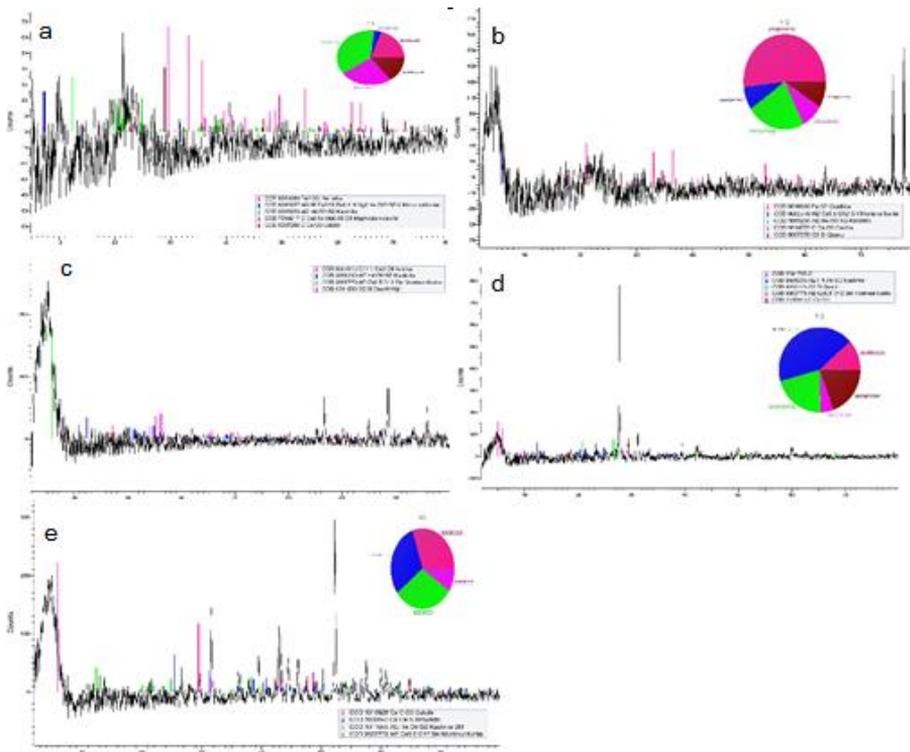
Fig. 17. XRD pattern of pigments sample from TT15; a- XRD pattern of red pigment, b- yellow pigment, c- blue pigment, black pigment, d- white pigment, e- mud Plaster

Mineralogical composition data of the pigment samples (Fig. 17) indicated that, the pigments in TeTiky tomb were those traditionally used in ancient as well as classical times and the differences found may be related to the impurities as well as the geological sources of the pigments used.

Red pigment: samples consist of a mixture of hematite - Fe_2O_3 , montmorillonite - $\text{Al}_2\text{O}_3 \cdot 4\text{SiO}_2 \cdot \text{H}_2\text{O}$, kaolinite - $\text{Al}_4(\text{Si}_4\text{O}_{10}) \cdot (\text{OH})_8$, magnesium calcite - $\text{CaMg}(\text{CO}_3)_2$ and calcite - CaCO_3 .

Yellow pigment: consists of a mixture of goethite - FeOOH , montmorillonite $\text{Al}_2\text{O}_3 \cdot 4\text{SiO}_2 \cdot \text{H}_2\text{O}$, kaolinite - $\text{Al}_4\text{Si}_4\text{O}_{10} \cdot (\text{OH})_8$] and quartz - SiO_2 .

Blue pigment: contain azurite - $\text{Cu}_2\text{CO}_3(\text{OH})$, montmorillonite - $\text{Al}_2\text{O}_3 \cdot 4\text{SiO}_2 \cdot \text{H}_2\text{O}$, kaolinite - $\text{Al}_4(\text{Si}_4\text{O}_{10}) \cdot (\text{OH})_8$, quartz - SiO_2 .

Black pigment: contains carbon C, Montmorillonite ($\text{Al}_2\text{O}_3 \cdot 4\text{SiO}_2 \cdot \text{H}_2\text{O}$, kaolinite - $\text{Al}_4(\text{Si}_4\text{O}_{10}) \cdot (\text{OH})_8$, Quartz SiO_2 and traces of calcite.

White pigment: sample consists of a mixture of and calcite - CaCO_3 , anhydrite - CaSO_4 , ontmorillonite $\text{Al}_2\text{O}_3 \cdot 4\text{SiO}_2 \cdot \text{H}_2\text{O}$ and kaolinite - $\text{Al}_4(\text{Si}_4\text{O}_{10}) \cdot (\text{OH})_8$.

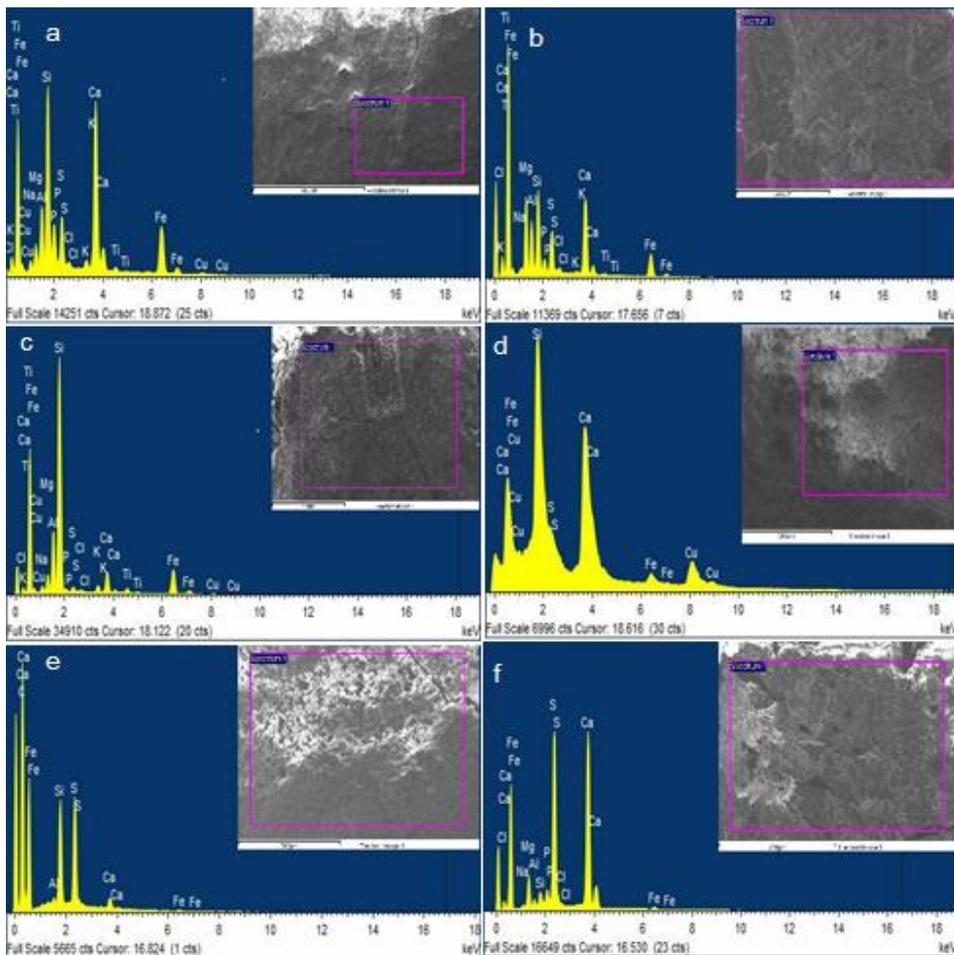
SEM-EDS examination in table 1 and figure 18 the results of the analysis carried out on the wall paintings from the tomb of GTT19.

Fig. 18. EDS spectra of the pigment samples from TeTiky tomb:
 a - red pigment; b - yellow pigment; c-blue pigment; d - green pigment;
 e - black pigment; f - white pigment

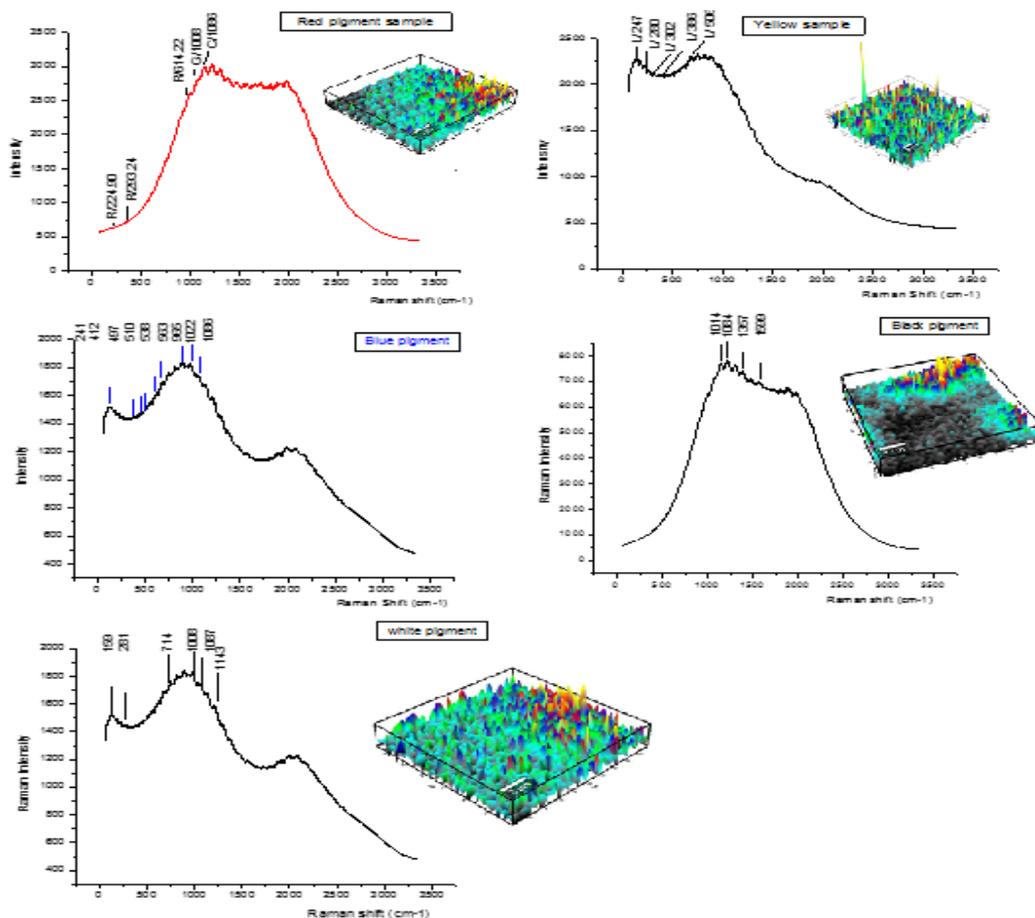
A μ -Raman spectrum recorded on the red pigment (Fig. 19a) shows the characteristic bands at $\sim 226, 298, 408$ and 614cm^{-1} are attributed to hematite.

A μ -Raman spectrum recorded on the yellow pigment (Fig. 19b) shows the characteristic bands at $\sim 247, 280, 302, 386, 460$ and 506cm^{-1} were recorded, which refers to goethite.

A μ -Raman spectrum shows the characteristic bands of Egyptian blue (calcium copper silicate, $\text{CaO}\cdot\text{CuO}\cdot 4\text{SiO}_2$) (fig.19c). Egyptian blue is identifiable through the characteristic bands at $1022, 965, 563, 538, 510, 497, 412, 328, 361, 241\text{cm}^{-1}$. The band at 1086cm^{-1} is attributed to calcite - CaCO_3 . Few spectra at 200 and 400cm^{-1} is probably due to the presence of quartz and amorphous silica.

A μ -Raman spectrum of the black pigment (Fig. 19d). There are peaks at 1355 and 1592cm^{-1} , indicating that carbon was used in the pigment.

A μ -Raman spectrum of the white specimen (Fig. 19e), which contains peaks at $281, 711$ and 1085cm^{-1} . The Raman peak wavenumbers of the white pigment are in very good agreement with those of calcite.

Fig. 19. μ - Raman spectra of the pigment samples of TeTiky tomb red sample: a - yellow sample; b - blue sample; c - black sample; d - the white sample

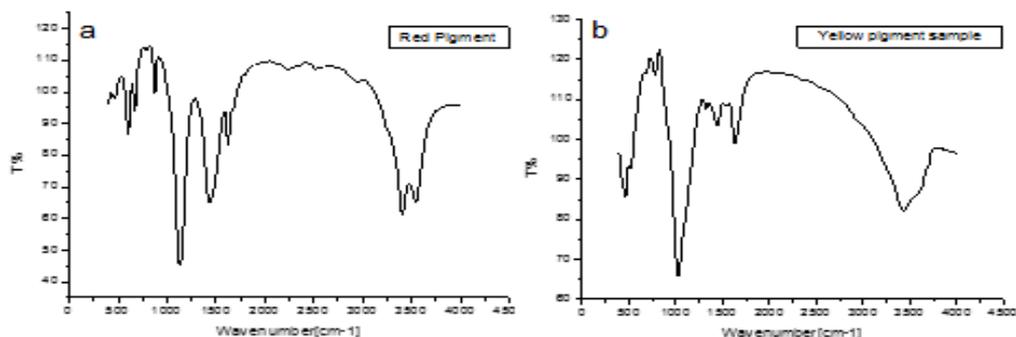
FT-IR spectra from the red pigment gave intensive band at 3620 and 3432cm^{-1} the signature of stretching band of (OH) group, 1630cm^{-1} is the fingerprint region of bending band of (OH) group 1430cm^{-1} is the stretching band of (C-H) group, 1120cm^{-1} , 790cm^{-1} , 640cm^{-1} , 440cm^{-1} are characterized of C-O stretching bands (Fig. 20a) FT-IR spectra from a yellow pigment gave intensive band at 3420cm^{-1} , 1626cm^{-1} , 1340cm^{-1} , 1022cm^{-1} and 462cm^{-1} (Fig. 20b). From the above-mentioned results, so Arabic gum is highly recommended to be the binder of these pigments.

Fig. 20. FTIR spectra: a - red pigment sample; b - yellow pigment sample of pigments samples from TeTiky tomb
