SCIENTIFIC CONSERVATION OF THE OUTSTANDING THEATERS OF THE 19th CENTURY AND THEIR INFLUENCE ON THE CREATION OF MODERN ART-SPACE

Abstract

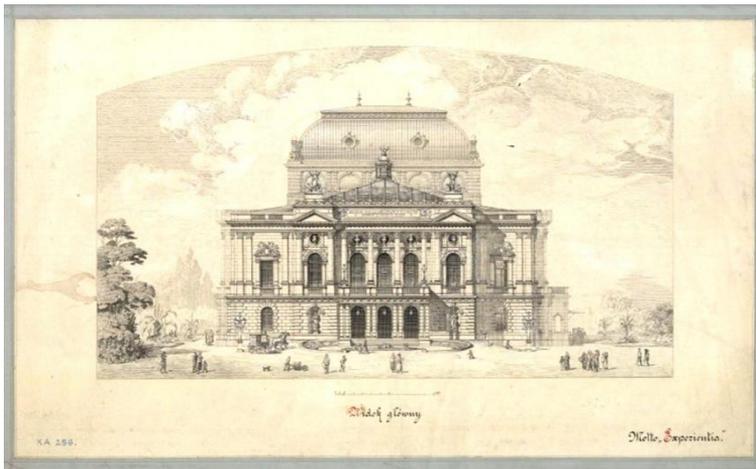
Fig.2. The project of the Municipal Theater in Cracow by F. Fellner and H. Helmer.

It is worth noting that at one time, the Vienna office of F. Fellner and G. Helmer also took part in the first contest (there were two) for the construction of the Municipal Theatre in Cracow. The drawing, presented by them, is kept in the National Archives in Cracow (Archiwum Narodowe w Krakowie) nowadays (Fig. 2).

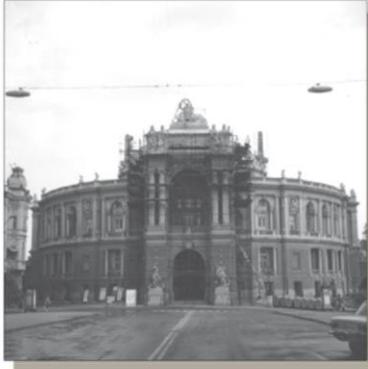
a. The condition of the facade of the Opera House before the restoration.

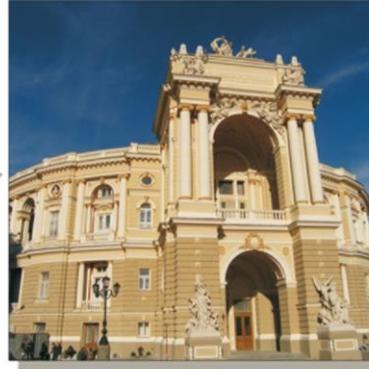
b. After the restoration. 2007.

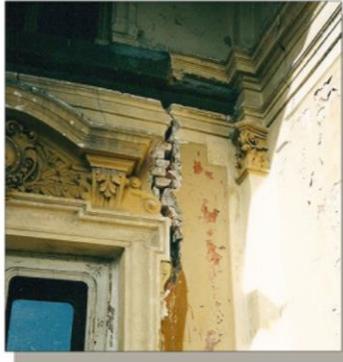
a. Emergency condition before restoration.

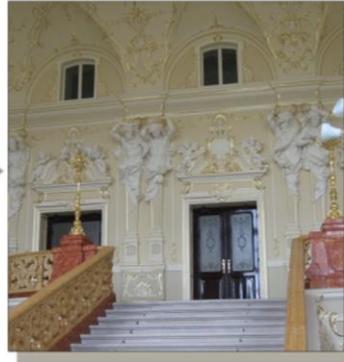
b. After the restoration, 2007.

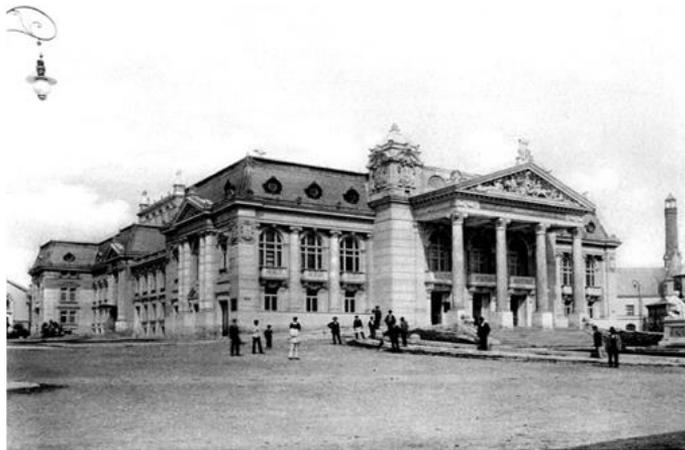
Fig. 6. The image of the National Theater of Iasi (1922), with the Power Plant on the right

Along with the theater, its power plant (Fig. 6) was inaugurated, which marked the beginning of electric lighting in Iasi.

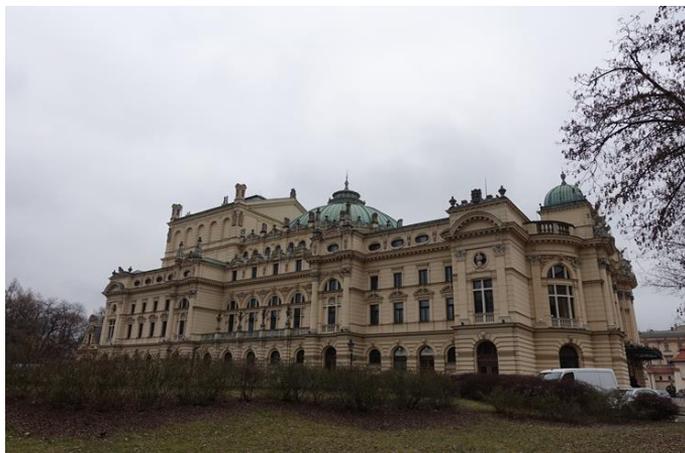
Fig. 11. View of the facades and dome of the theater from Plant. Photo by K. Paprzyca, 2021.

The most economical span of steel roof purling is 6.0m with an interval of 80–200cm, averaging about 120cm. It was a widespread solution at that time. Riveted steel lattice purlings were used in the stage roof; the double-gable structure was fixed in the upper part longitudinally (Fig. 11).
