HYDROPHOBIC CONSOLIDANTS FOR TREATMENT OF GRANITIC SCULPTURES AT TELL BASTA, EGYPT: A CASE STUDY

Ragab ABOU-ELHASSAN^{1,*}

¹ Department of Restoration and Conservation, Faculty of Archaeology and Tourism Guidance, Misr University for Science and Technology, Cairo, Egypt.

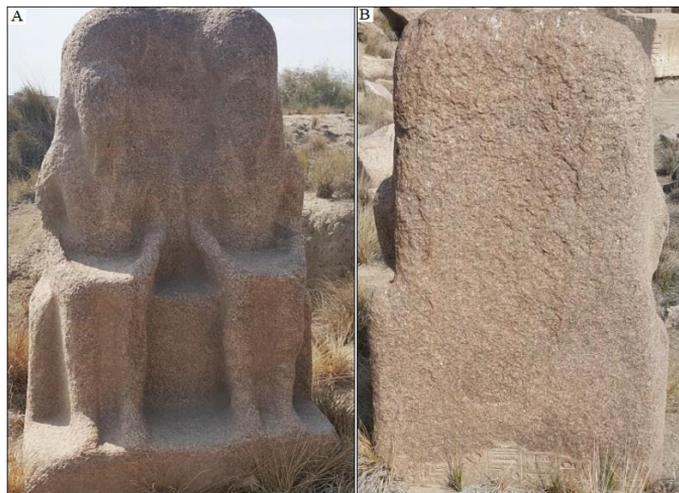
Fig. 2. Front and back views of the studied granitic statue of Ramesses II (A) accompanied by the god Amun-Ra at Tell Basta (B)

The case study is a granitic statue of Ramesses II accompanied by the god Amun-Ra (Fig. 2) that was discovered in the temple of Bastet. The statue has been subjected to aggressive deterioration factors such as variation in temperature, solar radiation, moisture, rain, dusty

winds, and air pollutants. Due to the previously mentioned deterioration factors, the studied statue was manifested by numerous physicochemical and mechanical deterioration symptoms such as fragmentation, scaling, fissures, efflorescence, brittleness, and loss of its original features [4-10].
