## CONSERVATION OF THE RESIDENTIAL AND PUBLIC ARCHITECTURE OF THE 19<sup>TH</sup> - EARLY 20<sup>TH</sup> CENTURIES (ON THE EXAMPLES OF KYIV AND CRACOW)

### Abstract

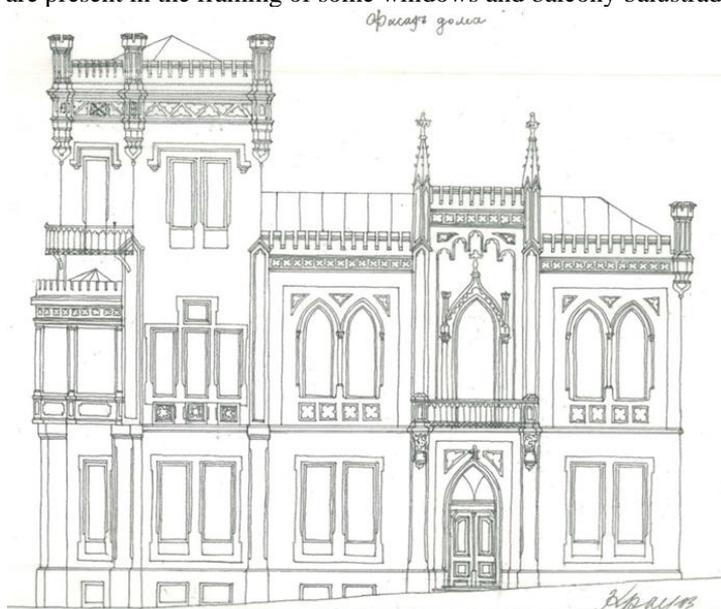
**Fig. 1.** The main facade of the mansion at 34 Taras Shevchenko Boulevard.

The second group of buildings is characterized by the presence of emphatically detailed Gothic decor in combination with specific forms – towers with pinnacles and finials, lancet windows and entrances. These are mainly mid-rise "elite" commercial apartment buildings with multi-room expensive flats (the house at 10 Malopidvalna Street and similar houses at 2b and 2v Andriivskiy Descent, buildings at 19 Shovkovychna Street, 1 Yaroslaviv Val Street, 34 Pushkinska Street, at 31 Taras Shevchenko Boulevard). The same group includes mansions at 14 Pankovska Street, 34 Taras Shevchenko Boulevard (Fig. 1), and 4 Verkhniy Val Street (Fig. 2).

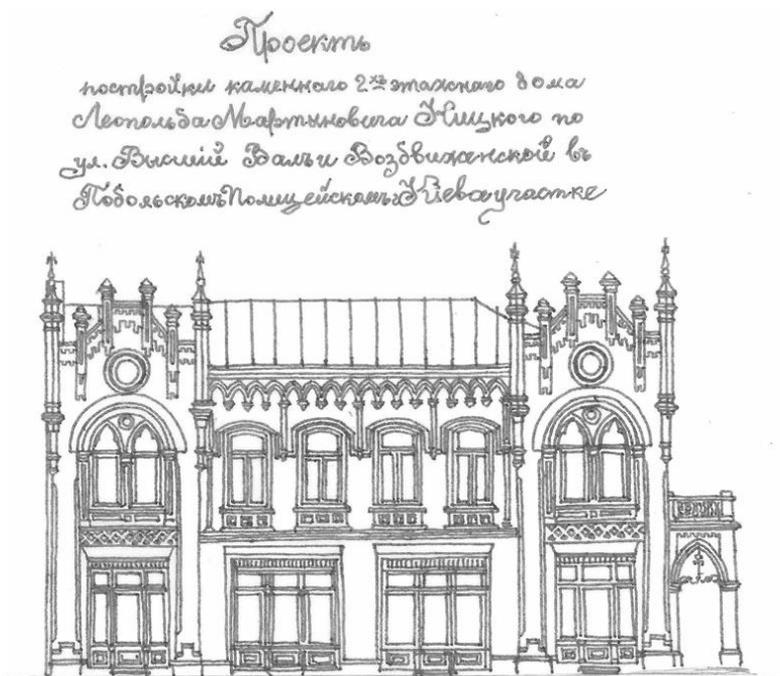
Fig. 2. The main facade of the house at 4 Verkhniy Val Street.

The neo-Gothic character shows in a corner bay window in the stylized medieval tower and a balcony on the top floor. Consequently, the signs of Art Nouveau are present primarily in the side parts of the facade on the 1st – 3rd floors and in the solution of the entrance part; the signs of neo-Gothic are visible in the solution of the central part and the upper floor with crowning.

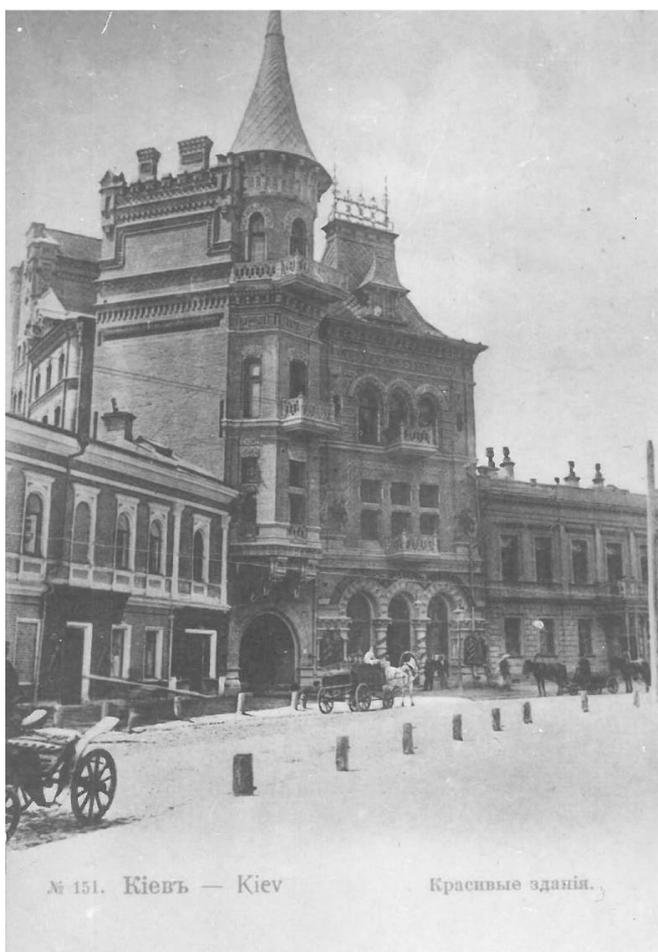
**Fig. 3.** The exterior of the house at 1 Yaroslaviv Val Street.  
The pre-revolutionary postcard from the funds of Y. Ivashko

Since historicism with elements of Gothic became a stylistic trend primarily for the mid-rise commercial apartment buildings, it explains the simplification of forms and especially of the Gothic decor on the facades, as such decor was expensive. House owners rarely spent money on decorating facades with Gothic ornaments with plant motifs and stylized machicolation instead of intermediate cornices; in Kyiv, there were practically no examples of the classic solution of a Gothic window with a wimperg – a high acute-angled carved gable above it. The stylized wimperg is present only on the facades of the houses at 19 Shovkovychna Street and 31 Taras Shevchenko Boulevard. A much more prevalent technique was the use of the lancet form of window and door openings without framing decor. For the same economic reasons, the owners very rarely ordered Gothic facades to be crowned with towers and pinnacles with spires in their house designs, the ribs of which in Gothic architecture were decorated with crocket – decor in the form of a leaf or a flower. Medieval Gothic pinnacles and gables were traditionally crowned with a finial or a figured spire. The stylized pinnacles are present only in five Kyiv buildings with Gothic elements – at 19 Shovkovychna Street, 23 Hoholivska Street, 4 Verkhniy Val Street, 31 Taras Shevchenko Boulevard and at 15 Andriivskiy Descent. Pinnacles adorn the side wings of the building, or its central part, and sometimes both. Examples of the most successful stylized neo-Gothic gable are the gables on the main facades of houses at 19 Shovkovychna Street and 23 Hoholivska Street. A bay window tower on several floors with a high spire is present only in the famous "House with Winged Monkeys" at 1 Yaroslaviv Val Street, where an accent bay window tower, giving rise to analogies with the French castles of Chaumont and Le Roy on the Loire, is in harmony with the high "French" roof (Fig. 3).

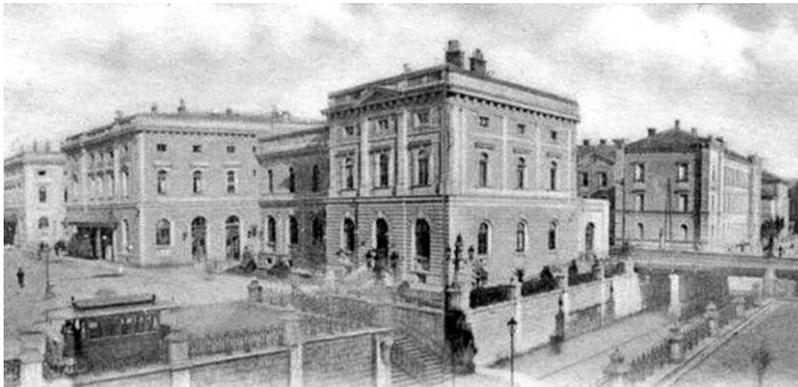
**Fig. 4.** The view of the Main Railway Station building at the beginning of the 20th century. Photo: Archives of Department of History of Architecture and Monuments Preservation, Faculty of Architecture, Cracow University of Technology

It should also be noted that the object comprises three massive cubic risalits. As the main accent of the composition of the building, one should name the side facades which rise above the railway tracks in acute-angled arcades, crowned with four narrow acute-angled turrets, between which two exits to the platforms are designed. The arcades are completed by a high attic with niches with semicircular or segmental arches. The facades are decorated with inter-floor and under-window friezes and under-window panels. Iron is widely used in the structures of the building, and the structures themselves acquired a neo-Gothic character, which subsequently led to the popularisation of iron structures in the Cracow architecture of the period. It should be noted, however, that the building was slightly altered and partially lost its original appearance.

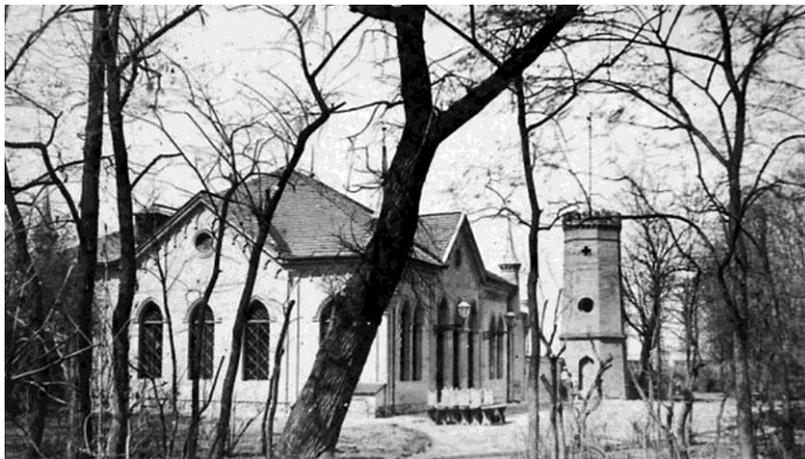
**Fig. 5.** The view of the building of the Shooting Society at the beginning of the 20th century. Photo: Archives of Department of History of Architecture and Monuments Preservation, Faculty of Architecture, Cracow University of Technology

The volume of the building, closely attached to the protruding arched portico, differentiated in height. Bearing and non-bearing walls are made of bricks. In the main hall, the floors are ready-made building elements on steel jacks. In the basements, there are barrel (cradle) vaults on dividing arches. Above the entrance portico, there is a vault based on an acute-angled arch, and there are cradle-type vaults in the hall, the rearward indoor spaces, as well as in the basements. The building is erected on the plan of an irregular quadrangle with an expressive drop in the main hall section. Its facades are made of unplastered bricks, except for the rear facade, and are decorated with beautiful brick details.

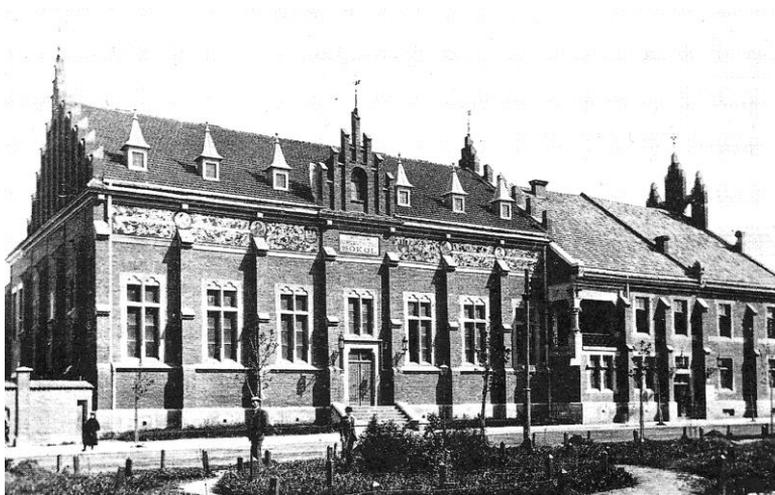
**Fig. 6.** The view of the building of the "Sokol" Gymnastic Society at the beginning of the 20th century.  
Photo: Archives of Department of History of Architecture and Monuments Preservation,  
Faculty of Architecture, Cracow University of Technology

The next notable example of a neo-Gothic public building is the edifice of the Gymnastic Society "Sokol" at Pilsudskiego Street, designed in 1889 by Karol Knaus and implemented five years later by Teodor Talowski (Fig. 6) [13]. The object has two expressive parts, which is associated with the already mentioned construction. Both parts are based on a rectangle, but the later part of the building is slightly wider and protrudes in front of the volume designed by K. Knaus which is more balanced in architectural appearance. The part of the building realized by T. Talowski is freer in terms of detailing, but it harmoniously combines with the earlier one. The main façade of the earlier part is symmetrical, with seven axes, accentuating the entrance and highlighting the axes with large rectangular windows, between which there are buttresses typical for Gothic. The main facade of the later part of the building has five axes; the entrance is located on the middle axis. Just like his predecessor Knaus, Talowski used here the buttresses which visually joined two parts from different times into one. The side facades are also a Gothic nod through the use of pointed tops and buttresses. The building is decorated with a fresco by the artist Frederick Lachner and interior decor by Anthony Touch [7].

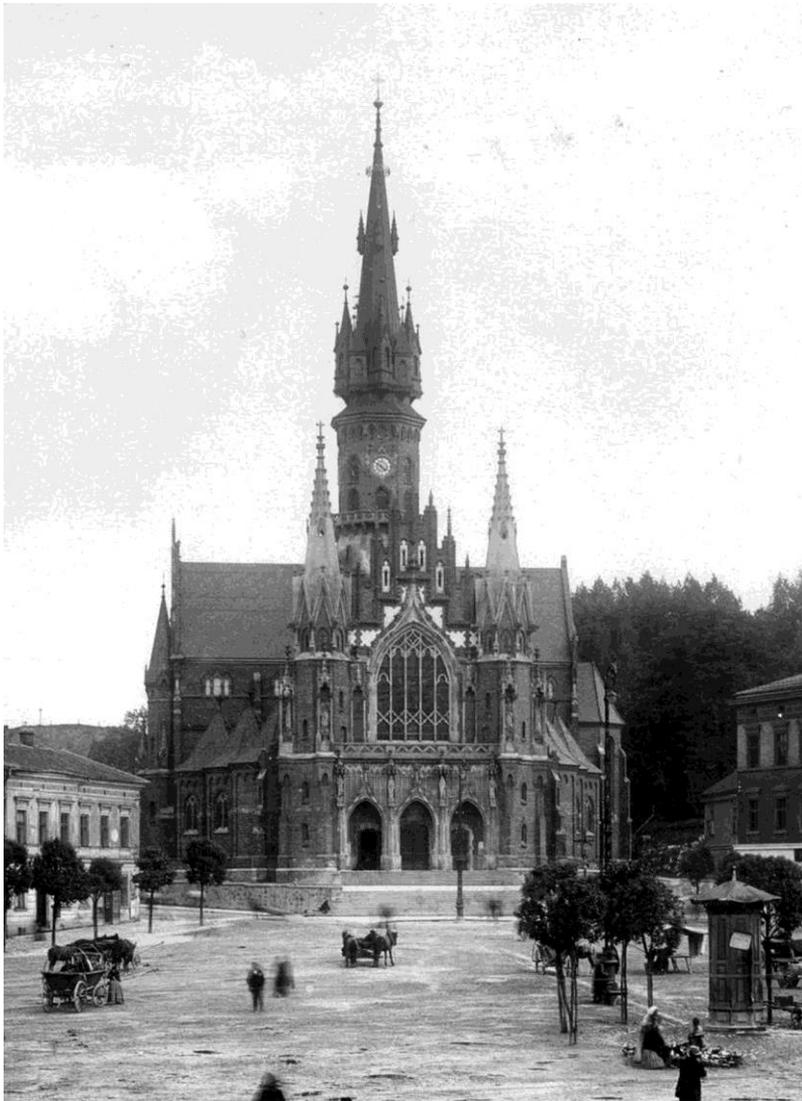
**Fig. 7.** The view of the Church of St. Joseph in Podgórze at the beginning of the 20th century.  
 Photo: Archives of Department of History of Architecture and  
 Monuments Preservation, Faculty of Architecture, Cracow University of Technology

In the group of the sacred neo-Gothic objects we should mention the Church of St. Joseph in Podgórze, built according to the design by Jan Sas-Zubrzycki in 1905 – 1909 (Fig. 7). Initially, the architect completed a competition project for the design of the Church of the Savior in Warsaw. Later the primary idea was somehow modified. It should be noted that the project fully corresponded to the context of the site, i.e. Podgorski Market [12]. Earlier on this site there was a church in the classicist style, which, due to its insufficient size, could not accommodate the number of believers. The church, built at the beginning of the 20th century, was a three-nave building with a transept, an ambulatory around the presbytery and the chapels at the side aisles. The building is crowned with ribbed cross vaults. The dominant feature of the shrine is a tower that rises above the "kamienice" (residential tenement buildings made of brick or stone) around the Podgorski market and imitates the tower of Saint Mary's Basilica. The interior of the church is designed according to the Gothic model in the style of "Vistula" Gothic with numerous altarpieces, pews, and other attributes of religious activity, made of wood. Wall decor in the form of polychrome and sculptures was executed by Bukowski *et al* [6].

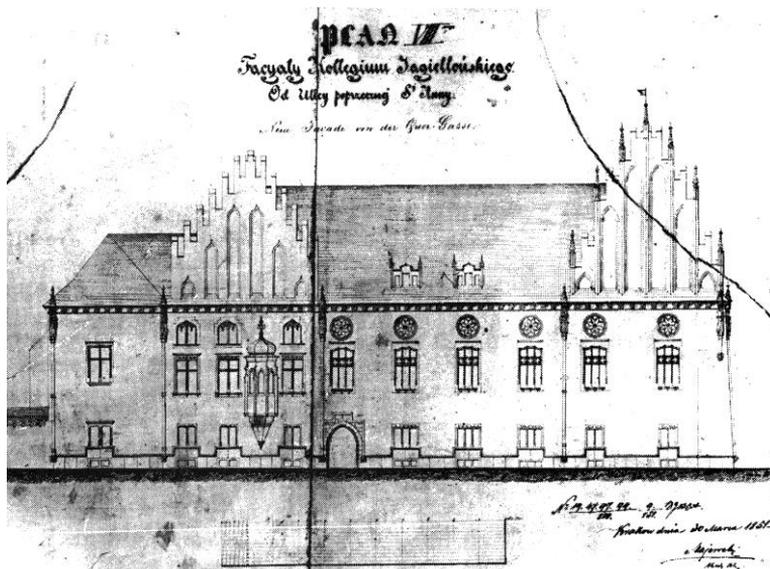
**Fig. 8.** An engraving depicting the facade of the Collegium Maius from the side of Jagiellońska Street, according to the project of T. Maevsky's reconstruction. Electronic copy:  
Archives of Department of History of Architecture and Monuments Preservation, Faculty of Architecture, Cracow University of Technology

It is impossible to ignore the restoration activities, which were often carried out in the neo-Gothic style in the indicated period. In this regard, at least the example of restructuring of the Collegium Maius, which took place in three stages, should be mentioned. The first stage (restructuring of the eastern wing) took place under the supervision of Karol Kremer, the second – Tomas Majewski (Fig. 8), the third – Felix Księżarski. Among other things, the changes affected the volume of the internal staircase, the installation of new window openings and new ornamentation, which used the style of different eras. The atmosphere of authenticity was created by ancient architectural details, as well as sculptures transferred here from other Cracow sites. A reference to the "Gothic of the Crusaders" is the use of the types of pointed arches, characteristic for the "Vistula-Baltic" Gothic [6]. In addition to the general praise of the described restoration, it should also be noted that such a clear interference in the structure of an architectural monument led to criticism of some members of the restoration industry.
