INFLUENCE OF STORAGE CONDITIONS OF ALABASTER MONUMENTS ON THE NATURE OF SURFACE CONTAMINATION

Olena LOTOTSKA^{1,*}, Viktoria KOCHUBEI²

¹ Lviv Polytechnic National University, Department of Restoration of Architectural and Artistic Heritage, 12 Bandera Str., 79013 Lviv, Ukraine.

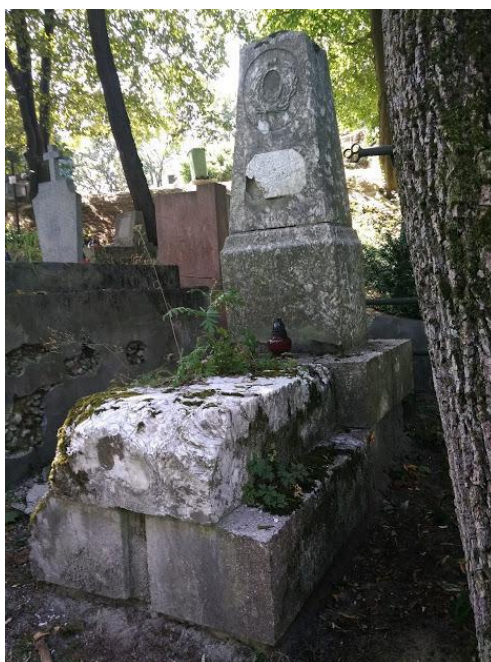
The headstone is located in the park area of Lychakiv Cemetery, in the open, without protection from climatic factors, and in a high humidity area (Fig. 1).

Fig. 1. Overall view of the alabaster headstone from the Lychakiv Cemetery

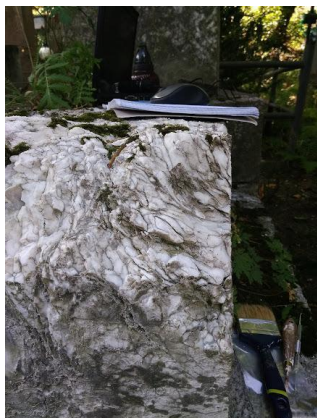
Water caused dissolution, corrosion, cracking of crystalline mass of the stone (Fig. 2).

Fig. 2. Deep cracking of the stone

Therefore, the main problem is water in any state of matter. Water causes dissolution, corrosion, cleavage and cracking. To preserve the alabaster tombstone, it is important to install horizontal and vertical waterproofing around the perimeter of the object to prevent water from entering the stone. To preserve the baptismal fonts from the courtyard of the Dormition Church and The Pidhirsi Castle, it is important to ensure stable climatic conditions, to store the fonts in a dry place, where the humidity does not exceed 60%. The problem of structural strengthening is that the stone, namely clay minerals, are supersaturated with moisture, thereafter their volume

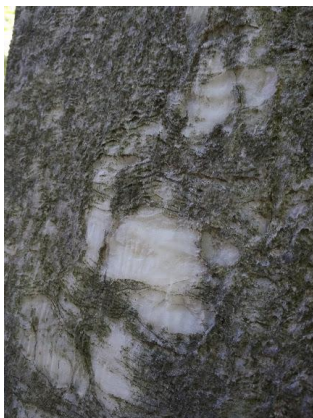
Because of water pressing on the headstone, thin furrows were formed in the direction of the water flow. The consequence of high humidity is the dissolution of crystalline mass and excessive moistening of clay impurities (Fig. 3). Minerals that make up clay can absorb moisture, increase in volume, and release moisture at high temperatures. Sudden temperature change causes the formation of new cracks and increases the size of the existing cracks in the stone. Ceaseless process of the cleavage of alabaster can be seen on the headstone. In fact, cracks form in the lines of clay veins (Fig. 4).

Fig. 3. Dissolution and corrosion of crystalline mass, volume increase of clay component

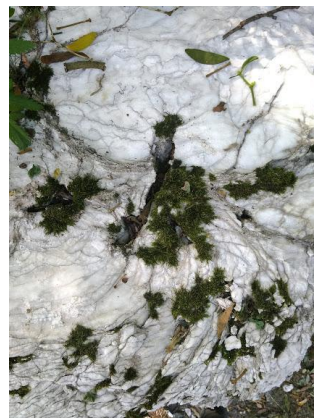
Dust, clay, and sand brought by wind to the surface of the stone act as a substrate for the development of the organic matter, and high humidity creates favourable conditions for its growth. Cavities and cracks are filled with dirt and become inhabited by small insects and microorganisms. The organic components, such as moss, lichens and vascular plants, are evident (Figs. 5, 6 and 7).

Fig. 4. Evolution of organic matter on the stone surface

Their roots grew deep between the alabaster crystals that led to deep cleavage and breaking of crystalline mass of the stone. Small insects, cobwebs and larvae inhabit cavities, cracks and hollows.

is to some extent increased. The stone must be dry in order to be strengthened. Hence, there is a problem of stabilization of water content in the structure of the stone. Elimination of biological damage causes a number of problems: to stop the growth of the root systems of mosses and vascular plants; to remove the remnants of organic matter from the pores, cracks, hollows without destroying the stone; to carry out antiseptic procedures to disinfect the deposits of biological material. The problem of removing surface contamination is to choose effective and non-destructive cleaning methods and materials. Thus, water, strong acids, alkalis and mechanical cleaning lead to the destruction of the crystalline mass. In addition, it should be noted that the damaged surface of the stone is vulnerable to any external factors [15, 16].

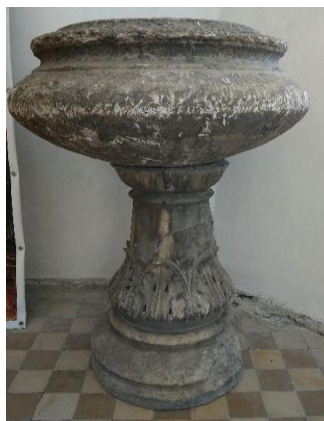
The alabaster baptismal font is kept in one of the halls of Pidhirtsi Castle. It dates back to the 19th century. The alabaster baptismal font consists of two parts: a basin and a pedestal (Figs. 9-11). The font is 110cm long. It is kept at the entrance to the hall of Pidhirtsi Castle (Pidhirtsi Castle is located in the village of Pidhirtsi in Lviv Region. The castle is a late

Fig. 9. Overall view of the alabaster baptismal font

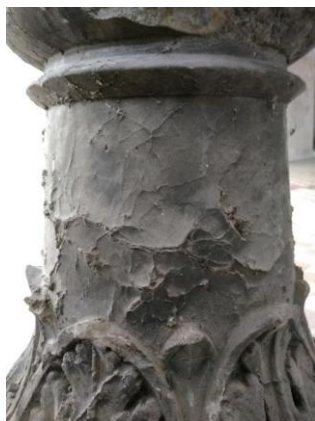
Fig. 10. Cleavage, cracks and dirt on the pedestal surface of the alabaster baptismal font

The baptismal font pedestal has deep cracks and stone cleavage, as well as a thick incrustation of black patina and dust contamination. Protruding formations on the surface of the stone, confined to the cracks, are documented (Fig. 10). The cracks and cleavage appeared because of sudden temperature change and frequent soaking of the stone.

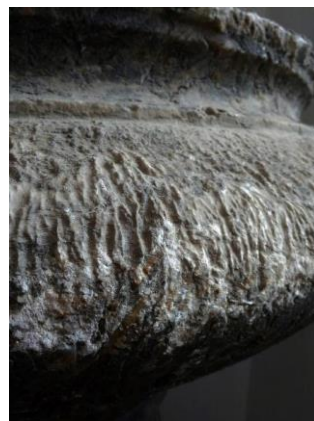
Fig. 11. The flowing water effect. Dissolution of alabaster crystalline mass in the direction of water flow.

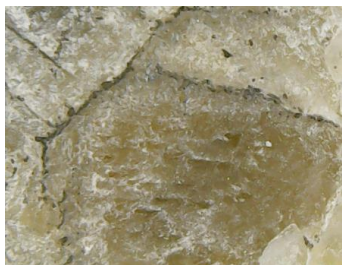
The alabaster's clay component can facilitate the formation of cracks on the surface of the baptismal font. It is known that clay minerals with a swellable component can actively absorb moisture. It is known that when water freezes (in cold seasons) it can increase in volume. It leads to the appearance of internal pressure in crystals, under the influence of which the existing cracks increase and new cracks form on the alabaster surface. Rise in air temperature and exposure to direct sunlight lead the clay minerals to the loss of surface water. This causes dehydration and breaking of clay inclusions from the crystalline mass, and formation of microcracks.

Microphotographs of cracking of alabaster crystalline mass and cracks filled with surface contamination are presented in Figures 12-14.

Fig. 12. Microphotograph of the cracking of crystalline mass, and

filling of the cracks with dirt

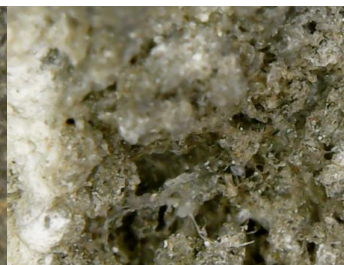
Fig. 14. Clusters of dirt. Surface formations confined to cracks

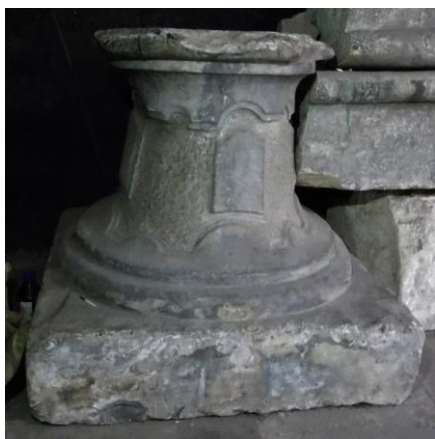
The alabaster baptismal font is kept in the courtyard of the Dormition Church in Lviv. It dates back to the 18th century. The baptismal font consists of two parts: a basin and a pedestal (Fig. 16). It is made of grey banded alabaster. The baptismal font is whitewashed in several layers with a lime mortar, which formed a solid carbonized encrustation on the surface of the stone (Fig. 17).

The baptismal font was kept disassembled in the courtyard of the Dormition Church (the pedestal was separated from the basin). The Dormition Church is a working church in Lviv, built in 1591-1629; made of brick and ashlar stone, situated in the centre of Lviv, where a large number of toxic gases, combustion gases and dust is emitted.

Fig. 16. The baptismal font pedestal

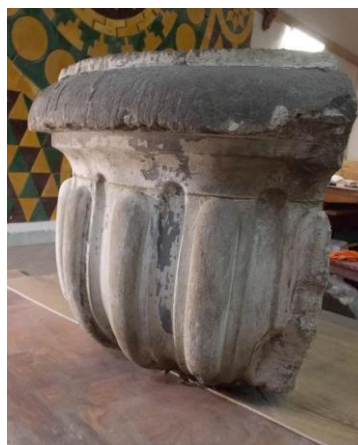
Fig. 17. A part of the baptismal font basin

For a long time, the baptismal font served as a flowerbed, and was placed under the gutter. It was in no way protected from the direct sunlight, rain or snow. Because of water pressing on the stone surface, in the direction of the water flow thin furrows were formed (about 2 to 4mm). The surface became ribbed and uneven. Small internal cracks, confined to the clay impurities area, are noticeable (Figs. 18-20). Such microcracks are caused by hydration-dehydration cycles and changes of atmospheric temperature.

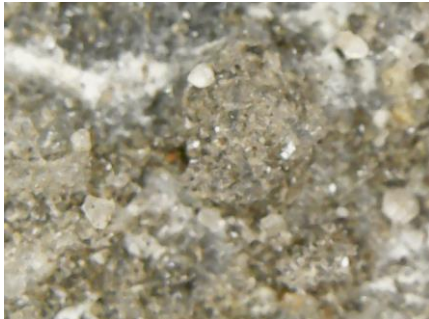
Microscopic study shows the clusters of contaminants with inclusions of various kinds - fibres, sand, clay, living organisms, and products of metal corrosion (Figs. 21 and 22).

Fig. 21. Micrograph of the dirt on the basin of the alabaster baptismal font

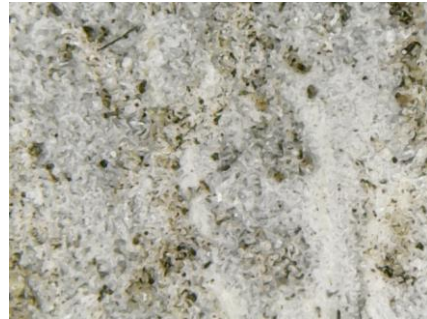
Fig. 22. Micrograph of limewash on the basin of the alabaster baptismal font

The sample of the encrustation with a near-surface layer of alabaster contains a significant amount of CaCO₃ and Ca(OH)₂. According to the micrography, it is due to the limewash on the surface of the stone.
