EXPERIENCE OF RESTORATION OF MURALS OF THE TRINITY GATE CHURCH IN KYIV: OVERVIEW

Abstract

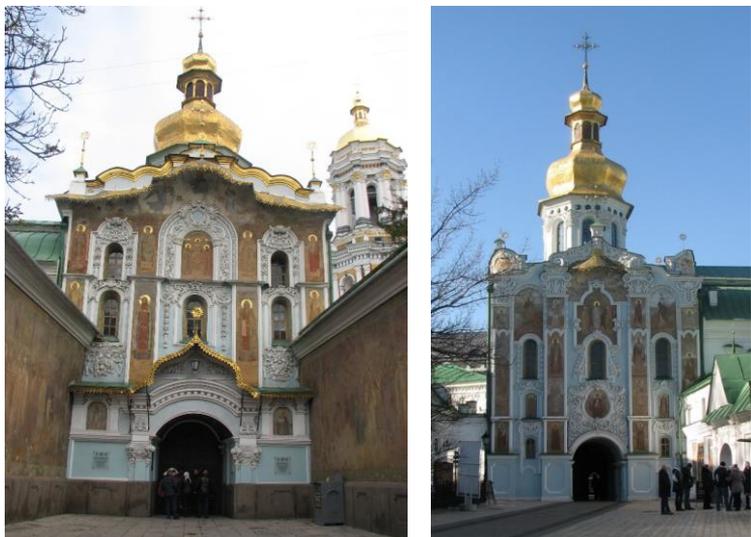
walls (11 images on the western facade and 19 on the eastern facade) (Fig. 1). At the same time, paintings were carried out in the interior of the temple.

Fig. 1. Trinity Gate Church. General view of the western and eastern facades

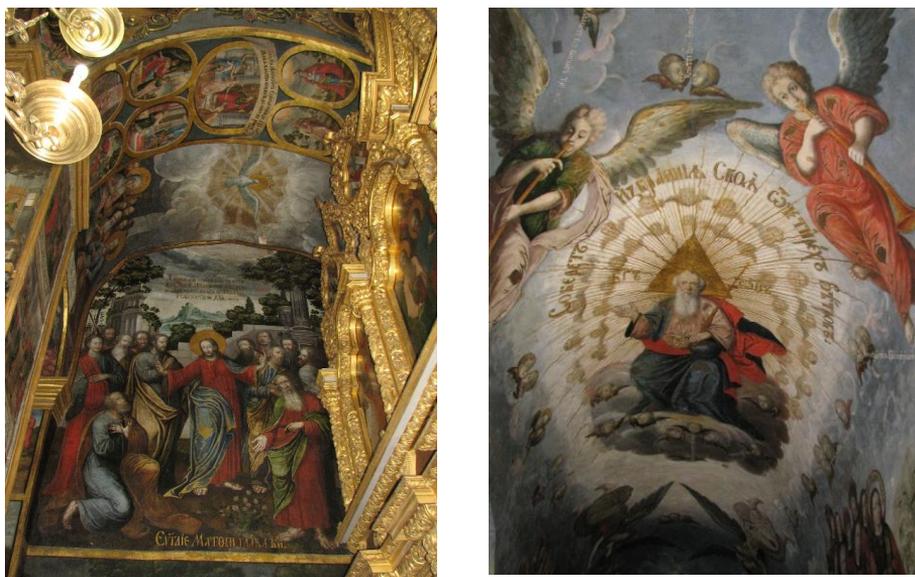
Using samples of Western European engravings, the best representatives of the Kyiv school of painting decorated the Church with a unique mural in oil technique (Fig. 2). Since its creation, interior and exterior paintings have been repeatedly refreshed and renewed, which was seen as a manifestation of concern for ancient painting and was the only means of preserving it until the early 20th century.

Fig. 2. Fragments of the interior paintings of the Trinity Gate Church

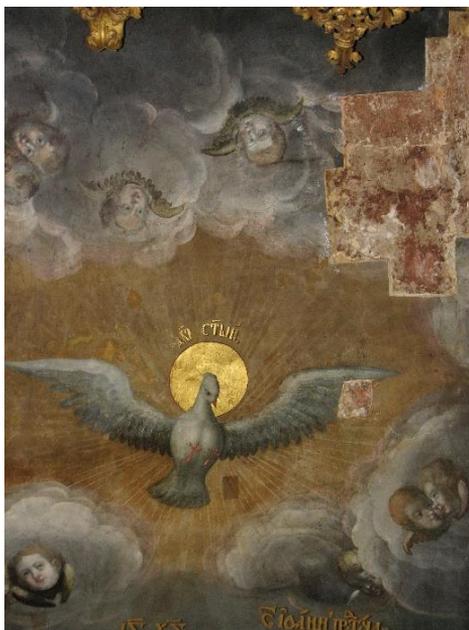
found in the sample. The study of the structural layers of the painting showed that a layer of adhesive red ocher and a layer of adhesive-chalk gesso glued with gelatine were applied on top of the plaster. The presence of red paint layer is a characteristic feature of the murals of the 17th century [22]. According to the results of probes made by restorers in some areas, most of the ancient masonry of the Church has preserved the original plaster with the remains of a painting that could date back to the 17th century. The probes showed ocher, black, red, gray and blue colors (Fig. 3). In general, the probing method found only about 100m² of adhesive painting on the vaults of the Trinity Gate Church. In the 20-30s of the 18th century the interior of the Church was renovated in oil technique. Lead whitewash, ocher, bleu d'azur, verdigris, copper lapis-lazuli, indigo, cinnabar was found in the palette of used pigments [13-17].

Fig. 3. Probe with the disclosure of the remnants of the adhesive painting on the composition of the southern vault of the transept

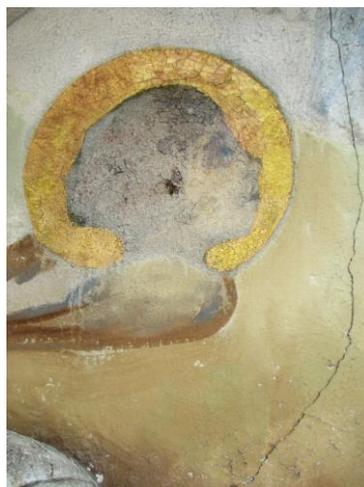
Fig. 5. Blushing of lacquer film and change of tone of restoration tinting. Fragment of the western facade
