# INTERNATIONAL JOURNAL CONSERVATION SCIENCE

ISSN: 2067-533X Volume 13, Issue 1, January-March 2022: 147-162

## STATE-OF-THE-ART TECHNOLOGIES OF IMITATION OF MURAL PAINTING FROM THE KYIVAN RUS AND BAROQUE PERIODS IN THE RECONSTRUCTED ST. MICHAEL GOLDEN-DOMED CATHEDRAL IN KYIV

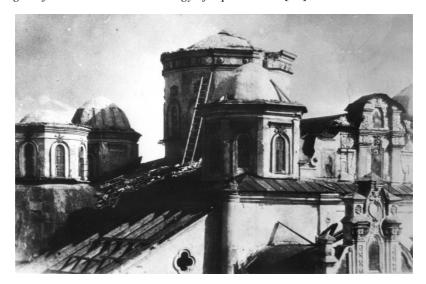
**Fig. 1.** Destruction of St. Michael's Golden-Domed Cathedral. Photo is from the stock of Ukrrestavratsiia Corporation

St. Michael's Golden-Domed Cathedral was destroyed in 1934 – 1937 (Fig.1), the part of the unique ensemble that survived included only a part of the walls, cell buildings, refectory church, and a small part of mosaics and frescoes in museums and a high relief of Archangel Michael from the pediment of St. Michael's Cathedral. The history of the construction, destruction, and reproduction of the unique ensemble of St. Michael's Golden-Domed Monastery is described in detail in M. Orlenko's monograph, *St. Michael's Golden-Domed Monastery. Methodological foundations and chronology of reproduction* [42].

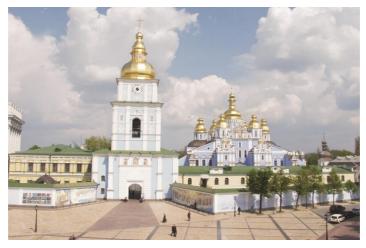
Fig. 2. Current state of St. Michael's Golden-Domed Monastery restored according to archival photographs. Photo is from the stock of Ukrrestavratsiia Corporation

The reproduction of this unique ensemble was started in accordance with the order of President of Ukraine Leonid Kuchma and the order of head of the Kyiv city administration O. Omelchenko, mainly at the expense of the Kyiv budget. The general contractor was Ukrrestavratsiia Corporation, and the architectural part of the project was developed by Yu. Losytskyi Architectural Workshop (Figs. 2 and 3).

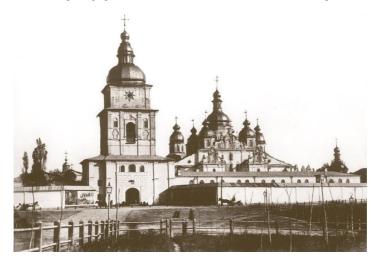
**Fig. 3.** An archival photo of the St. Michael's Golden-Domed Monastery. Photo is from the stock of Ukrrestavratsiia Corporation

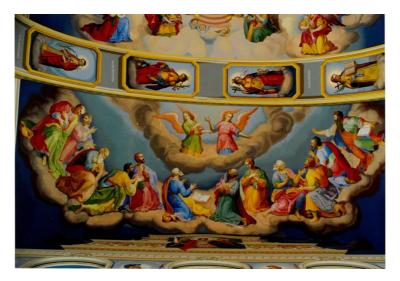
**Fig. 8.** The lower part of the composition "Queen of Heaven". The Apostles. Photo taken by the author, S. Baiandin

- murals of completion: there are images of cherubim in the skoufos, the eight Prophets in the sub-dome space, fire seraphim are pictured on the pendentives, the northern and southern walls of the sub-dome space have pediments with angels with cartouches "Lord of Hosts" and "Jesus Christ", on the northern wall there is an image of the Lord of Hosts, the Holy Spirit, the composition "Request for the Lord's prayer" with marginal scenes on its sides;
- murals of the two (central and western) capitals of the vault: the composition "The Queen of Heaven" (Fig. 8);
- paintings of the southern wall: the hagiographical cycle of St. John the Baptist and the image of five scenes from the life of the Holy Great Martyr Catherine, on the middle chapel the composition "Catherine against the background of the Sinai mountains" (Fig. 9);

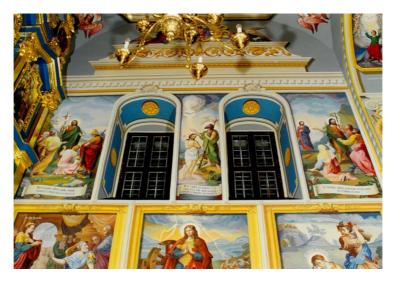
**Fig. 9.** The cycle "The Life of St. John the Forerunner" on the southern wall of the Catherine aisle. Photo taken by the author, S. Baiandin

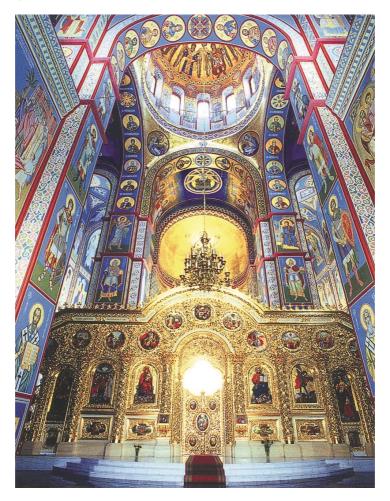
**Fig. 10.** The central part of the restored St. Michael's Golden-Domed Cathedral with the main baroque icon stands. Photo from the stock of Ukrrestavratsiia Corporation

According to the aspects presented above, the image-carrying concept of the Cathedral presents the recreated golden dome of St. Michael, in the form put into operation, as an integrated system by combining two parts - the central one, which is inspired by the ancient fresco mural from Russia, and the side aisles of St. Barbara and St. Catherine imitating 18th-century Baroque murals (Fig. 10).
