CONSERVATION OF 19th CENTURY DEFENSIVE STRUCTURE. THE CASE OF FORT SWOSZOWICE IN CRACOW, POLAND

This paper discusses the issues associated with conservation of selected elements of the existing military object. The subject was presented on the case of Fort Swoszowice, which is the late 19th century defensive structure recently renovated and adapted to new function. Fort Swoszowice belongs to the system of fortifications that were built in concentric rings around the city of Cracow during Austro-Hungarian monarchy. After decades of neglect, the fortifications are getting more attention as important parts of the cultural heritage of the city. One group of problems associated with conservation of the structure addressed the technical condition of the materials: concrete, brick and metal elements, which showed the signs of deterioration due to lack of proper conservation. The other group of problems were connected with military purpose of the building. The descriptive methodology was chosen as the most appropriate for the case study. The archival maps and manuals were studied in order to get knowledge on the conditions specific for the military structure. Furthermore, the conservation

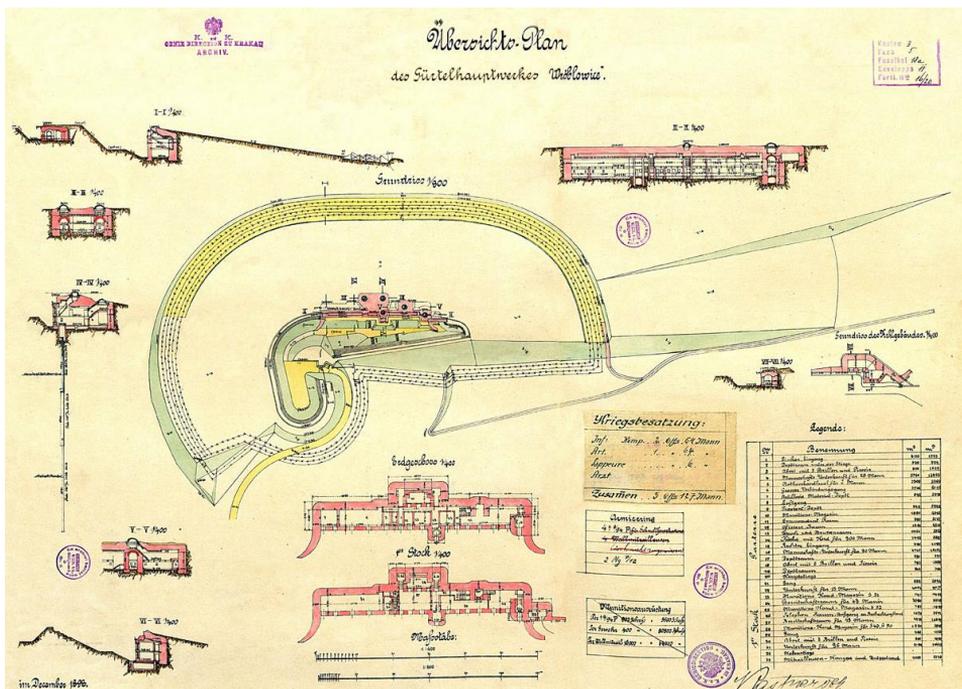
Fig. 2. Archive plan of the Fort from 1898. K. u k. Geniedirektion in Krakau, Übersichtsplan des Gürtelhauptwerkes “Wróblowice“, site plan scale 1:800, floor plans and sections scale 1:400. Cracow, December 1898, update February 1914; KA Wien, file ref. NFA FP FK k.1443

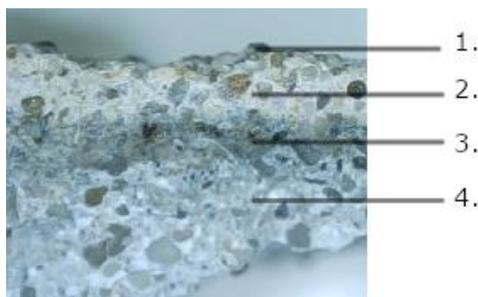
Fig. 3. Stratigraphy revealed subsequent layers: 1. Glazed remains of a sanded layer, body-tinted plaster; 2. A high pink-ochre layer; 3. A dark grey layer (most probably cement milk); 4. Plaster

The microscope revealed fragments of layers – sanding and paint layers, lossened, glazed, mixed with clusters of crystallised salts. The samples contained traces of chrome green, grey (white with black), and traces of the iron pigment – ochre. The samples collected from masonry joints constituted hard, grey lime-cement mortars, with a layer of tar on the surface.

Prior to restoration works, lab tests were conducted on samples of plasters and mortars. Stratigraphic and opencast studies were performed on the walls and ceilings of the shooting gallery and the preserved metalwork of the fort (balustrade, doorframes, steel structure inside), and they allowed to specify the colours and technology applied on surfaces of concrete and metal elements. The studies were performed in two stages: before the works, and after the disassembly of non-original elements. Samples of plasters with layering were subjected to stratigraphic and microscopic tests in order to determine the order of layers. The tests were performed by means of the USB microscope in magnifications of 50-200x. The layers were identified with the application of microscopic and microchemical methods. It was expected to determine the original colours of the elevations as guidelines for subsequent restoration works (Laboratory tests were performed by "Pracownia Badań Laboratoryjno-Konserwatorskich Barbary Sowy-Holewińskiej w Krakowie").

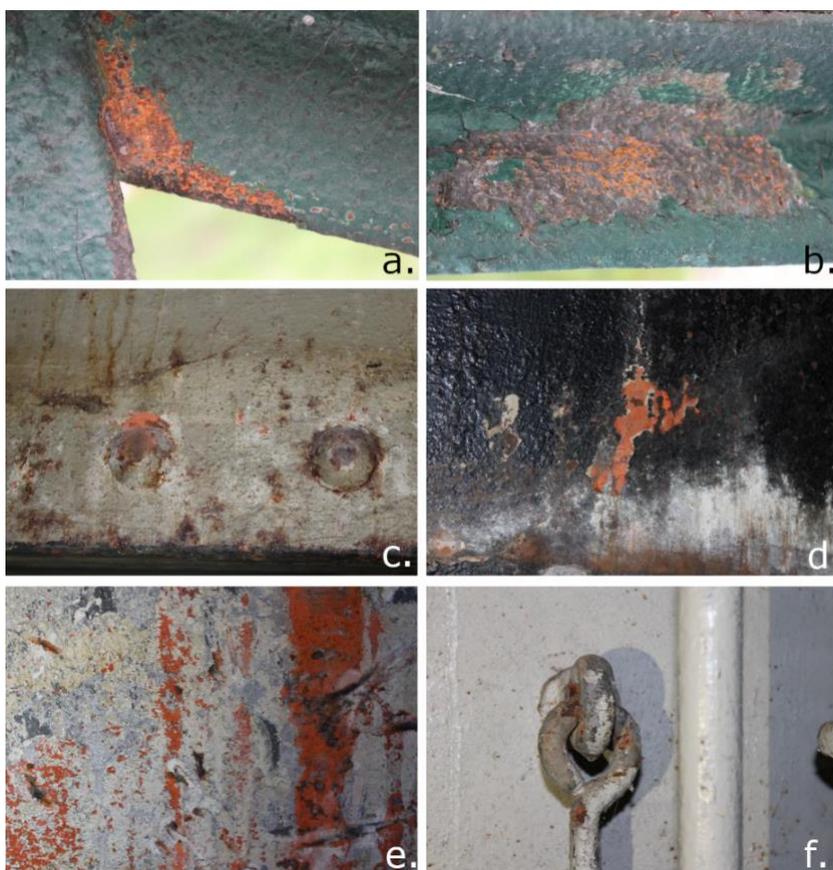
Tests on the balustrade (Fig. 4a and b), revealed the presence of 5 technological layers in 4 historical layers. The oldest preserved historical layer applied on red lead was a layer of graphite grey paint, painted smoothly, similar to the colour NCS S 6500 – N. On other metal elements (Fig. 4c-f) 6 technological layers in 5 historical layers were revealed, with the oldest preserved paint layer on the red lead primer in the colour of Roman cement. On it, there was a layer of greenish light grey paint, similar to the colour RAL Kieselgrau 7032, next a layer of dark grey paint with a touch of blue, similar to the colour RAL Basaltgrau 7012, then another layer of paint in RAL Kieselgrau 7032. The last chronological layer repeated the colour RAL Basaltgrau 7012 or RAL Eisengrau 7011.

Fig. 4. Stratigraphic tests of the metalworks: a, b – the balustrade; c, d, e, f – other metal elements, such as door frames, window frames, and the metal interior structure

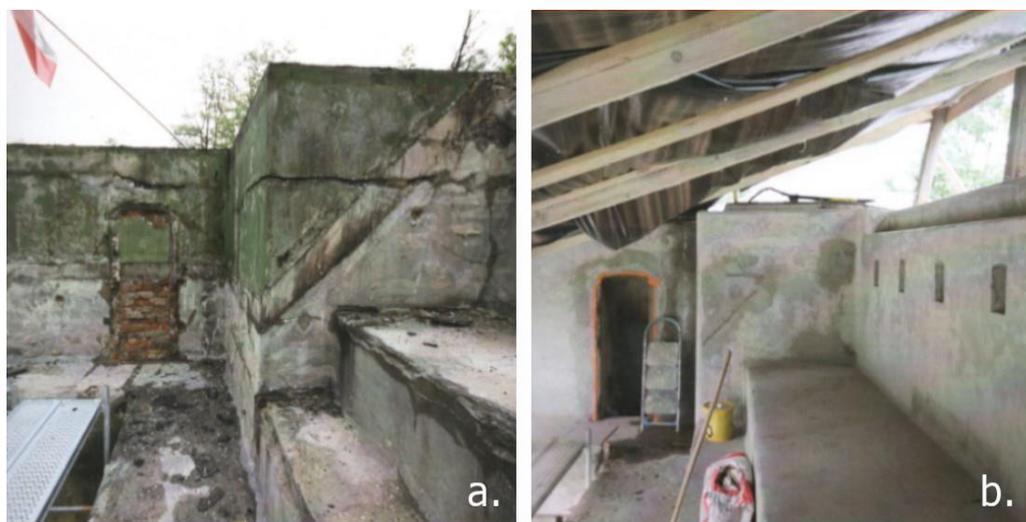
During the works it was possible to inspect in detail the technical condition of the gallery after the disassembly of the secondary roofing (Fig. 5). The concrete there was covered with a layer of dirt caused by weather conditions. The inspection also revealed cracks and a moderate degree of concrete corrosion, sometimes cavities in the aggregate revealing thicker aggregate fractions (gravel). Concrete elements of the gallery were covered with mortars and brick walls which were used for the roofing. Niches for bullets were partly bricked up and sealed with mortar, and technical openings for fitting steel sheets were sealed with wooden pegs and mortar.

Fig. 5. The condition of the shooting gallery after the disassembly of the roof (a.) and during conservatory works (b.).

During the works the secondary fillings and walls covering some niches were removed in order to restore the original disposition. The concrete surface was cleared of all secondary mortars. Corroded fragments of concrete were removed mechanically. The surface was cleared by means of abrasive blasting, repainted layers were removed, cracks were filled up with mass based on the cement binder modified with Sto Crete BE Haftbrücke polymers by Sto. A repair and reprofiling layer were applied by means of ribbed steel wire clamps protected with anti-corrosive aerosol. Bigger cavities and cracks in concrete were filled with mortar based on hydraulic cement. A two-component waterproofing layer was applied, consisting of acrylic mass with the addition of Portland cement with an embedded armoured reinforcement mesh and anti-alkaline impregnation. Vertical planes of the flat roofs were levelled and provided it with a texture and character as close as possible to the original surface of the natural fortress concrete. To this end, mineral mass reinforced with glass microfibre Faserputz by Sto was used. Water draining canals in the concrete flooring of the gallery by the passageways were uncovered and preserved.

Colour samples were matched to the results of the stratigraphic and opencast tests. During the construction of the fort (1897-1989) the flat roof was executed as a concrete one. Several seasons after building armoured forts of this class (thirteen forts were built in Cracow in 1895-1899) it turned out that the flat roofs had to be additionally insulated against precipitation. In 1902 a special technical instruction was issued focusing on sealing concrete flat roofs [25]. Therefore, after 1902 zink plate standing seam roofing was made. Thanks to this, despite numerous subsequent repaintings of the cover, the oldest colour versions of the concrete were preserved. A double glaze was made by applying silicate paint by Keim – mixed colours S 113 (3 parts), 9007 (1 part), S 187 (1 part), S 070 (1 part), fixative (2 parts). The mixing of colours resulted in warm grey with an addition of and ochre-based hue. Test results are in line with the findings of researchers from the 1960s, when the remains of the original paints were still legible: “(...) What is new is the paint camouflage, introducing the colour of light sand on the walls, sometimes with black spots, and dark ochre for the towers and armoured surfaces” [6].

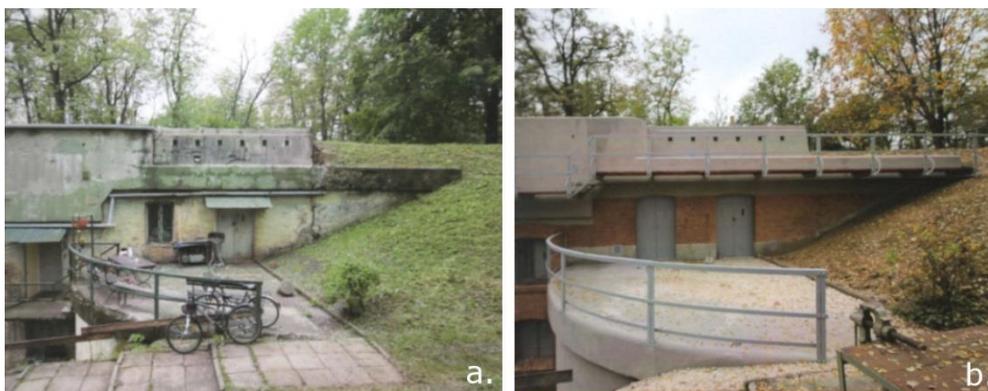
The bricks of the elevations were covered with a layer of dirt caused by weather conditions and repainted with green oil paint. In several places a yellow layer was visible from underneath the green paint. It is in line with Austro-Hungarian guidelines on painting elevations of forts in the Przemysł Fortress – the walls were painted with perishable paints so that the colour of the elevations could be changed depending on the seasons (green in summer, most probably white in winter). This served the purposes of camouflage. In the Swoszowice Fort it was decided to restore the natural colour of bricks, without any camouflaging painting.

Some of the bricks were corroded, there were cracks and cavities in the wall structure, there were also fillings with cement-lime mortar visible. The eastern part of the barracks had not been protected against dampness, a considerable crack requiring to be repaired was noticed (Fig. 6).

Fig. 6. Condition of the eastern elevation prior to the commencement of works (a.) and after their completion (b.). Visible repainting, cracks, and cavities in the brick wall, as well as altered brickwork and sizes of openings.

In order to liquidate the oil paint layer, attempts were carried out to jet clean the bricks by means of different methods: hydrodynamic, chemical, abrasive blasting with quartz dust, abrasive blasting with a biological agent. The mechanical cleaning method can lead to surface damage, however, as observed by S. Samolik et al; brick in general is less fragile than plaster or limestone. Therefore, despite its disadvantages mechanical cleaning is often chosen as the basic method of removing the unwanted layers, due to its simplicity and low costs [26]. Eventually, low pressure abrasive blasting was chosen, varied depending on the strength of bricks, by means of quartz dust and biological cleaning Gumage. This way oil layers and dirt caused by weather conditions were removed from the bricks. Corroded bricks and joints around the main entrance to the fort and around certain window frames were removed mechanically by manual chipping. Secondary walls in the eastern part of the barracks were eliminated, as well. Graded spraying impregnation was applied with the use of impregnates for strengthening weathered and loosened surfaces, based on ethyl esters and silicic acid KSE 100 and KSE 300 HV by Remmers.

As it turned out, it was necessary to reconstruct the brickwork. To this end full construction bricks were used, arranged in compliance with the principles of fortress brickwork. Cavities in bricks and joints were filled with a body-tinted mineral mixture in local colours by Hufgard Optolith and Optosan TrassFuge. The colours of putties and discolourations were merged with original colours of individual bricks by means of silicate glazing Restaurolasur by Keim and a silicate binder to glazings Optomal fixative by Hufgard Optolith. For the purposes of protection against weather conditions, brickwork hydrophobisation was carried out using the silane-siloxane solvent preparation Fungosil SL by Remmers.

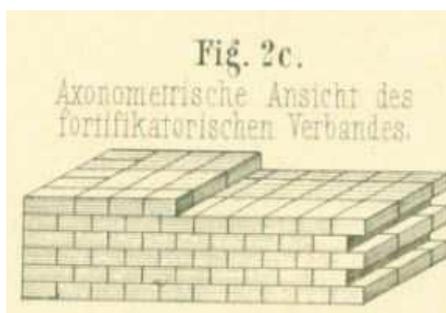
It should be pointed out that brick walls (Fig. 7) of the fort were made in line with fortress building rules, i.e., only the heads are visible, all wall layers are the same. Joints between adjacent layers are shifted relative to each other by half the width of the brick (by half of the head). Due to the high strength of the wall, this method was used to build walls of forts, citadels, and other defence facilities. Further development of artillery, however, forced a departure from bricks in favour of more durable materials, most of all reinforced concrete and steel.

Fig. 7. The way of arranging bricks with the head facing the front of the wall. The so-called fortress binding of the wall (*Fortifikatorischer Verband*), Source of illustration: *Constructions-Details der Kriegs-Baukunst, Band I*, Wien 1878; Table No. 4 "Mauern, verschiedene Ziegel-Verbände".

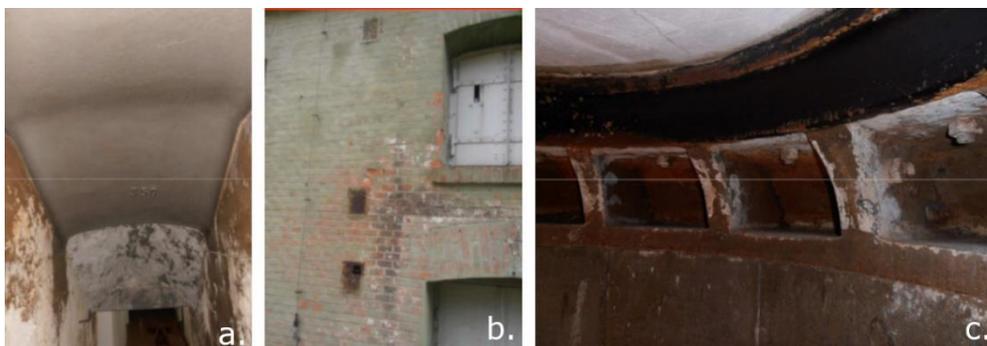
Cast steel armoured domes have not been preserved – they were disassembled in the second half of the 20th century. The forearm has been preserved – consisting of two parts: the upper girdle (equipped with a track, bearings, and a gutter), and the lower girdle (segmented, with characteristic niches on its perimeter). The sequence of niches was interrupted with a profile to be joined to the armoured vault above the entrance. Additionally, the armoured vault – an element with the profile of a basket arch over the stairs to the tower reinforced the concrete part of the vault. All these elements were made of cast steel. The state of preservation was average, the outer layer of metal had been destroyed (Fig. 8). An additional factor with a negative effect on the condition of steel elements was lack of appropriate ventilation in the towers and concentration of steam.

Fig. 8. The condition of preservation of metal elements. A-Visible armoured vault to the artillery turret S50; b – Fragment of the elevation of the barracks – visible ventilation grills; c – the upper girdle of the forearm in the turret S50. Source of illustration: authors' photo.

Most original armoured doors and window shutters were preserved, and they required only conservatory measures. Steel elements intended for conservation were cleaned of oxide corrosion elements by sanding and manual mechanical methods. Steel roofs above door openings and armoured doors were renovated. The designs were prepared on the basis of relics found in opencast studies and by analogy to preserved leaves of armoured doors on the ground floor. The tee-bar balustrade was recreated, maintaining the spacing of supports in compliance with preserved relics of fittings. Missing rivets in the metal joinery of entrance openings to the passageways were added, too. Chlorinated rubber primer paint Everal Extra 80 by Tikkurilla was applied. The balustrade was painted graphite grey smoothly (according to the shade guide of Lowigraf steel-graphite 95, 131-7754-03-95-XX-1, other metal elements were close to the colour RAL Kieselgrau 7032, in line with the results of stratigraphic tests.
