RESTORATION, OPERATION AND INCLUSION OF MUSEUMS IN LARGE CITIES WITH NOISE LOAD

Serhii BAIANDIN¹, Aneta PAWŁOWSKA², Oleksandr IVASHKO^{3*},
Oleksii PRYIMACHENKO³, Pavlo BAIANDIN¹, Maciej KOKOSZKO⁴,
Andrii DMYTRENKO⁵, Vitalii PAVLIUK⁶

Abstract

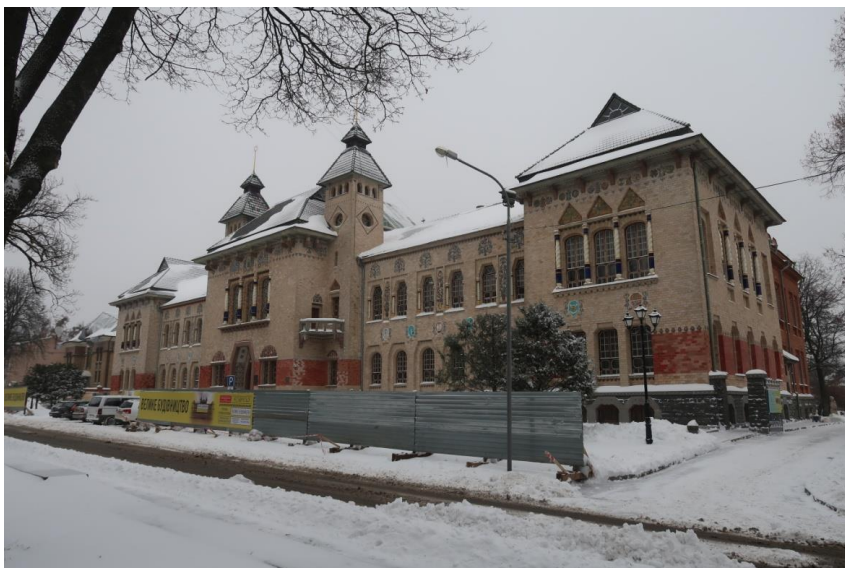
Fig. 1. The building of the former Poltava Provincial Zemstvo (now – Vasyl Krychevsky Poltava Local Lore Museum). Current state under restoration. Photo by P. Baiandin, 2022.

Despite the difficulties in the construction process, the unique building in the national Ukrainian style was built in several years: at the end of 1904, construction and finishing work was completed in two side wings, in 1905 – roofing work, in 1905–1908 – construction work in the central parts and in the middle wing.

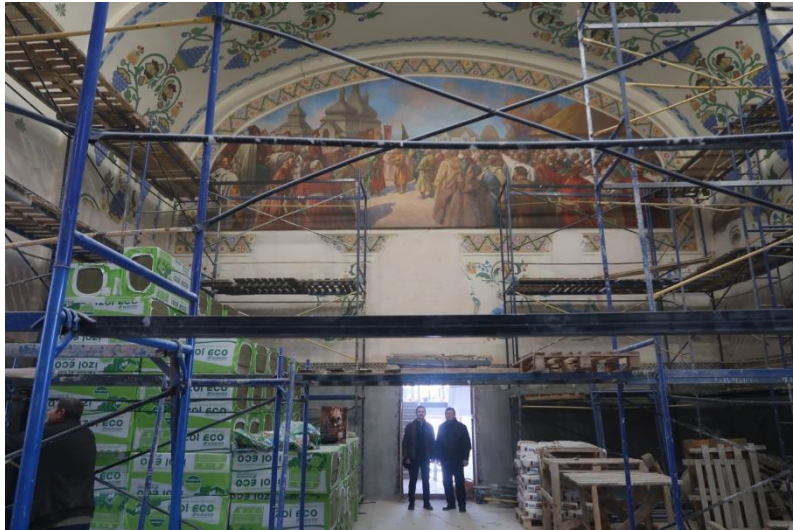
Fig. 5. Scaffoldings in the Celebration Hall. Photo by P. Baiandin, 2022.

We have developed a detailed design of the scaffolding for the Celebration Hall with a 3D model for the general contractor who was responsible for the construction of the scaffolding. The upper levels of the scaffolding have been stepped to provide maximum access to the vault surface. The main frame of the scaffolding was erected from framed scaffolding, and the upper level was covered with solid wooden platforms (Fig. 5).

We fenced all the platforms where the work takes place with a triple fence (double fence at the top and one side at the bottom – protecting against falling of the tool or material).

For access to places that are difficult to access from the scaffolding, we have assembled 12 pedestals (height – 420mm, width – 600mm, depth – 800mm), from which there is good access

for work. To lift parts of scaffolding, materials, water and tools to the upper level (to a height of eight meters), an electric hoist with a carriage on an I-beam was installed.

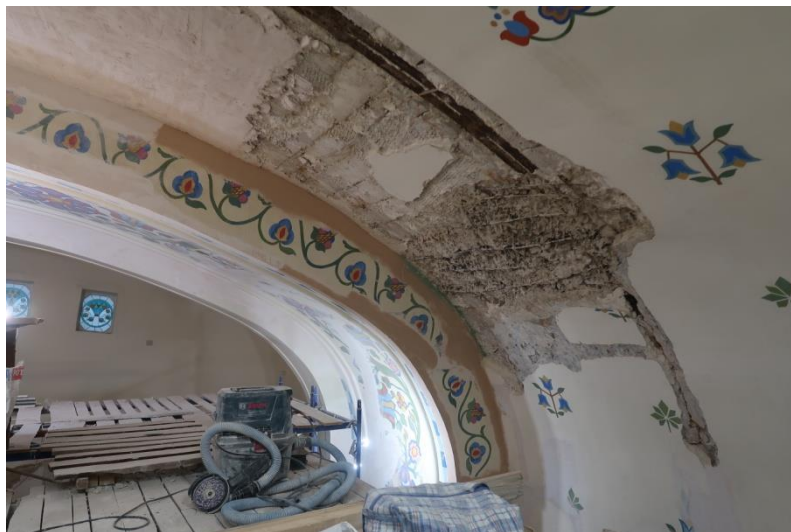
Fig. 6. Repair process of the vault surface. Photo by P. Baiandin, 2022.

The building of the Poltava Museum of Local Lore was built of red clay bricks of the standard size 60×120×250mm (the strength of the brick is very low, produced by local production in Opishnia). The Celebration Hall in the plan is elongated along the major axis and has a cruciform outline of the plan – the central part is covered with a vault, and the side boxes on both sides are covered with slabs on I-beams. There is a balcony with a choir place above the main entrance. The flooring under the hall consists of metal I-beams on which wooden beams and the floor rest. The vault of the central volume is made of parallel metal trusses resting on brick walls. The trusses are assembled from a double riveted corner. There are numerous traces of damage

from the 1943 fire – some truss elements are bent. Reinforced concrete slabs 10cm thick and about 25cm wide are laid on the lower belt of the trusses, which form the vault (Fig. 6). The distance between the trusses is approximately 2.5m. The roof of the tiles rests on the upper chord of the trusses. The attic above the hall is unheated. The roof of the tiles rests on the upper chord of the trusses. The attic above the hall is unheated. The central volume of the hall has a skylight in the center of the vault.

Basically, on the surface of the walls and the vault, the original lime-sand plaster of very weak strength was applied, as well as the plaster from the period of the post-war restoration of 1954–1962, when the collapsed part of the vault in this room was also restored. Some areas on the right and left walls (from the side of the boxes) (at a height of 2.5 to 5 meters from the floor level in the hall) are covered with cement plaster, which is badly cracked. With the last restoration 1992–1996 on top of the cracked plaster, two layers of gauze were glued, which performs a reinforcing function, preventing cracks from showing through in full to the surface.

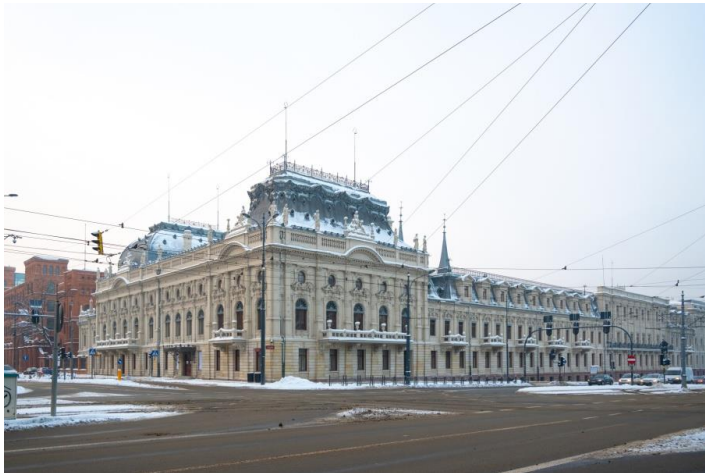
Poltava and the fate of Izrael Poznański's palace located on Ogrodowa Street. The building in Łódź was designed and executed in several stages, from 1898 to 1902, by architects Juliusz Jung, Dawid Rosental and Adolf Zeligson. Originally, the building was intended to be a representative seat of one of the wealthiest factory owners in Łódź at the turn of the 19th and 20th century, currently it is the seat of the Museum of the City of Łódź. At the same time, it is one of the most interesting factory owner's residences of the 19th century in Europe (Fig. 7).

Fig. 7. The former Poznański Palace (now – Museum of the City of Łódź).
Photo by A. Pawłowska, 2022.

The building combines various and extremely decorative, dynamic French forms in the style of the Second Empire, concealing magnificent interiors with a monumental staircase and representative rooms: the dining room and the mirror room.
