RESTORATION AND CONSERVATION OF THE STONE TOMB OF PRINCESS ELENA (1799-1867)

Abstract

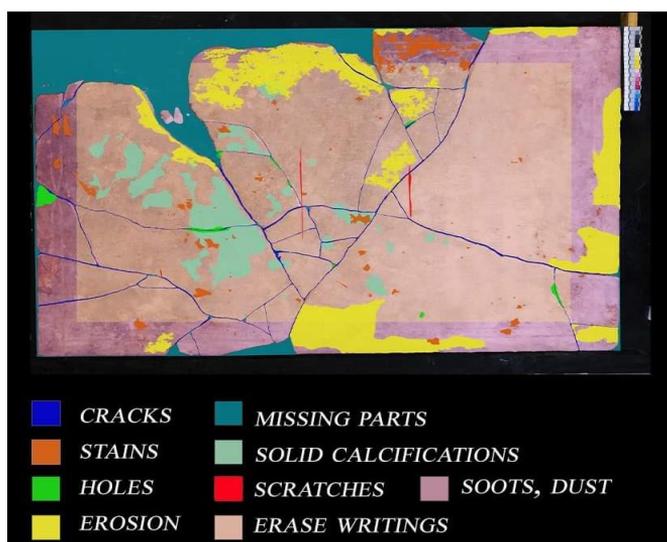
Fig. 1. Map of the manifestations of damage

The effect object is photographed as a full image, followed by focusing on the places of damage, the manifestations of damage are photographed very accurately because these photos are the only evidence that show the state of the object and the smallest depiction of details and recording them. By using Photo Shop program, will be transformed as maps to show the manifestations of damage (using a variety of colors), as in figure 1 and Table 1 [13, 14].

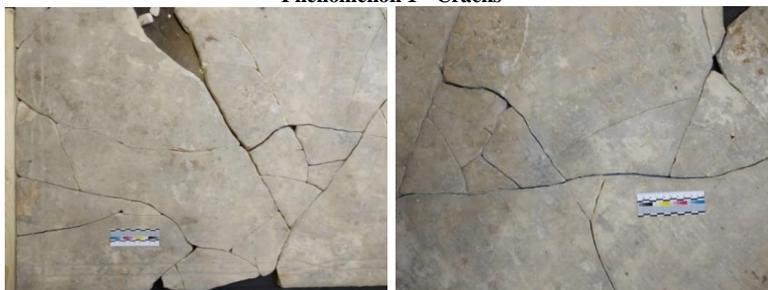
Phenomenon 1 - Cracks

Large cracks in the stone slab, because of destruction, they turned into pieces of stone that were shattered and separated from each other

The process of collecting pieces of stone is one of the most difficult processes of restoration. The restorer must be of a high degree of efficacy in case of gathering process. The stone slab was separated into three parts they were gathered as a one stone.

The stone pieces were gathered by using 6mm stainless steel nails that were cut to different lengths depending on the size of the stone, holes were drilled, and stainless-steel nails were inserted into them. An experiment was carried out to gather pieces of stone together to make sure that the cracks were perfectly closed, while the level of the stone surface remained the same. use the adhesive, Before the step of using the adhesive each piece of stone is prepared separately, so it will be easier to gather and together, as in figure 4.

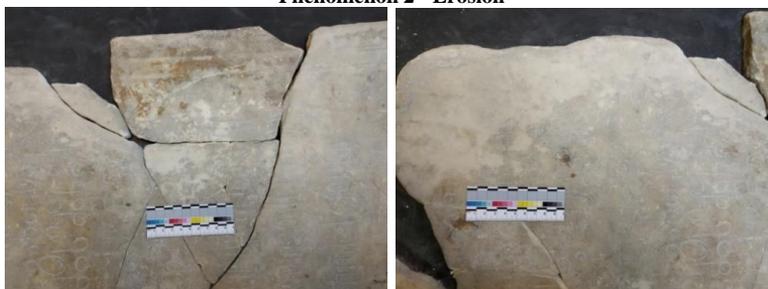
Phenomenon 2 - Erosion

The disintegration and separation of some pieces of stone from the surface layers of the stone

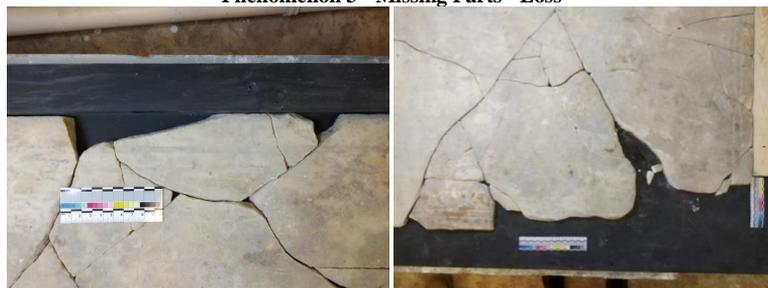
Phenomenon 3 - Missing Parts - Loss

Missing parts in a stone slab that are missing due to destruction, corrosion, and stone slab handling operations

After finishing the completion process filling and reparation of the stone slab process is started Materials used in the process of completing the missing parts: Polyester Resin 440 501 + Marble dust - calcite (in a 2:1 ratio) - Peroxide (Catalyst) (1:20 ratio) [22, 23].

Polyester resin is the most common type of resin because it is much tougher than epoxy. The process of preparing the additional material (artificial stone) was carried out by adding polyester resin to a large bowl and gradually adding calcite marble dust in a ratio of 2:1 with continuously stirring until the mixture was completely mixed. In addition, some colored oxides are added to achieve the desired degree of coloration of the mixture, which is identical or like the original color of the stone, as some oil paints were added to the white and darker yellow color to bring the mixture to the desired degree [24].

The required amount of the mixture is determined accordance to the missing parts needed, the methyl ethyl ketone peroxide catalyst is added as a catalyst and as a reaction activator. In the ratio of 1 catalyst peroxide to 20 mixtures of polyester resin and calcite marble dust, the rate of drying of the mixture after the filling process depends on this. After pouring, this will cause a reaction that increases the temperature due to the internal friction of the resin mixture. The casting process is carried out and the missing parts are gradually filled with thin layers on the top of each other, and fabric strips of linen fibers are placed between each layer of resin to support and give strength and durability to the stone after hardening, as in figure 6[25].

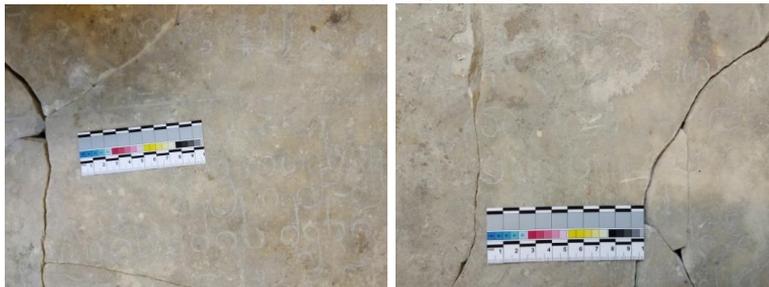
Phenomenon 4 - Scratches

Scratches When using a sharp tool or rubbing against the surface of the stone, the stone is scratched and deformed

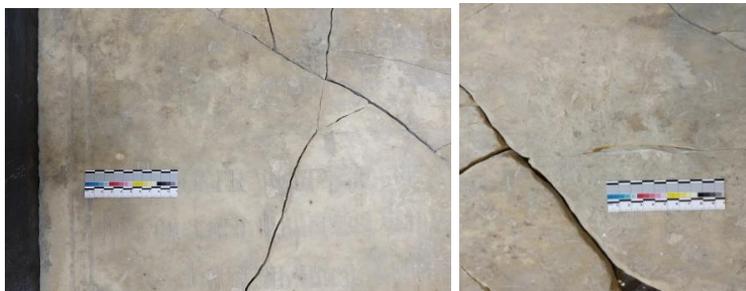
Phenomenon 5 – Holes

Holes are the weakest spots on the stone surface that fall off and separate from the stone

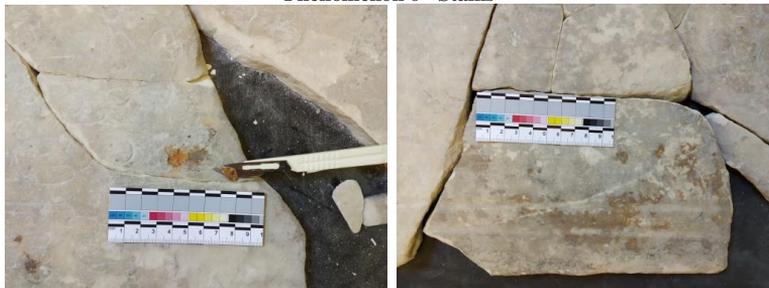
Phenomenon 6 - Stains

Rust spots on the surface of a stone are brownish spots that penetrate the subsurface layers and pores of the stone

Chemical cleaning is used in the least limits in the case of tough spots dirt and colored stains that are difficult to remove by mechanical cleaning. The restorer must take the necessary care when cleaning with chemicals, as chemicals cause reducing the proportions of the stone to avoid damaging it. Chemical cleaning includes wet cleaning using water or aqueous solutions, it is used in a form of organic solvents such as acetone and ethyl alcohol [17].

Cleaning with water was used as a preliminary step to chemical cleaning which has been proven by many studies to be one of the best detergents for many types of dirt, especially for clay calcifications and plankton such as dust and color stains. An attempt was made to clean with water, the results were good, the calcification of dust and dirt was removed from the surface of the stone specimen, but no good result was achieved in brown spots [19] another attempt was made in cleaning using acetone and ethyl alcohol at a concentration of 5:10% to remove hard calcifications and colored spots, but it was not able to remove completely the dirt.

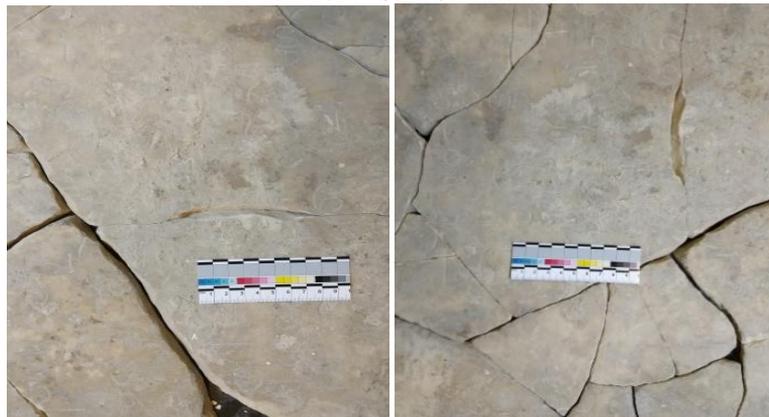
Phenomenon 7 - Solid Calcifications

In the past, cement mortar was used to anchor and fix the slab in place, resulting in stains of cement on the surface of the stone, the edges, and the back of the slab

The cleaning process was carried out using brushes of different sizes [17]. After removing the dust from the surface of the stone, hard calcifications (continuous layers on the surface of the stone) had been appeared. Hard layers were removed from the surface of the stone by using medical scalpels, this process had been carried out slowly, and the restorer must take care to protect the stone from scratches, as in figure 2 [18].

Removing the hard layer: use a 1:1:1 solution of a mixture of white ethyl alcohol + water + acetone as a cotton cloth compress, which is left on the surface for a few minutes, this process was repeated several times [19] However, this method did not remove the sticky dirt well, so the following mixture was used:

250mL of mild soap + 1000mL of Distilled water + 250mL of ammonium hydroxide. Using such mixture in cleaning showed very good results in removing calcified hard layers on the stone surface. After the cleaning process was completely finished, in which the dirt, hard layers and concrete stains were removed, the cleaning process was successful and the patterns appeared as in figure 3[20].

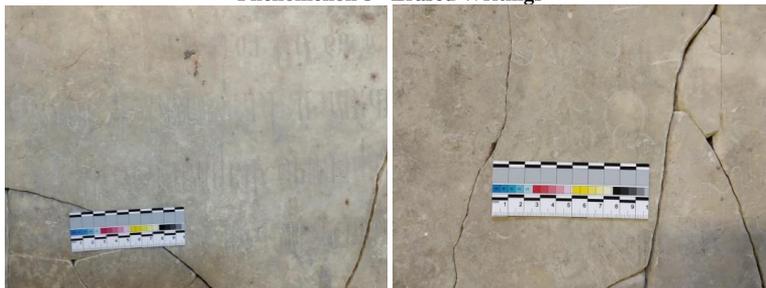
Phenomenon 8 - Erased Writings

With the passage of time and environmental conditions, inscriptions and drawings wear off the surface of the stone slab, making them difficult to be recognized

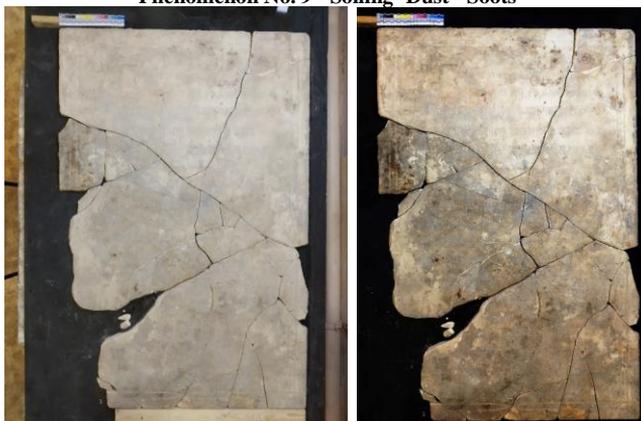
Phenomenon No. 9 - Soiling -Dust - Soots

A thin layer of particles (dust from the air) covers the surface of the stone.
This dirt adheres to the surface layers of the stone in different shapes
