## MODERN TECHNOLOGIES IN RESTORATION OF ARCHITECTURAL MONUMENTS (ON THE EXAMPLE OF ST. VOLODYMYR'S CATHEDRAL IN CHERSONESOS)

*The article is devoted to the analysis of the use of modern materials in the restoration of architectural monuments (on the example of St. Volodymyr's Cathedral in Chersonesos (in modern Sevastopol). The article structures historical facts related to the history of the cathedral and the description of its architecture, identifies problems with the state of emergency of the cathedral before the restoration work, presents a comprehensive system of the entire list of activities and analyzes the state of restored elements in the post-restoration period. This proves that in some cases the use of modern technologies and materials in the reproduction and / or restoration of architectural monuments is rational and acceptable.*

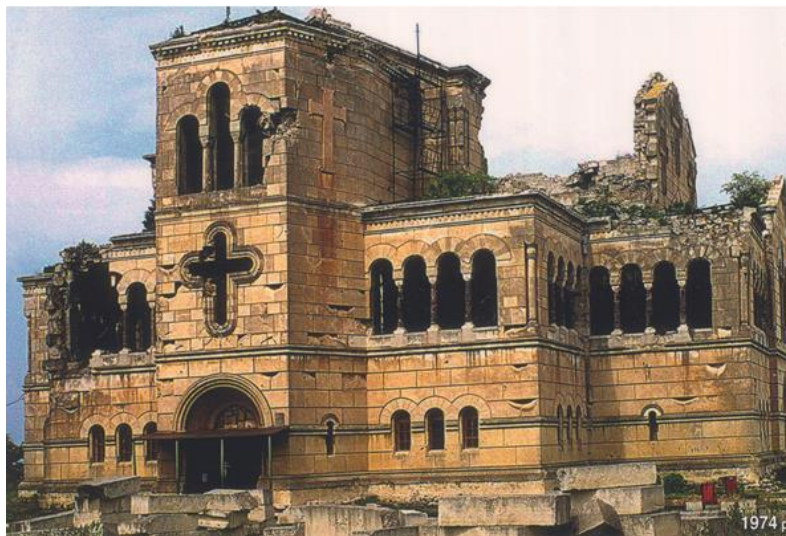
In 1961, a special commission inspected the ruins of the cathedral and concluded that it could not be rebuilt, and its ruins should be dismantled. However, the staff of the Chersonesos Museum-Reserve managed to defend the priceless monument. In 1969–1970, a project for the conservation and adaptation of St. Volodymyr's Cathedral for a museum was developed, but this project was not implemented (Fig. 1).

**Fig. 1.** The state of St. Volodymyr's Cathedral in 1974.  
Photo from the stocks of the Ukrrestavratsiia Corporation

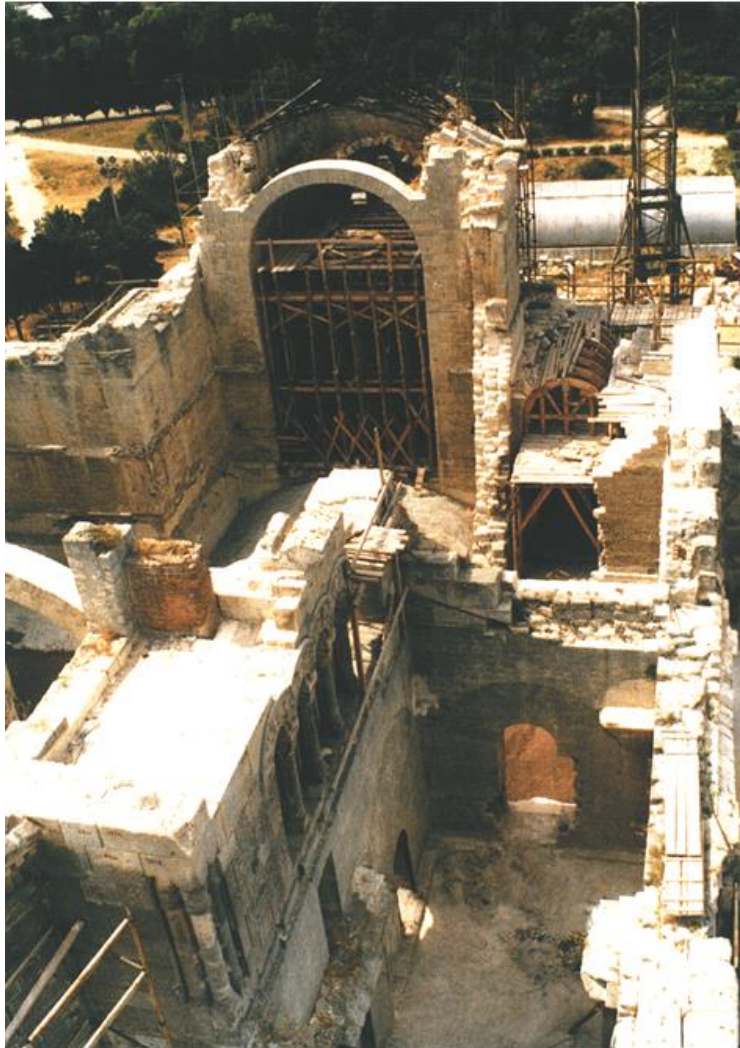
**Fig. 2.** The beginning of the cathedral walls restoration.  
Photo from the stocks of the Ukrrestavratsiia Corporation

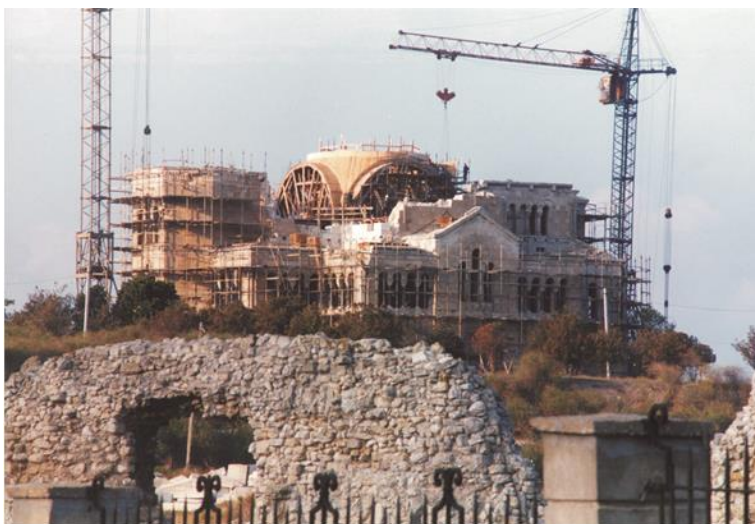
The structural scheme of the building was such that it was possible to reproduce the physical volume of the cathedral in a parallel way. That is, the transfer of deformed parts of the building could be performed in parallel with the construction of the inner cross-shaped volume, followed by the addition of the volume of the light drum (Fig. 3).

**Fig. 3.** The recreation the physical volume of the cathedral.  
Photo from the stocks of the Ukrrestavratsiia Corporation

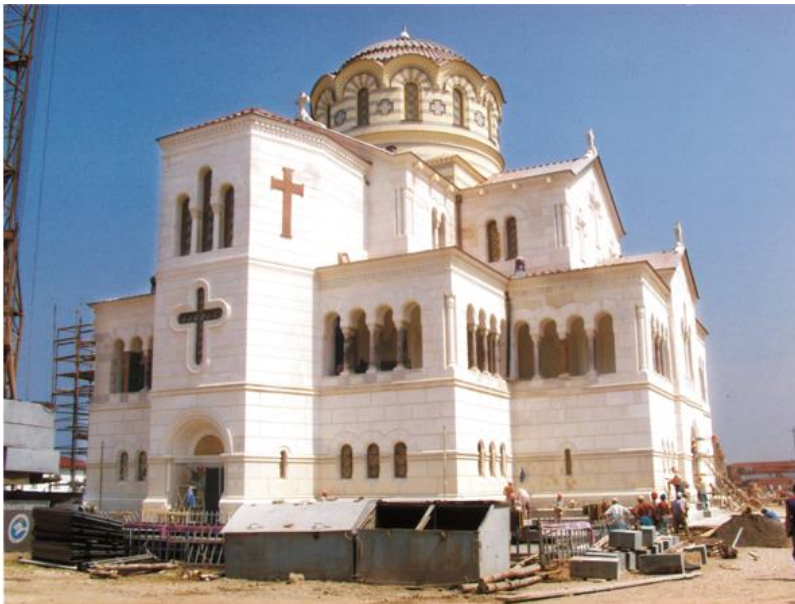
The roof of the cathedral was made of copper tiles as a weatherproof material that does not require additional protection (Fig. 4). The technology of gilding works has also been developed.

**Fig. 4.** The state of the cathedral after the completion of the first stage of restoration (July 25, 2001).  
Photo from the stocks of the Ukrrestavrtsiia Corporation

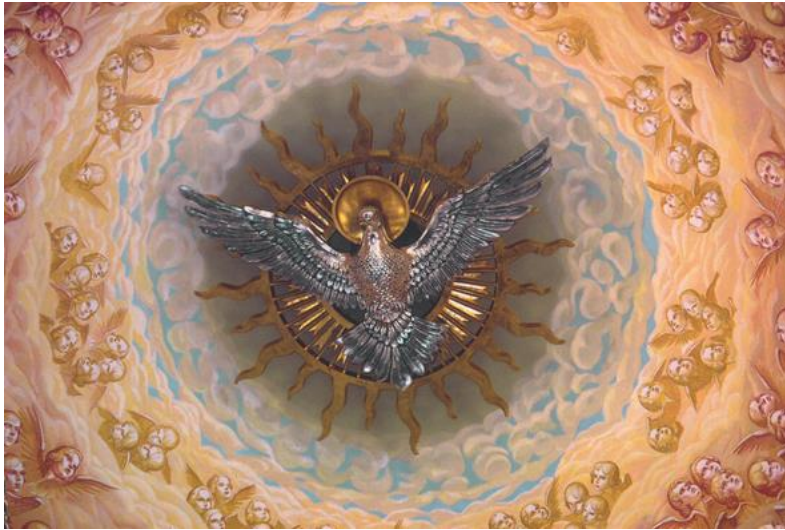
In St. Volodymyr's Cathedral, many decorations are made of metal. Master restorers made extremely complex net fences, lattices, lamps and chandeliers (Fig. 5).

**Fig. 5.** Metal decorative elements in the interior of the cathedral.  
Photo from the stocks of the Ukrestavratsiia Corporation

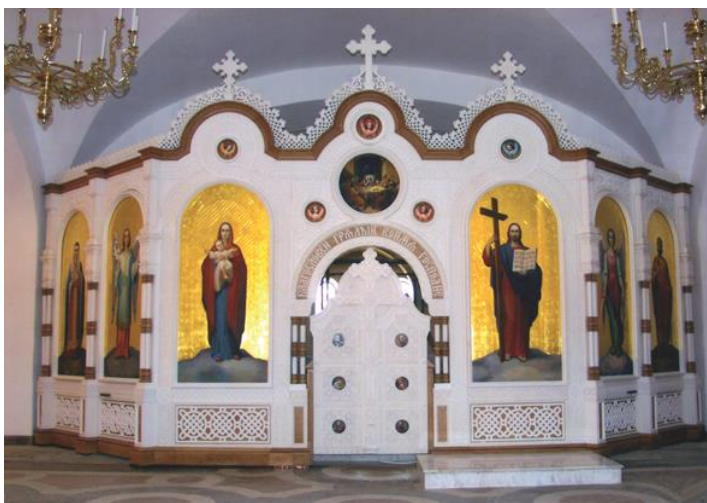
**Fig. 6.** Marble iconostasis on the lower level of the cathedral.  
Photo from the stocks of the Ukrestavratsiia Corporation

Modern performers of the marble iconostasis in the Byzantine style made it using new technologies. Details of the iconostasis, which were made on machines with a digital program of stone processing, were delivered from Italy, all manual processing and stone carving was carried out by Ukrainian stonemasons-restorers on site (Figs. 6 and 7). The iconostasis is made of Italian marble Bianco Carrara, Bianco, Lassa, Portuguese marble Rosso Levante, Greek onyx insert.

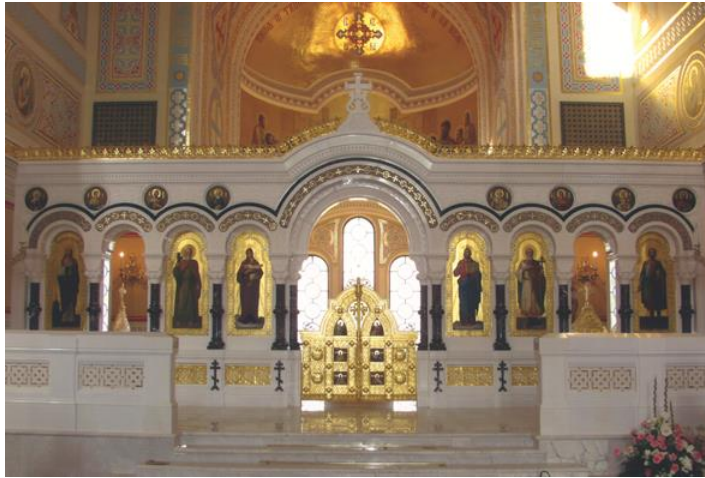
**Fig.7.** Marble iconostasis on the upper level of the cathedral.  
Photo from the stocks of the Ukrrestavratsiia Corporation
