## ‘PAA GRANT’ OUTDOOR CONCRETE SCULPTURE AS CONSERVATION OF CULTURAL HERITAGE: A SCULPTOR- CONSERVATOR-RESTORER APPROACH

*The study explores the deteriorating condition of ‘Paa Grant’ outdoor concrete sculpture and provides a sculptor-conservator-restorer approach in handling the artwork by justifying the need for restoring the defects that have been ignored endlessly since its production. In this study, descriptive and studio-based methods constituted the form of mixed methods research design used. The unstructured interview and direct observation were the instrumentations used for the data collection. Data was analysed using descriptive and document review analysis tools. It was revealed that the ‘Paa Grant’ outdoor concrete sculpture had defects such as cracks and broken offs that caused spalling, delamination, corrosion of metals due to the prevalence of exposure to weathering conditions. The enhancement of restoration methods further boosted the concrete sculpture from further deteriorating. The maintenance culture of conservation and restoration practices on public sculptures in Ghana and beyond should be encouraged to establish any fault and forestall further deterioration

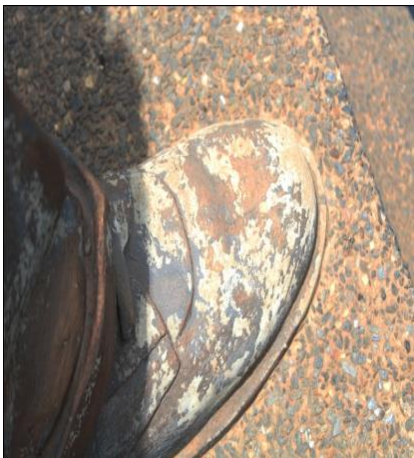
**Fig. 1.** Fading and peeling of paint on the sculpture

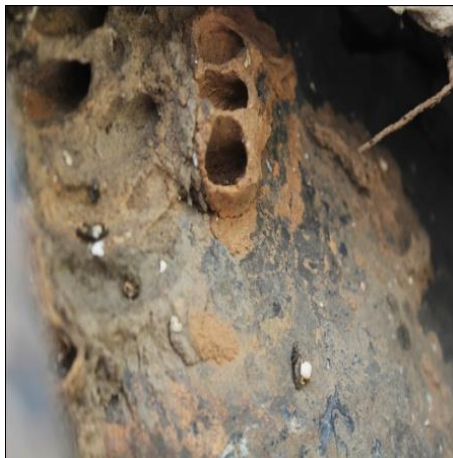
**Fig. 2.** Wasp holes on the sculpture

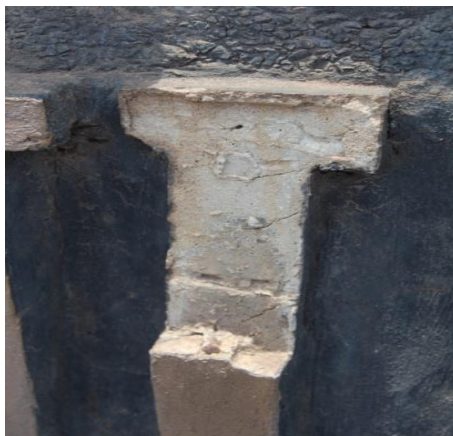
Again, the study revealed that the sculpture has defects of broken off of concrete portions; corrosion of reinforcing steel in concrete resulting in an expansion that creates tensile stresses in the concrete sculpture. This situation eventually causes cracks, delamination and spalling, concrete scaling causes fading, flaking and peeling of paint on the sculpture. The wasp holes or nests on the sculpture cause defects to the surface by destroying the paint finish of the work. It was observed that these defects on the sculpture were signs of flaws where iron rods for the reinforcement of the artwork were exposed to an exceedingly saline setting of New Takoradi. This observation points to the fact that concrete works with metal reinforcement near saline areas tend to deteriorate. It was believed that the size of metals or wire mesh for an outdoor concrete sculpture to be half-inch that may bond effectively with mortar [26]. This observation is contrary to the Paa Grant sculpture at New Takoradi. In the assessment, the artist had used a one-inch wire mesh for the artwork. This material has big holes in it and could not bond with mortar properly at the tip of the sculpture’s jacket. The metal used at the tip of the jacket was one inch, which was bigger for such an area. This situation affirms the preservation ethics of poor craftsmanship. The exposed metals have led to spalling of the outdoor concrete sculpture [32, 33].

**Fig. 4.** Break offs on the pedestal of the sculpture

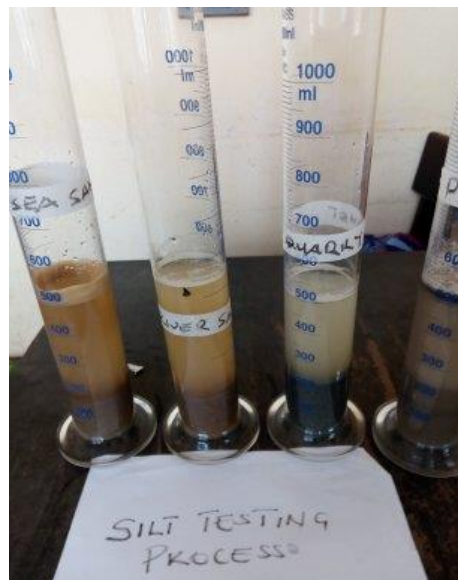
A review was done on non-destructive testing methods such as silt content analysis testing as shown in Table 2 and Figure 5.

**Fig. 5.** Silt content test

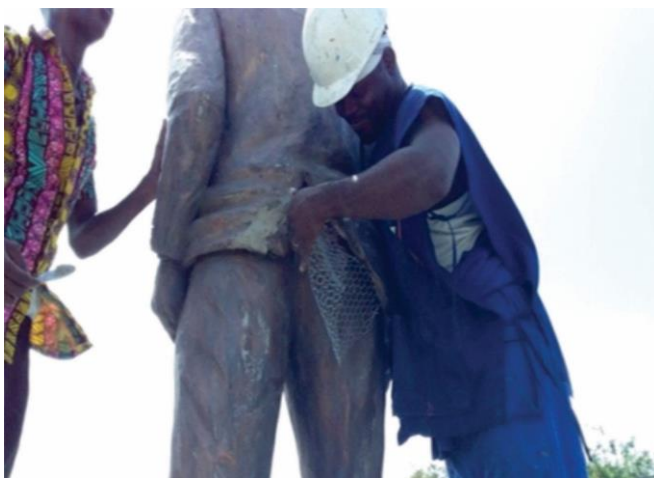
Fig. 6. Retouching the broken-off portions on the sculpture

In undertaking the surface preparation for the outdoor concrete sculpture (Paa Grant), was taken care to provide an appropriate substrate for the repair. The practice was done to ensure the enhancement and fine details of the sculpture. Surface preparation began with cleaning the dirt from the surface and removing broken- portions of concrete with a hammer, plier and wire brush. Paint peels off was removed by scraper and sandpaper to establish the degree of the repair. It was then followed by cutting the border of the broken-off areas. The affected area was extended beyond to provide a better bonding and solidifying with the existing concrete. The outdoor concrete sculpture (Paa Grant) was cleaned to get rid of powder substances and dirt. However, it is believed that the implementation of a maintenance strategy for the sculpture is the most effective way to help shield the artwork from deteriorating. Again, the defects such as cracking and delamination of metal caused by corrosion were removed for proper restoration. The nylon bristle brush was used to remove the excessive and expose cement paste. A half-inch wire mesh was used to create a variable surface to match the original concrete as shown in Figure 6.

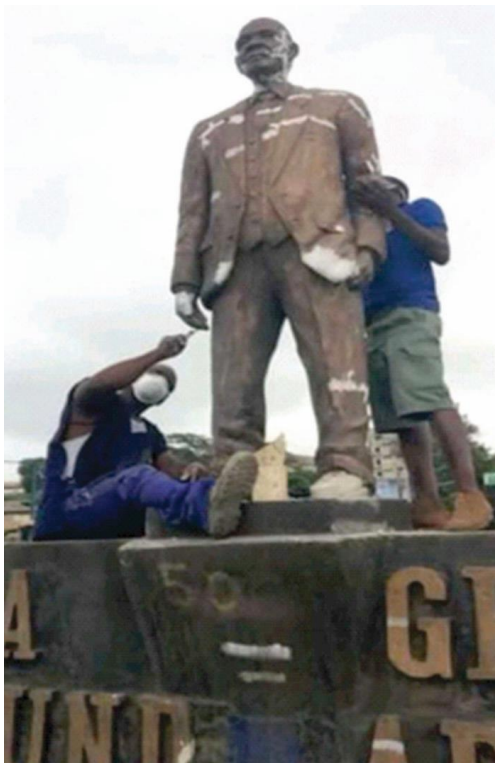
**Fig. 7.** Practitioners restoring the sculpture of Paa Grant with cement mixture (penetrating sealants) and enamel paint

Figure 7 illustrates how the active cracks were filled with cement mixture as penetrating sealants. The detailing of work with sealants required considerable attention. Protection systems such as the application of resin were applied onto the sculpture before the introduction of the patina to protect it. This practice is believed to increase the length of the lifespan of the concrete sculpture.

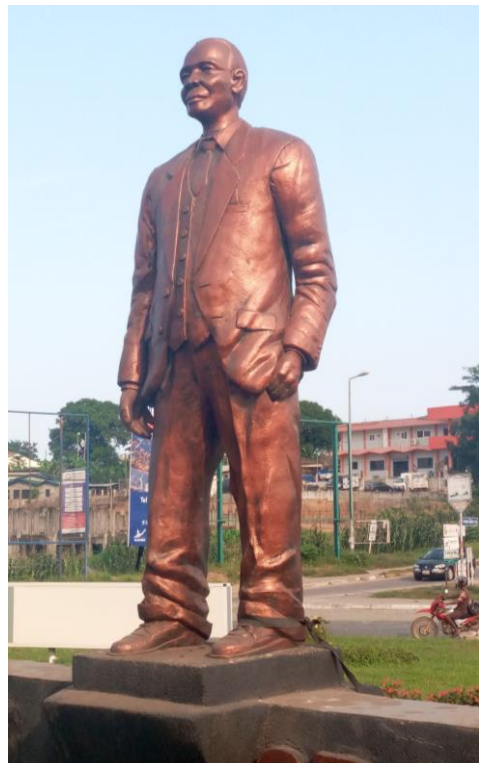
**Fig. 8.** The restored and finished sculpture of Paa Grant

The finishing was done to retain the original form of the restored sculpture with bronze enamel paint, as shown in Figure 8.
