## RISK ANALYSIS OF RESTORATION WORKS BY FINE KINNEY METHOD: AN EVALUATION OVER MASONRY CIVIL ARCHITECTURE EXAMPLES IN FATİH DISTRICT, ISTANBUL

**Table 7.** Risk analysis of masonry row houses site works around Fath area (Fine Kinney method)

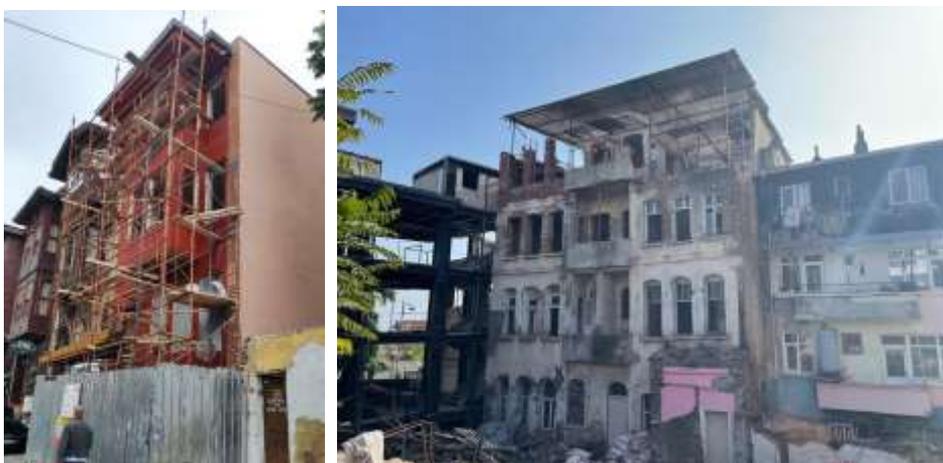
**Fig. 2.** The examples of masonry civil architectural structures in Fatih area: poor work cage (left) and people working without proper work precautions (right)

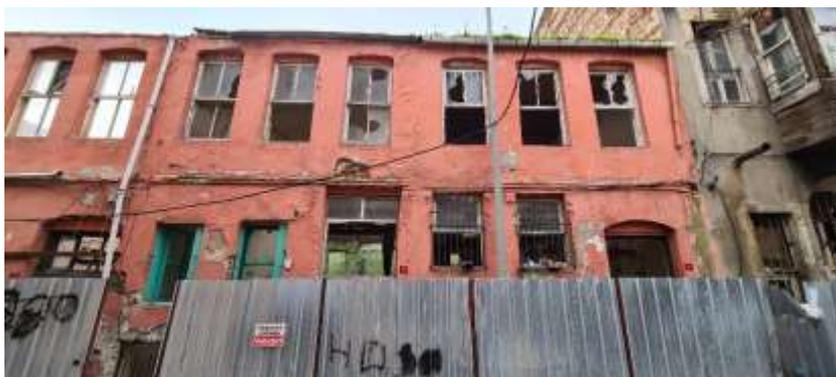
**Fig. 4.** Fatih-Kumkapı area: deteriorated masonry row houses (listed civil architectural examples)

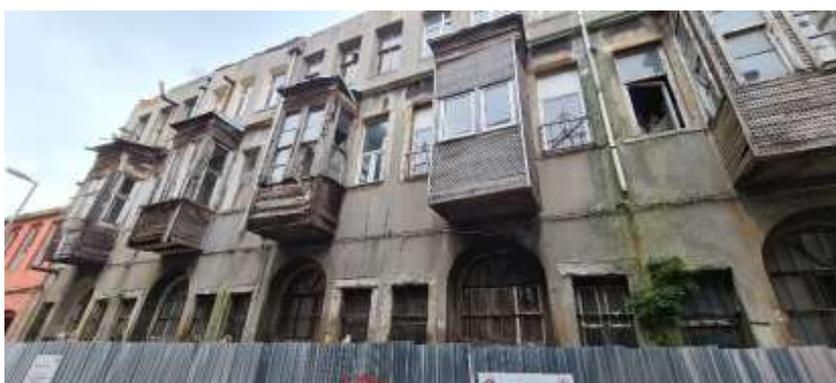
**Fig. 5.** Fatih-Kumkapı area: deteriorated masonry row houses (listed civil architectural examples)
