## MICROCLIMATE ANALYSIS OF TWO HISTORIC CHURCHES IN LUBLIN – OPTIMAL HYGROTHERMAL CONDITIONS FOR PRESERVATION OF CULTURAL HERITAGE

### Abstract

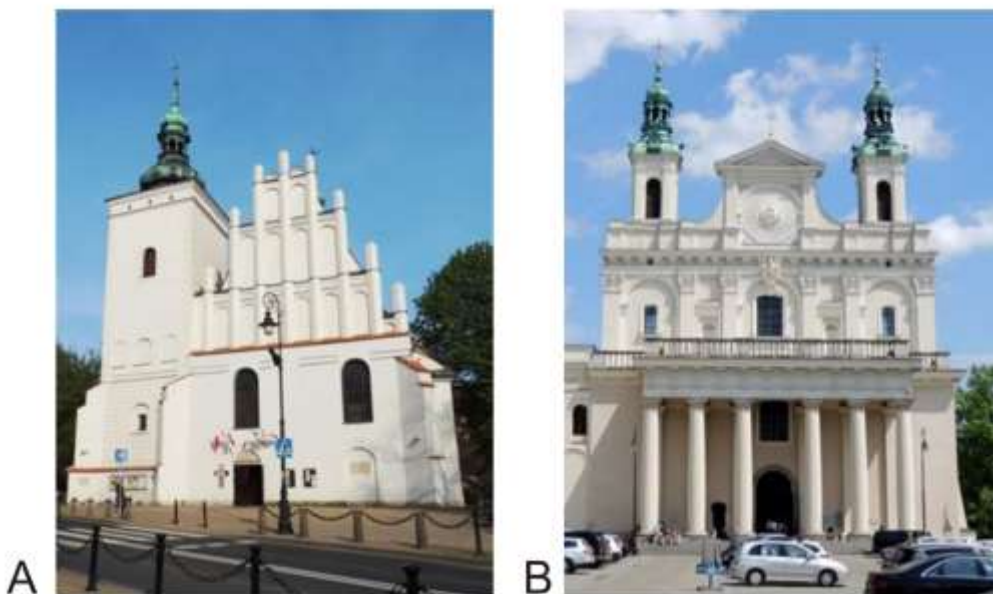
**Fig. 1.** A: Church of the Assumption of the Victorious Virgin Mary (Post-Bridgettines Church);  
B: Metropolitan Cathedral of St. John the Baptist and John the Evangelist (Lublin Cathedral)

Measurements of temperature and humidity were made in two churches in Lublin. The first, the Church of the Assumption of the Victorious Virgin Mary, known as the Post-Bridgettines Church (Fig. 1A), was built in the years 1412–1426. It has been rebuilt and renovated many times. Its current shape dates back to between 1430 and 1450. After 1530 the earlier presbytery vault was changed from a rib vault (visible only in the garret) to a barrel vault with lunettes with stucco decorations and paintings. The church combines two styles, Gothic and Lublin Renaissance, but also contains elements from other historical periods. The most important interior details include fragments of Gothic polychrome from 1430 and 1460–1470, a 15th-century painting of St. Bridget of Sweden, the 17th-century presbytery vault, a series of seventeen 17th-century paintings representing the life of St. Bridget, and the Gothic Revival wooden side altar.

The second building analysed was the Metropolitan Cathedral of St. John the Baptist and John the Evangelist, known as the Lublin Cathedral (Fig. 1B). Its construction was begun in 1586 but was not completed until the 17th century. At that time, it was one of the largest churches in Poland. The cathedral was destroyed several times by fire, including in 1752, and

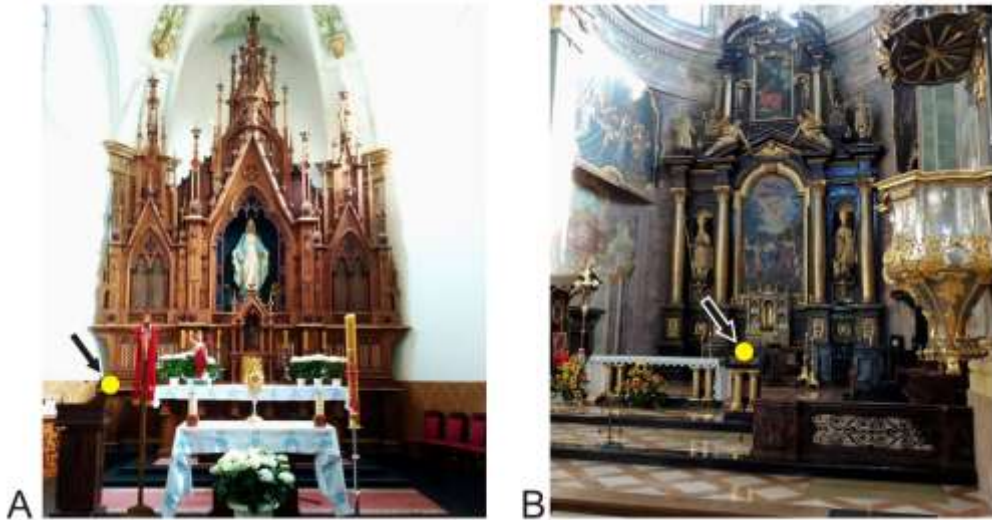
**Fig. 2.** Measurement points by the altars in: A: the Post-Bridgettines Church; B: the Lublin Cathedral

In each of the churches two measurement points were selected at similar locations – one near the main altar (Fig. 2) at the end of the nave and one in the underground crypts (Fig. 3). Air temperature and relative humidity (RH) were measured at 10-minute intervals using HOBO U23-001 Data Loggers in accordance with European standards EN 15757 and EN 15758 regarding the conservation of cultural property (from  $-40^{\circ}\text{C}$  to  $+70^{\circ}\text{C}$  and from 0% to 100% RH, resolution  $0.04^{\circ}\text{C}$  and 0.05% RH, accuracy  $\pm 0.2^{\circ}\text{C}$  and  $\pm 2.5\%$  RH). The data loggers were placed in shaded locations for 24 hours a day. Data obtained during the entire year of 2016 were used to analyse the magnitude of hour-to-hour changes in air temperature and relative humidity, compare current conditions with the range of optimal values, and determine the ‘historical climate’ of the buildings. The temperature and humidity values referred to in the paper, reflecting the weather conditions in Lublin in 2016, were obtained from the meteorological observatory in Litewski Square, located in the centre of the city less than 300 m from the Post-Bridgettines Church and less than 600m from the Lublin Cathedral.

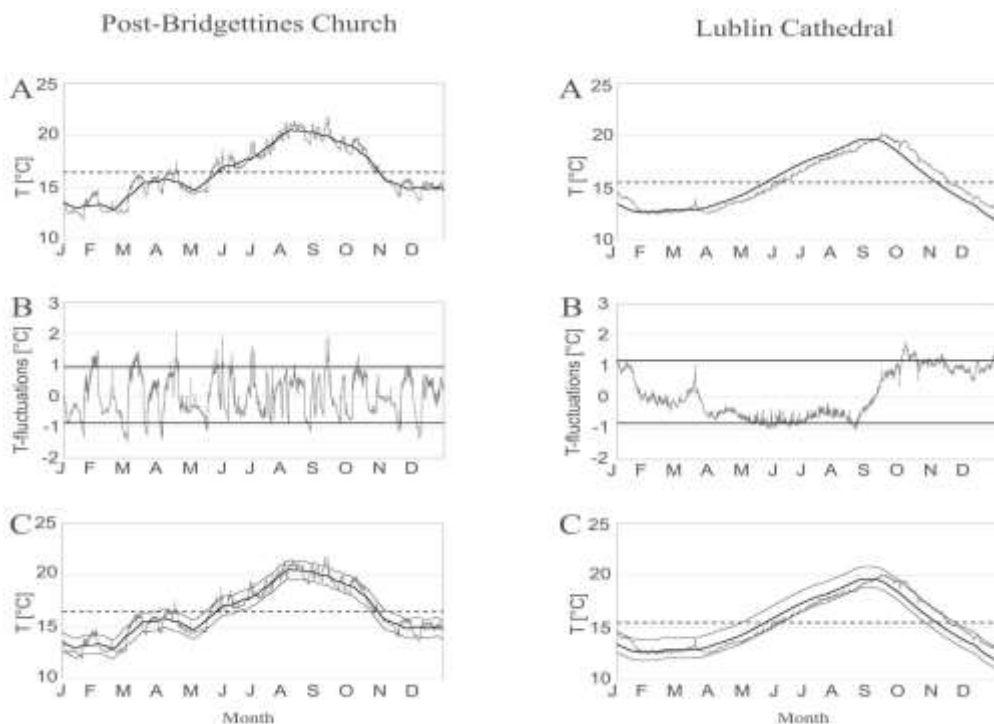
**Fig. 7A.** Indoor 10-minute air temperature (grey line), seasonal cycle (black line), and annual average (horizontal black dashed line) in the crypts in 2016; B. Short-term fluctuations of air temperature around the seasonal cycle with lower and upper limits as 7th and 93rd percentiles (black lines); C. Air temperature target level and range (black dotted lines)

The ranges of actual temperature values were similar in the crypts of the two buildings. The seasonal cycle values in the crypts of the Post-Bridgettines Church ranged from 12.8°C in

February to 20.5°C in August, while in the Cathedral crypts the MA ranged from 11.6°C in December to 19.6°C in August (Fig. 7A). The graph in Figure 7B presents the upper and lower limits of acceptable temperature deviations from the MA in both locations. In the crypts of the Cathedral the range of optimal values is more narrow ( $-1.0/+1.8^{\circ}\text{C}$ ) than in the other building ( $-1.5/+2.0^{\circ}\text{C}$ ). Comparison of the limits with actual values shows that the temperature in the crypts should range from 11.9°C to 21.4°C in the Post-Bridgettines Church and from 10.8°C to 20.8°C in the Cathedral (Fig. 7C).
