## MICROCLIMATE ANALYSIS OF TWO HISTORIC CHURCHES IN LUBLIN – OPTIMAL HYGROTHERMAL CONDITIONS FOR PRESERVATION OF CULTURAL HERITAGE

*This study concerns the microclimatic conditions in two historic churches of the temperate climatic zone located in Lublin, Poland: Lublin Cathedral and Post-Bridgettines Church, having regard to their underground crypts. The measurements of the air temperature and RH lasted all 2016 and were compared with optimal heritage protection values included, inter alia, in American instruction ASHRAE Handbook. Furthermore, for both buildings the historic climate was calculated, based on the European Standard EN 15757:2010, and the target ranges were specified.*

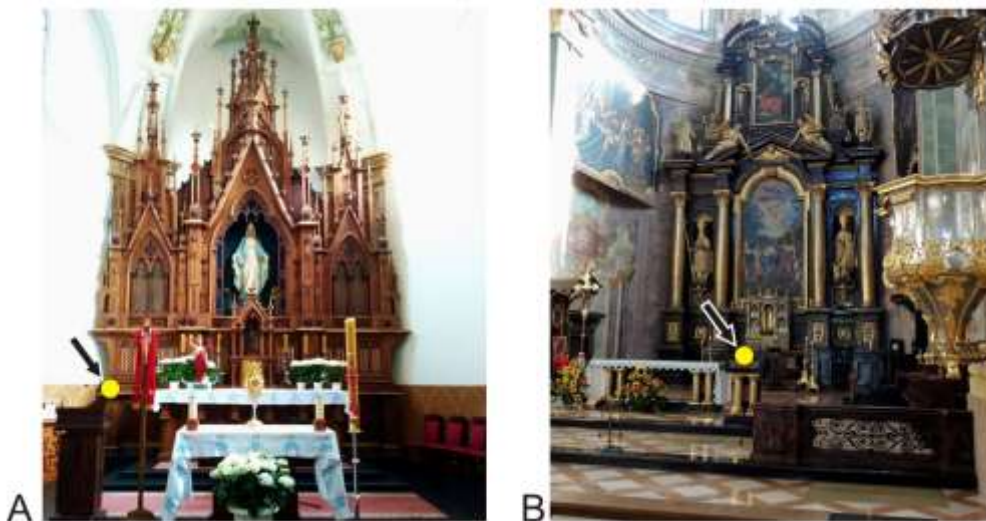
Fig. 2. Measurement points by the altars in: A: the Post-Bridgettines Church; B: the Lublin Cathedral

In each of the churches two measurement points were selected at similar locations – one near the main altar (Fig. 2) at the end of the nave and one in the underground crypts (Fig. 3). Air temperature and relative humidity (RH) were measured at 10-minute intervals using HOBO U23-001 Data Loggers in accordance with European standards EN 15757 and EN 15758 regarding the conservation of cultural property (from  $-40^{\circ}\text{C}$  to  $+70^{\circ}\text{C}$  and from 0% to 100% RH, resolution  $0.04^{\circ}\text{C}$  and 0.05% RH, accuracy  $\pm 0.2^{\circ}\text{C}$  and  $\pm 2.5\%$  RH). The data loggers were placed in shaded locations for 24 hours a day. Data obtained during the entire year of 2016 were used to analyse the magnitude of hour-to-hour changes in air temperature and relative humidity, compare current conditions with the range of optimal values, and determine the ‘historical climate’ of the buildings. The temperature and humidity values referred to in the paper, reflecting the weather conditions in Lublin in 2016, were obtained from the meteorological observatory in Litewski Square, located in the centre of the city less than 300 m from the Post-Bridgettines Church and less than 600m from the Lublin Cathedral.

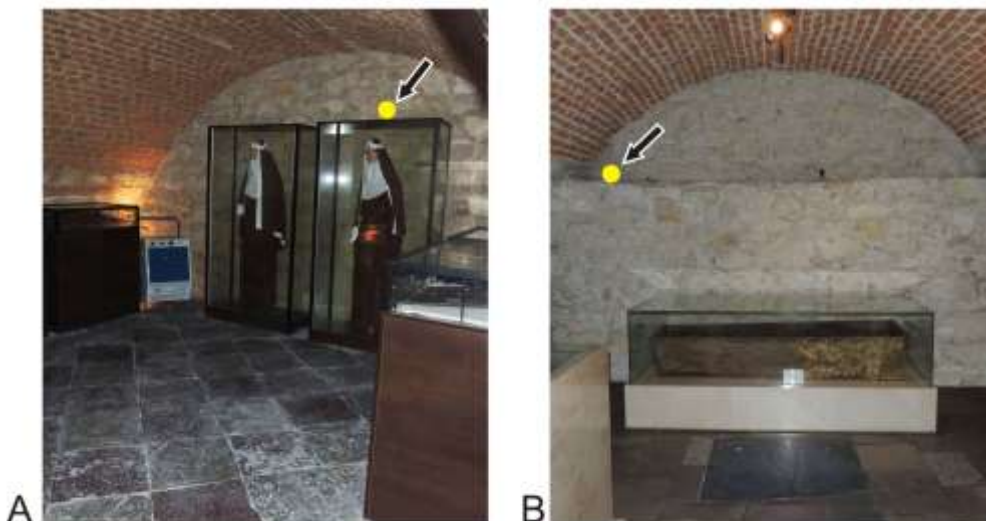
Fig. 3. Measurement points in the crypts in: A: the Post-Bridgettines Church; B: the Lublin Cathedral

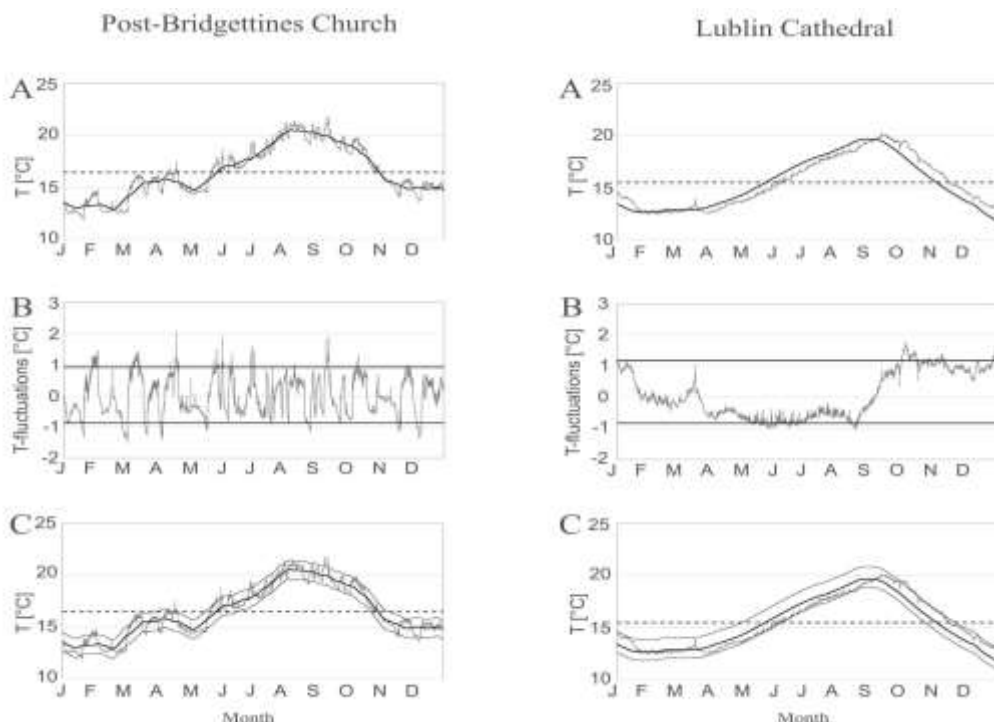
**Fig. 7A.** Indoor 10-minute air temperature (grey line), seasonal cycle (black line), and annual average (horizontal black dashed line) in the crypts in 2016; B. Short-term fluctuations of air temperature around the seasonal cycle with lower and upper limits as 7th and 93rd percentiles (black lines); C. Air temperature target level and range (black dotted lines)

February to 20.5°C in August, while in the Cathedral crypts the MA ranged from 11.6°C in December to 19.6°C in August (Fig. 7A). The graph in Figure 7B presents the upper and lower limits of acceptable temperature deviations from the MA in both locations. In the crypts of the Cathedral the range of optimal values is more narrow (-1.0/+1.8°C) than in the other building (-1.5/+2.0°C). Comparison of the limits with actual values shows that the temperature in the crypts should range from 11.9°C to 21.4°C in the Post-Bridgettines Church and from 10.8°C to 20.8°C in the Cathedral (Fig. 7C).
