REPRODUCTION AND RESTORATION OF ICONOSTASES OF UKRAINIAN CHURCHES

Abstract

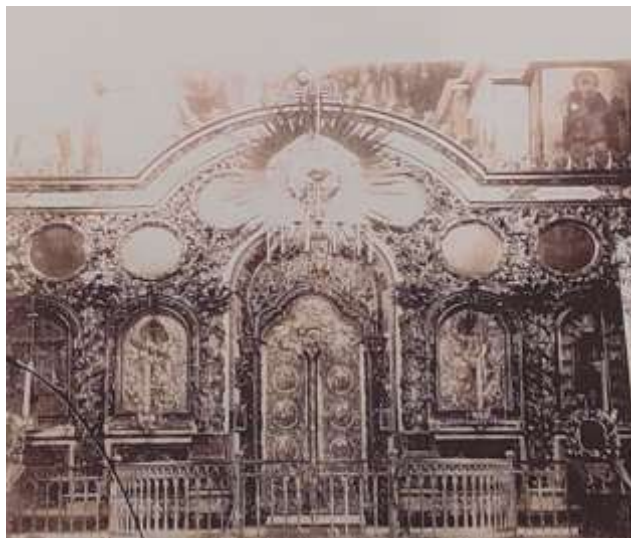
Fig. 2. Archival photo of the central iconostasis of St. Michael's Golden-Domed Cathedral. From the stocks of the "Ukrrestavratsiia" Corporation.

The only preserved part of the original central iconostasis of St. Michael's Cathedral is the authentic Royal Doors. It did not belong to the Baroque period, as it was made in 1811. The Royal Doors actually consisted of six elements: two silver leaves in the minting technique, each of which was assembled from three parts. The composition of the Royal Doors was completed by the image of God the Father in clouds and rays located in the arch of the iconostasis above the gate. As it was found out by the specialists of the "Ukrrestavratsiia" Corporation, the Royal Doors were decorated with copper and silver gilded overhead parts, and two types of gilding were used on these parts – a rather dense and bright gilding of a "warm shade" on copper on the figures of sitting angels, and a thin, transparent "cold shade" – for silver [16].

The examination revealed a different condition of the parts of the Royal Gate, because although the gate leaves were in good condition, the bas-relief with the image of God the Father was in an unsatisfactory condition, it needed to be restored. Due to the special value of the authentic Royal Gate and the conditions of operation of the recreated St. Michael's Cathedral as an active cathedral, a copy of it was made by the electroplating method and installed in the cathedral. Given the openwork complex surface of the leaves of the authentic Royal Gate, the large number of elements and the large size, the authentic Royal Doors were disassembled into its components to produce the exact shape, and then reassembled. The project of the central iconostasis was developed by the creative architectural workshop of Yu. Losytskyi. The reproduction of elements and details took place as closely as possible to the original, however, in some cases, the reproduction of lost elements could take place on the basis of studying the corresponding analogues. The central iconostasis was recreated as it was at the time of the destruction of the St. Michael's Cathedral, since it was originally not three-tiered, but five-tiered, the two upper tiers were dismantled in 1888, in order to open for viewing ancient mosaics and frescoes. The lower part of the multi-tiered baroque iconostasis, built in 1718 at the expense of Hetman Ivan Skoropadsky, was to be reproduced. This lower part of the iconostasis consisted of three tiers of icons, the lower row of which depicted scenes from the Old Testament and the Apocalypse, and above it the local and Feasts tiers were placed [16].

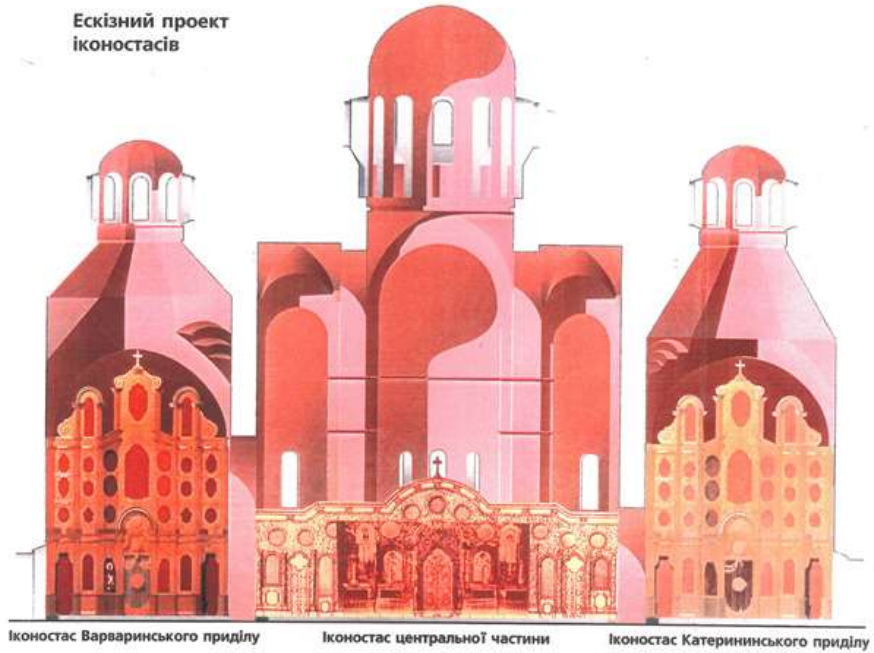
Fig. 3. Sketch project of the iconostasis of the central nave, St. Barbara's and St. Catherine's aisles of St. Michael's Cathedral. Photo from the stocks of the "Ukrestavratsiia" Corporation.

The source base for the drawings of the reconstructed iconostasis (Fig. 3) were archival photos of the general appearance of the iconostasis and its individual parts from the National Art Museum and in the Munich edition of the book by H.K. Lukomskyi "Kyiv".

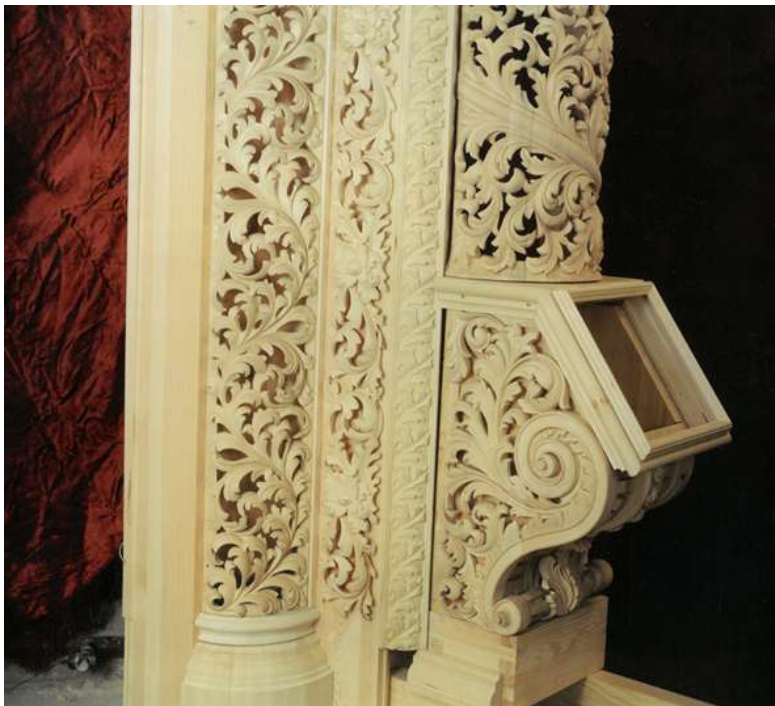
Fig. 4. A fragment of the portal of the Royal Door of St. Michael's Cathedral. Photo from the stocks of the "Ukrestavratsiia" Corporation.

Drawings of the carpentry structures of the iconostasis were developed separately, templates were made in the Ukrainian Baroque style, carpentry preparation for artistic finishing and high-relief openwork through-and-through carving with hand tools was carried out (Figs. 4, 5 and 6).

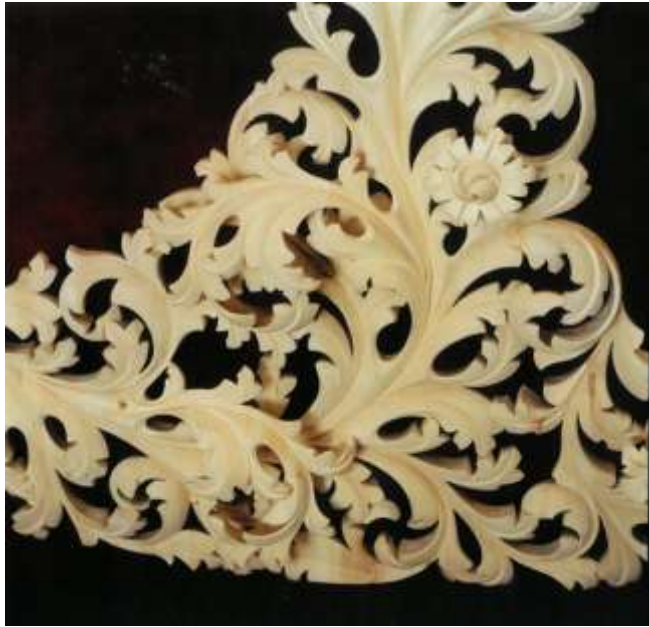
Fig. 5. A fragment of the carving of the Feasts tier of the central iconostasis of St. Michael's Cathedral.
Photo from the stocks of the "Ukrestavratsiia" Corporation.

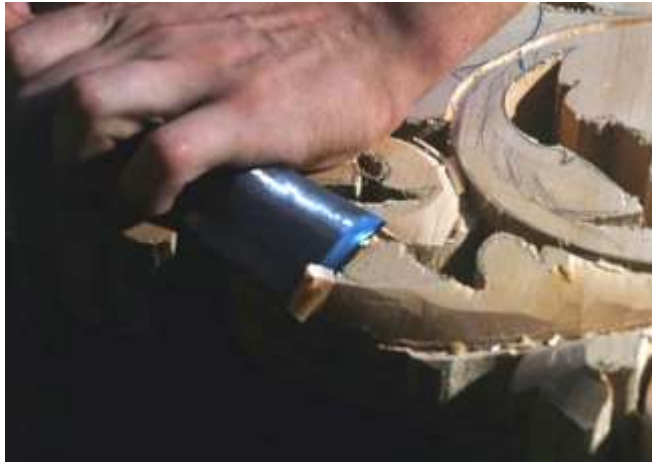
Fig. 6. The process of carving parts of the central iconostasis of the Dormition Cathedral.
Photo from the stocks of the "Ukrestavratsiia" Corporation.

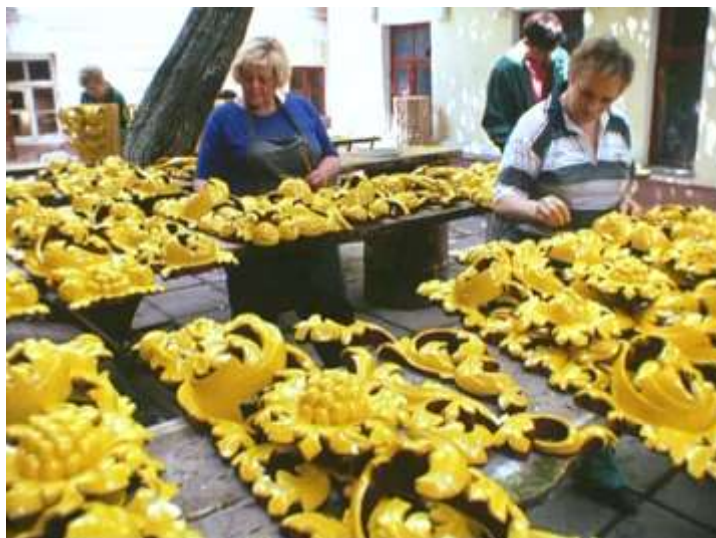
Fig. 7. Preparation of fragments of the central iconostasis of the Dormition Cathedral for gilding.
Photo from the funds of the "Ukrrestavratsiia" Corporation.

century, and the cathedral was restored to the condition of this period, including elements, church utensils, iconostases and wall paintings (Fig. 7).

The supporting structure of the main iconostasis was made of metal to facilitate further operation and strengthen the iconostasis. Thus, the wooden parts of the frame structure – pine boards for the carved decor – were relieved of the excessive weight of the lush decor. Finished details of the carved decor were gilded with gold leaf.

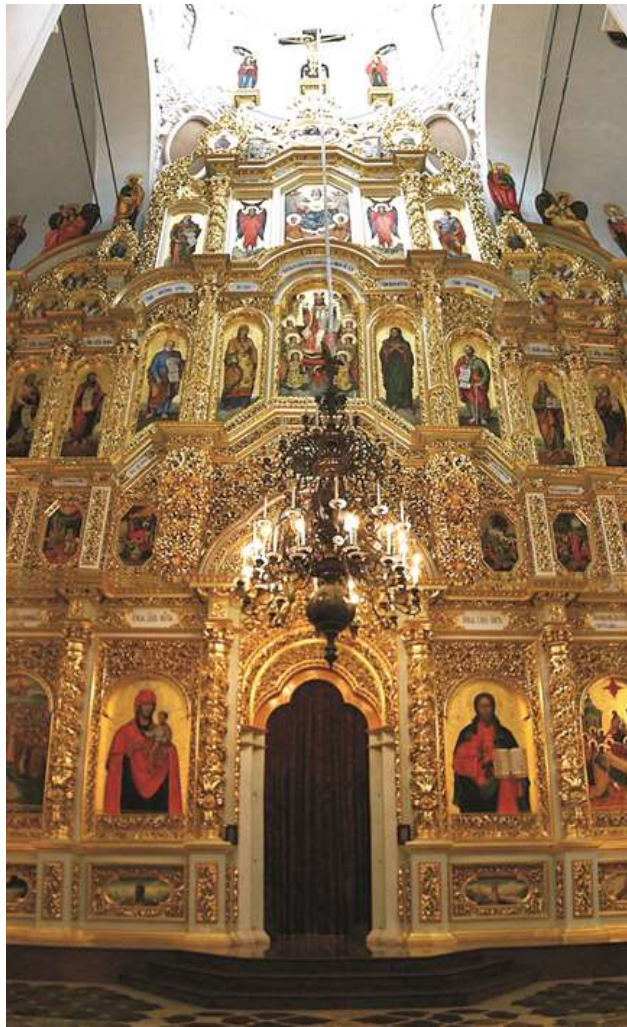
Fig. 8. Reproduced central iconostasis of the Dormitionion Cathedral.
Photo from the stocks of the "Ukrestavratsiia" Corporation.

Today, the five-tiered carved iconostasis, reproduced according to archival photographs and written evidence, once again adorns the majestic interior of the Dormition Cathedral (Fig. 8).
