RISK ASSESSMENT OF VARIOUS TREES GROWN IN THE INNER PART OF FIRST ZONE TO THE PRESERVATION OF THE BOROBUDUR TEMPLE

Keywords: Biological characteristics; Borobudur temple; Heritage building; Risk assessment; Tree species

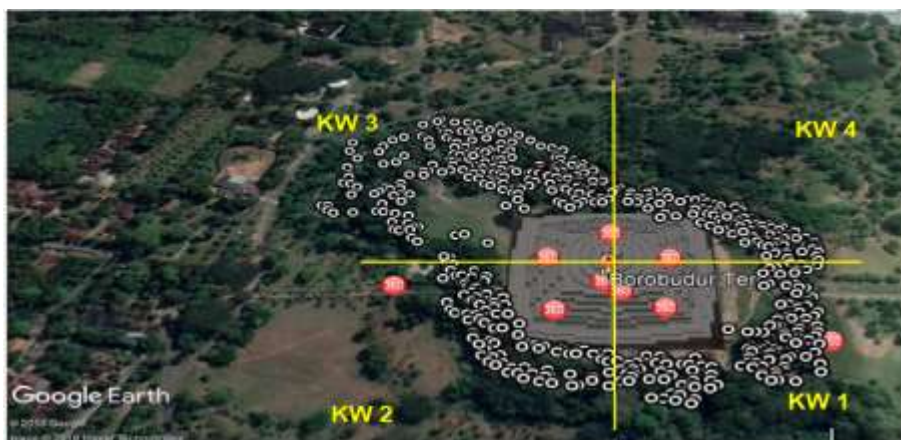
Fig. 1. Spatial distribution of the 613 observed trees in the four quadrants [3] of zone 1 of Borobudur temple.

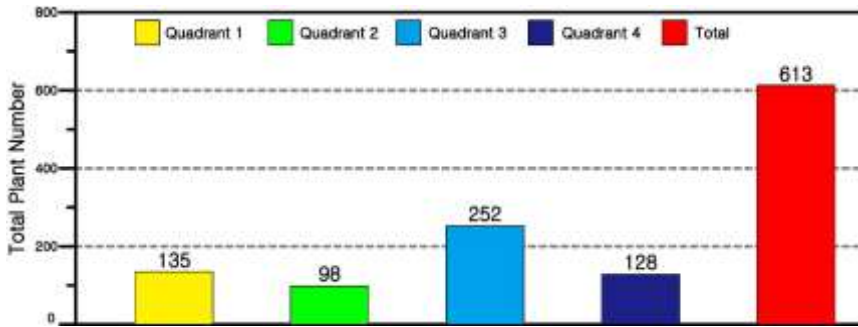
Fig. 2. Distribution and the total number of trees in the observed area in (zone 1) of Borobudur temple.

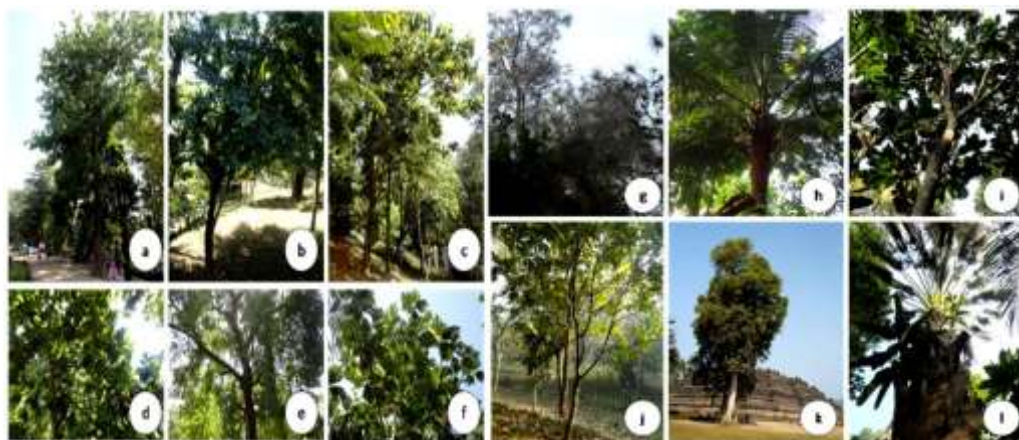
Fig. 4. Tree species planted in the inner part of zone 1 of Borobudur temple; a. *Terminalia catappa*, b. *Crescentia cujete*, c. *Tectona grandis*, d. *Ficus lyrata*, e. *Tamarindus indica*, f. *Artocarpus altilis*, g. *Pinus merkusii*, h. *Satakentia liukiensis*, i. *Barringtonia asiatica*, j. *Calophyllum inophyllum*, k. *Canarium vulgare* and l. *Corypha utan*.

There were five most frequent species that often found in the observed area, namely *Calophyllum inophyllum* (Calophyllaceae), *Ficus religiosa* (Moraceae), *Tectona grandis* (Lamiaceae), *Swietenia macrophylla* (Meliaceae) and *Satakentia liukiensis* (Arecaceae). Species of *Calophyllum inophyllum* was the most abundant tree (54 individuals) followed by *Ficus religiosa* (48 individuals) and *Tectona grandis* (39 individuals). Among these 93 tree species, 20 of the most abundant tree species in the observed area are shown in Fig. 3. The trees planted in the observed area have shown various canopy architectures, ages, and sizes. Some of those are illustrated in Figure 4.

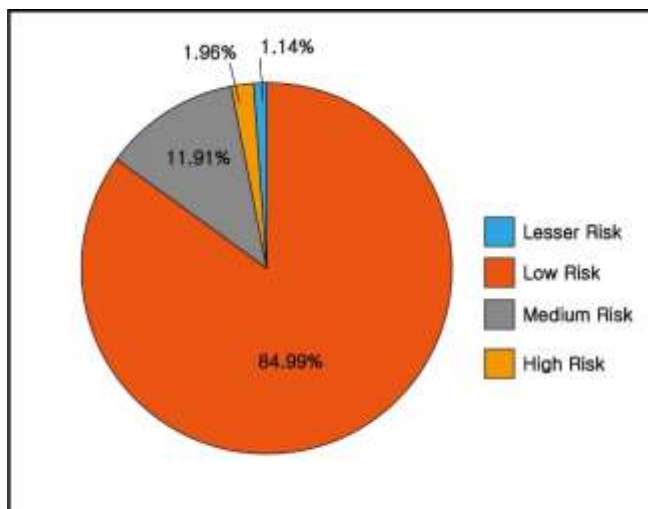
The results of risk analysis showed that there were 613 existing trees in the inner zone 1. Among these, there were 12 individuals categorized as high risk (1.96%), 73 individuals (11.91%) classified as medium risk, and 521 individuals (84.99%) were low risk, and only 7 individuals (1.14%) had lesser risk (Fig. 5). Those 12 trees have been categorized as high-risk to the preservation of the temple, namely *Terminalia catappa* (3 individuals), *Canarium vulgare* (1 individual), *Tamarindus indica* (1 individual), *Ficus lyrata* (2 individuals), *Ficus callosa* (1 individual), *Pinus merkusii* (2 individuals), and *Tectona grandis* (2 individuals) (Table 2). All of those trees are located near the temple, approximately 5.5 to 21.0 metres distance from the outermost structures of the temple.

Fig. 5. Percentage of four risk categories based on the assessment result.

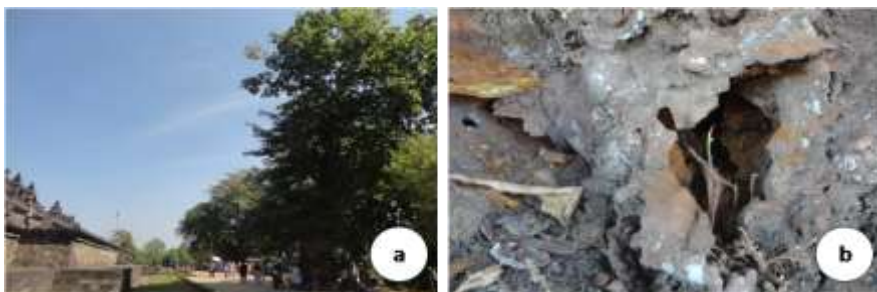
Terminalia catappa had relatively low scores at Step 1, but their scores on Step 2 were relatively high due to their individual characteristics. In Step 2, these two individuals of *Terminalia catappa* meet with all of three criteria, so they may have risk damage to the temple due to their lateral root penetration and also risk damage caused by fallen trees or branches since their TZR and height value \geq the closest distance of the tree to the temple. These both *Terminalia catappa* also showed heavily damaged tissues in the basal main trunk that may reduce their physical strength, especially when the main trunk withstands the heavy canopy at the top.

The tree height of both *Terminalia catappa* that exceed their relative distance to the temple presents a serious threat associated with the possibility of falling trees or branches. It is known that *Terminalia catappa* has long horizontal branches that are arranged in obvious tiers, giving a broad pagoda-like canopy shape. On the other hand, the wood density of this species is categorized as moderately strong (0.46 g/cm³) [16]. Therefore, the old large tree of *Terminalia catappa* or even its huge branches are very vulnerable to collapse due to strong winds, especially those that are planted in open area. Large tissue damage in their lower trunks can reduce the trunk's physical strength. Thus, it will further increase the risk of falling trees. Moreover, many of *Terminalia* species, including *Terminalia catappa*, have a relatively fast growing rate and usually can grow into very large trees (the basal stem is up to 1.5 m in diameter) with broad horizontal branches as well as their lateral roots [17]. Therefore, this species is not best choice to be planted close to the heritage building without carefully routine maintenance.

Fig. 6. a. *Terminalia catappa* that grows near the Borobudur temple; b. Large cavity with decayed tissue in the base trunk of *Terminalia catappa*

Fig. 7. a. *Terminalia catappa* trees planted around temples are often used by visitors as a shelter; b. The root of *Terminalia catappa* that begin to decay.

1. **Group 1** represents the tree species associated with all three criteria in Step 2: a high risk of root penetration, risk of falling tree, and heavily damaged main trunk. For example, *Terminalia catappa* 1 and *Terminalia catappa* 2 that have tree's height value that exceed the closest distance to the temple (high risk from falling tree and branches), heavily damaged main trunks which may reduce its strength, and a greater TZR value (13.59 metres) that may cause a high risk of root penetration beneath the temple. Several studies have shown that vegetation close to walls can occasionally cause wall cracks. The growing root of the tree can penetrate the building foundations and walls, causing cracks to form [21]. Another research indicates that *Terminalia catappa* is a fast-growing tree species, with rapid growth causing cracks in the walls due to the expanding action of developing lateral roots [17, 22, 23]. Severe tissue damage in the trunk of both trees (*Terminalia catappa* 1 and *Terminalia catappa* 2) will reduce the physical strength of the trunk and it becomes more vulnerable to collapse (Figs. 6 and 7).

All the individual trees that have been categorized as high-risk should be carefully managed in order to reduce the hazard risk. The most efficient strategy for long-term period, probably can be done by translocating all those high-risk trees to a new place that far away from the temple. However, if those high-risk trees are decided to remain in its position, then the intensive high-risk tree management strategies should be done, these including: (a) establishing an artificial barrier to maintain the tree roots, so they cannot penetrate to the temple's structures; (b) regular stem pruning to keep the trees at a certain height with lesser risk; (c) regular extreme stem pruning and regular fruit trimming to keep the trees at a very short height in order to minimize the seed dispersal distance by wind as well as to decrease the fruit quantity, (d) stop the process of decaying plant tissue by using chemical treatment, (e) improving the strength of decayed trunk with concrete to fill the cavities, (f) put the warning sign board for the trees with high risk of falling tree or branches.

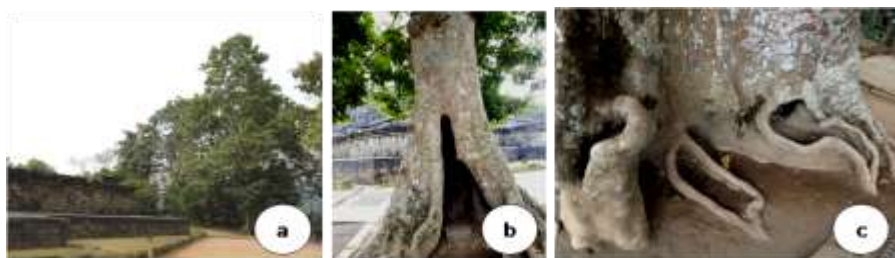
Another tree categorized as high risk was *Canarium vulgare* (risk index = 23) due to its relative distance to the temple. This tree with a height of about 18 m and grows near the temple with a distance of about 6 m. In addition, a primary symptom of decayed tissue was found to perforate the basal stem, while hollow at the basal stem and root may also sign of the decaying more of stem tissue at the unseen lower part of that living tree. These conditions can reduce the physical strength and weaken the robustness of the stem and so it will cause the tree to fall down anytime (Figs. 6-8). By considering the huge diameter of the trunk and the height of the tree, if it falls towards the temple building then it may cause a very serious physical damage.

Fig. 8. a. An old *Canarium vulgare* tree grown very close to the Borobudur temple; b. Large cavity with decayed tissue in the stem base of *Canarium vulgare*; c. The basal area of *Canarium vulgare* with tissue damaged symptoms.

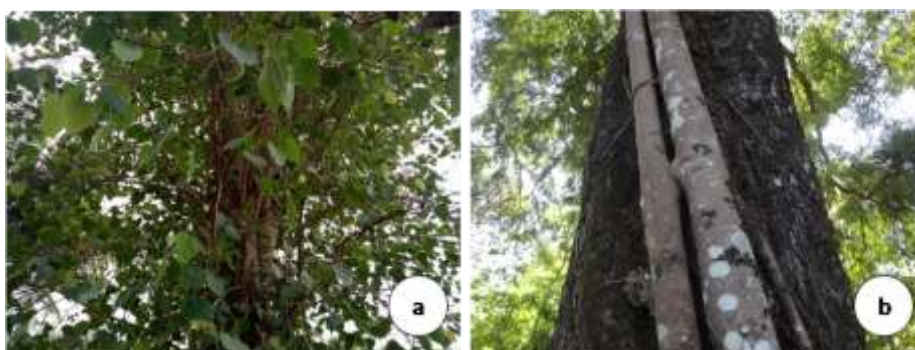
Fig. 9. a. A large tree of *Ficus religiosa* planted in the inner part of zone 1;
b. *Pinus merkusii* with a climber of *Ficus* sp. from *Urostigma* section.

The most common *Ficus* species planted in the inner part of zone 1 was *F. religiosa* or Bodhi tree (Fig. 9). Species of *Ficus religiosa* is a long-lived large tree which adapted to the environment with limited water, soil, and nutrient content. This species also can grow as epiphytes or even lithophytes to colonize the rock permanently [24]. However, the aggressive lateral root character is thought to threaten the temple structure if it grows close to the temple or even grows in the narrow gap of the temple stones. The seed characters of *Ficus religiosa* that

are small and easily grow in the narrow cleft of the temple stones make this species need to be managed with special attention [32].
