A STUDY OF ABANDONED UKRAINIAN WOODEN CHURCHES IN POLAND. CURRENT STATE AND CONSERVATION RECOMMENDATIONS

Abstract

The paper summarises conservation research carried out on abandoned wooden Ukrainian Greek-Catholic churches from south-eastern Poland. As an example, two architectural objects remaining in complete ruin are discussed: the church in Babice and the church in Mięgisz Stary. Both of them were erected in log construction and have rich interior polychrome. Conservation methodology was discussed, which must combine often contradictory challenges and aspects: both the need to stabilise the architectural body (which requires the replacement of a significant amount of historical substance) and the intention to preserve as much as possible the remains of the interior painting decoration (in the majority, polychrome was made directly on structural elements). The method of polychrome transfer was therefore discussed, which guarantees the preservation of the authentic character of the temples as well as their aesthetic and historical value. In addition, a detailed study of the remains of the iconostases of both temples (icons are currently stored in museum warehouses) and the issu

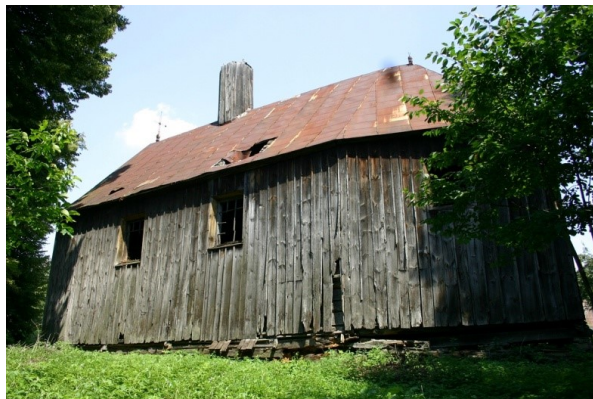
Fig. 1. The Greek Catholic Church of the Dormition of the Mother of God in Babice;
photo T. Tomaszek

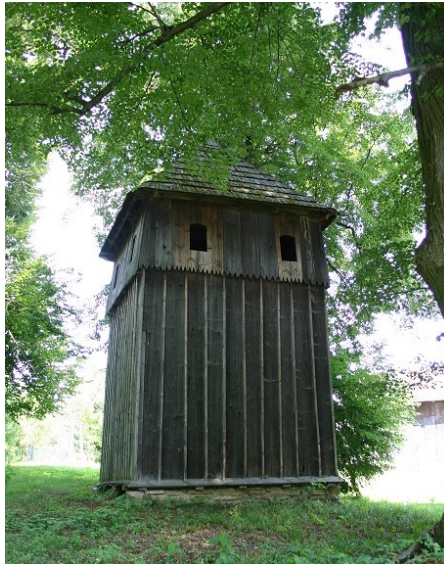
Fig. 2. A free-standing wooden bell tower near the Greek Catholic Church of the Dormition of the Mother of God in Babice, photo T. Tomaszek

The free-standing, wooden belfry located near the church was made of a frame structure. It is erected on a central square plan and it has vertical walls covered with boards. In the upper part it is enriched with a chamber like space with slightly inclined walls. It is crowned with a tent roof covered with shingles.

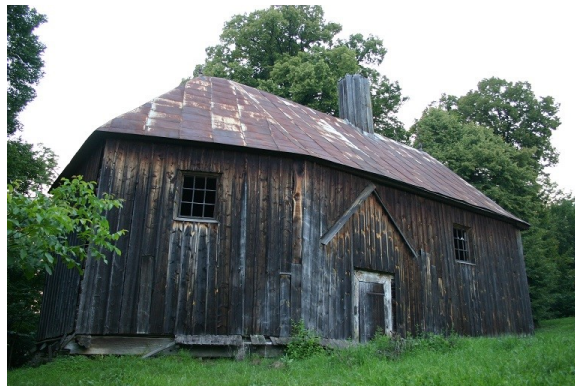
The wooden Greek Catholic church in Babice was built on a log structure. It is an oriented building, seemingly single-spaced, closed on three sides from the east, 17.70m long and 9.10m wide. A vestibule (in frame construction) is added to the main body from the west in post and beam construction, whereas from the north it was enriched with a sacristy (not preserved until today) (Fig. 3).

Fig. 3. Greek Catholic Church of the Dormition of the Mother of God in Babice; view from the north – traces of a lost sacristy on the wall; photo T. Tomaszek

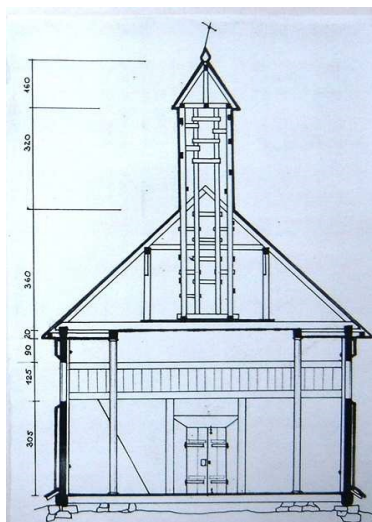
Fig. 4. Inventory drawing of the Greek-Catholic church in Babice - cross-section based on: P. Haszczyń, *Babice Historical Trail - Stop 3*, http://www.spbabice.edu.pl/pdf/sciezka_historyczna.pdf.

The beams of the walls are made of coniferous wood, and the foundation beam (with a cross-sectional diameter of 35x35cm) is made of oak wood. In the corners, dovetail joints with a covered tenon have been used. According to the preserved traces, it can be assumed that the foundation beam of the lost sacristy was cornered to the northern foundation beam of the main body, and the beams of its eastern and western walls were fixed "in the notches" in the northern wall of the church. The framework of the walls of the church is fastened with a top plate. At the same level as the top plate, parallel to its northern and southern beams, there are beams connected with corner joints and supported inside the building with wooden poles (each with three poles). The girt beams and additional beams on the poles provide direct support for the roof structure. The pillars inside the main part of the church create a characteristic division of space, introducing side pseudo-aisles 150cm wide each (Figs. 4 and 5). Additional reinforcements in the form of vertical slats (called in Polish "lisice") were installed to stiffen the framework of the walls. And so, on the southern wall, they are located in three places, while on the northern wall, they are located in two places [1].

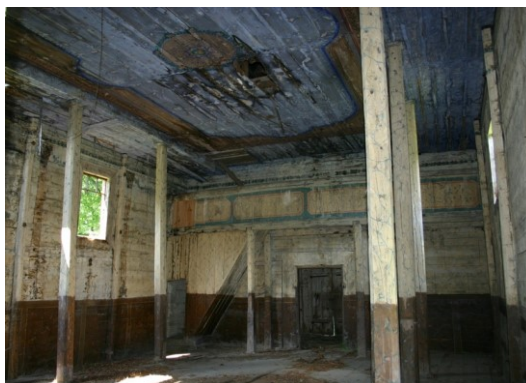
Fig. 5. Greek Catholic Church of the Dormition of the Mother of God in Babice; interior from the side of the choir, visible division into pseudo-aisles obtained with the help of the rows of pillars; *photo T. Tomaszek*

The sanctuary was separated from the single-space body of the building by means of a curtain wall made of planks (which is also the main body supporting structure of the iconostasis) (Fig. 6). The inner space of the church is limited from above by a flat ceiling, lowered on the sides and supported by pillars.

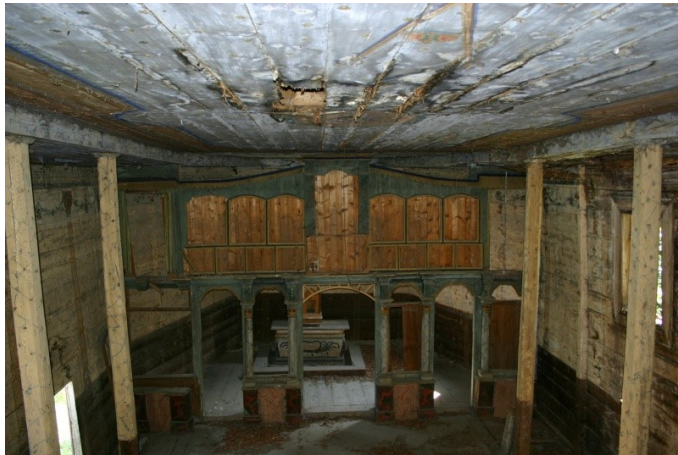
Fig. 6. Greek Catholic Church of the Dormition of the Mother of God in Babice - view of the sanctuary separated from the nave by a curtain wall of iconostasis (currently devoid of icons), photo T. Tomaszek.

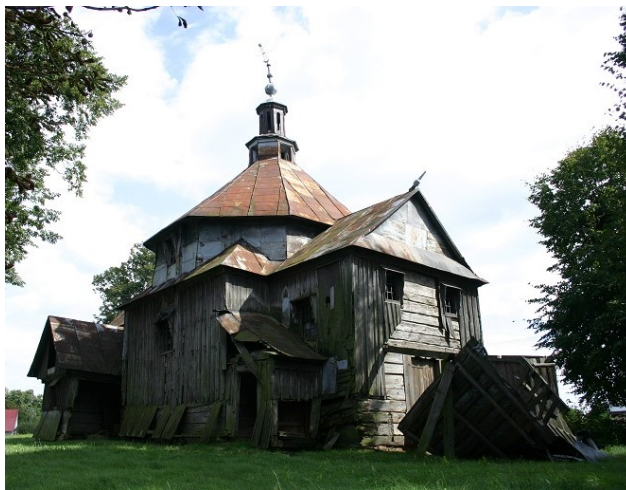
The wooden orthodox church of the Protection of the Purest Mother of God in Mięksiz Stary (Fig. 7) belongs to the oldest and most typologically unique Greek Catholic churches of the Przemyśl region of the Podkarpacie voivodeship. Apart from keeping the typical characteristics of rural wooden Greek Catholic churches from the area of Podkarpacie, the

shape of its architectural structure explicitly refers to the masonry tradition of monumental Roman Catholic baroque churches. This is mainly noticeable both in the particularly accented central part of the church, the nave, covered by a wooden, orthogonal, dome-like structure topped with a roof lantern, as well as in the partially preserved illusionistic polychrome of the interior [6, 7].

Fig. 7. Orthodox church in Miękisz Stary; photo T. Tomaszek.

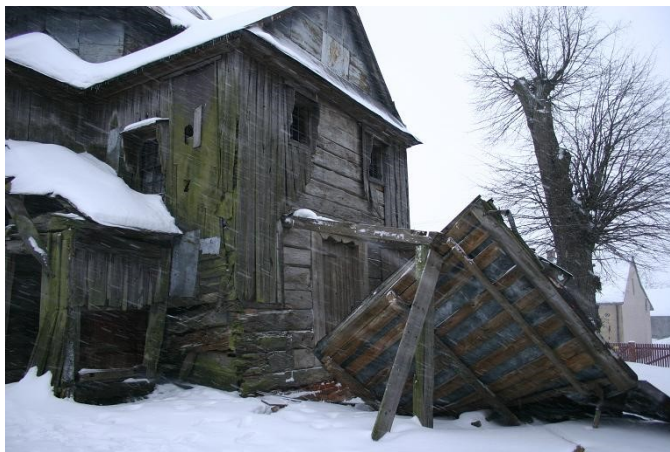
According to the 2019 conservation surveys carried out, the state of preservation of the church and polychrome has deteriorated further since the last inventory carried out in 2006 [6]. In addition to the natural factors causing the degradation of the church, which are moisture, fungi, and the activity of wood eaters, vandalism has also come to the fore. It manifests itself in the destruction of the lower parts of the building and, above all, in the execution of a number of inscriptions or drawings on the layer of the original polychrome inside the church. (These inscriptions, with vulgar content, are made with spray paints and various types of markers.) Presumably, due to the loss of structural stability and the weight of the snow layer on the roof, the porch adjacent to the women's porch from the west collapsed (Fig. 11).

Fig. 11. Collapsed porch adjacent to the women's porch from the west, photo T. Tomaszek

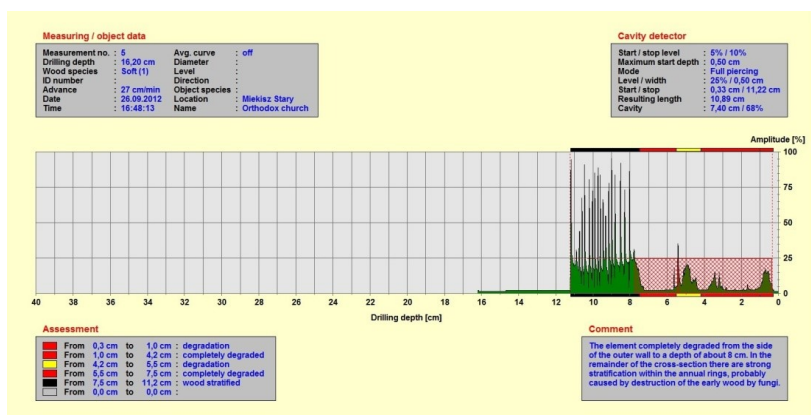
In order to identify more precisely the condition status of the Greek-Catholic churches in Miękisz Stary and Babice, the analysis using the Resistance Drilling Method (RDM) was conducted *in situ*. For this purpose, the device called the resistograph IML-RESI F400-S was used. The examinations consisted of performing a number of drillings in selected wooden elements, which made it possible to determine the condition status of the wood tissue in cross sections of these spots (drilling points). This analytical method can be considered a quasi-non-destructive method, as for drilling, a very thin and flexible drill was used, so the diameter of the hole that remained after the execution of the measurement was not wider than the exit openings made by wood borers [10].

The data from the above-mentioned analyses were collected in the form of graphs showing the amplitude of the resistance in relation to the depth of the hole (the analytical method performed was based on the measurement of cutting resistance during drilling through the wooden element). It allowed the assessment of the range and an element of degradation, thus a preliminary assessment of the strength of wood (the test shows if the analysed wood has increased, medium, or reduced strength parameters) [11]. This technique is highly effective in the study of historical wooden structures [10-13].

Fig. 12. The exemplary graph obtained during performed tests of drilling resistance of wooden elements of orthodox church in Miękisz Stary

The RDM analyses have confirmed the very bad condition status of the temples. They also showed that the most degraded remaining wooden elements are located in the lower parts of the churches. In general, there are parts roughly at a height of up to 1.5 metres from the ground. It is due to their direct contact with groundwater and thus increased moisture content. These tests have also shown that the type of degradation is clearly differentiated and results directly from the location of the analysed element in relation to the cardinal direction as well as a spot in the building.

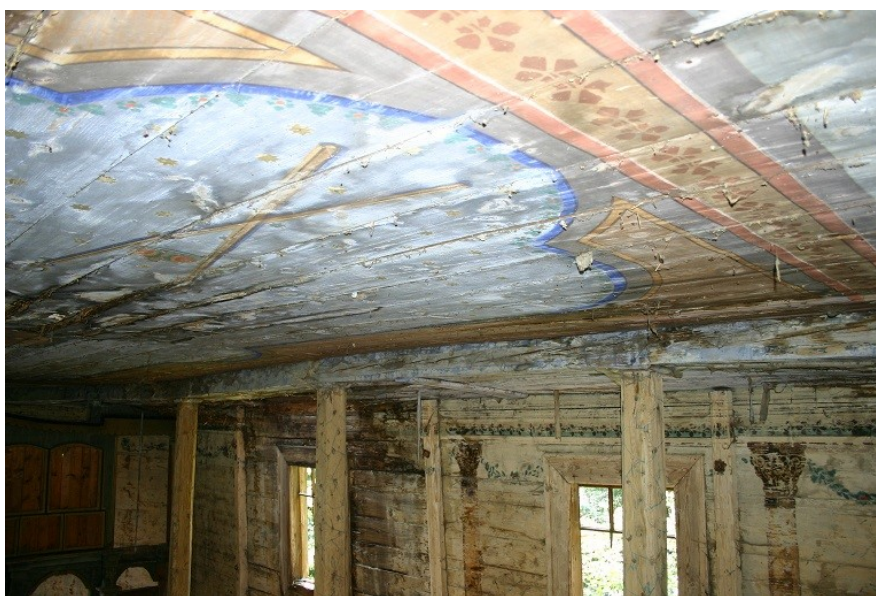
The interior of the church is covered with tempera polychrome of an ornamental character, imitating architectural divisions and stone surfaces (marbling). Its state of preservation is critical, and it requires immediate conservation work (Figs. 13 and 14).

Fig. 13. Greek Catholic Church of the Dormition of the Mother of God in Babice - ornamental polychrome covering the walls and imitating architectural divisions, currently in very poor condition - view of the southern wall of the nave and the sanctuary (iconostasis wall), photo T. Tomaszek

The condition status of the painted in tempera polychrome decoration is critical, and therefore it is demanding full technical and aesthetic conservation. Due to the complicated process of replacing degraded wooden elements or their degraded fragments with new elements, the partial transfer of polychrome from these elements (or fragments), which are allocated for complete removal and covered by painted decoration, should be conducted. The transfer of polychrome should be performed regardless of the general method of conservation intervention (approach) in relation to the main architectural structure of the temple, both in the case of the elevation of the structure as well as its dismantling into individual components.

The carried out analyzes have proved that the best conservation solution is a transfer of the paint layers to the new base simultaneously together with lying beneath it layer of grounding as well as the surface layer (external layer) of wooden element. In other words, it is recommended a mechanical “*decoupling*” of the outer surface of the painted wooden element along with the covering it the polychrome layer (and grounding) from a “substantial” part of this element. This “*separation*” can be made by cutting off, and the place of its execution must be at each time precisely determined after detailed analysis of the element (Fig. 31).

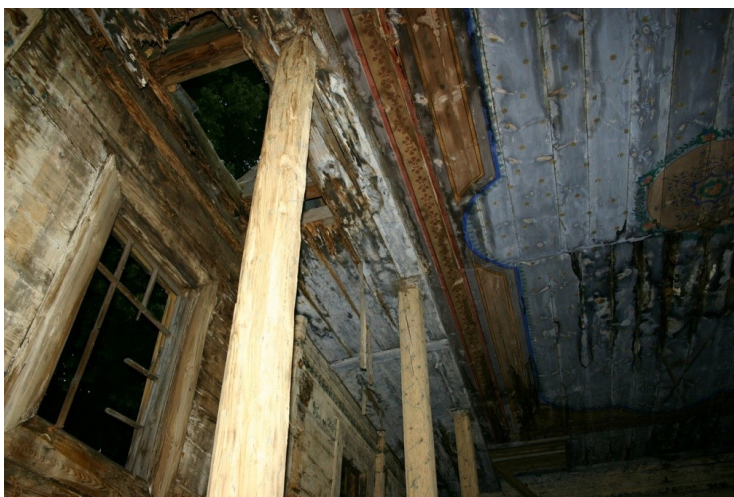
Fig. 14. The Greek Catholic Church of the Dormition of the Mother of God in Babice - advanced degradation of wooden structural elements covered with polychrome on the ceiling of the nave and the southern wall; from the south, right next to the wall, there is a visible hole in the ceiling and roof, photo T. Tomaszek

Due to the advanced degree of degradation of a substantial amount of the wooden elements of both temples, it is expected to replace these degraded elements with new ones obtained from the same species of wood and fabricated following as much as possible the traditional processing methods. Following this approach, only the parts that are completely degraded should be subject to complete replacement. In the case of partially degraded items, when it will not affect their mechanical strength or the local or global stability of the object (building), it is recommended to remove only the damaged fragments. Then, in their place, the "insertions" obtained from a new wood (fabricated in a traditional way and maintaining the original form) should be substituted. If possible, the resulting additions should be combined with the remnants of the original elements using traditional carpentry joints. If such bindings are not sufficient, it is recommended to strengthen the contact points of the original with the "insertion" of an appropriately selected binder.

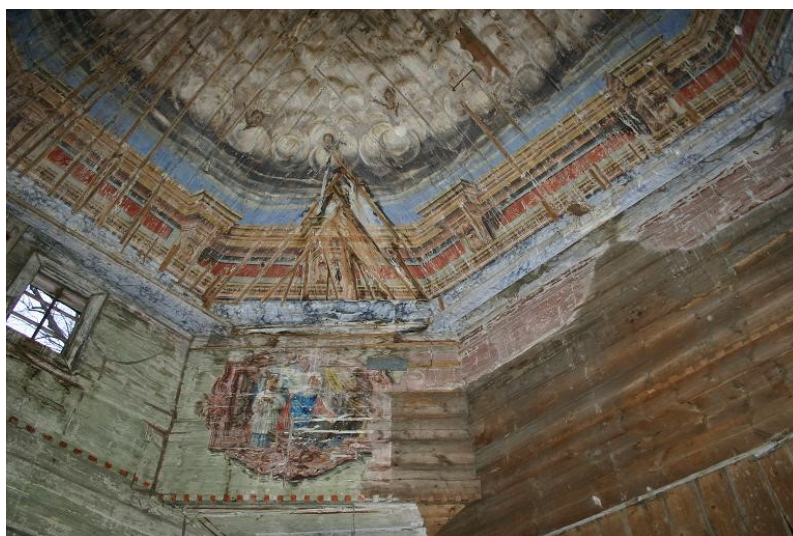
Fig. 15. Wall polychrome of the church in Miękiż Stary, visible illusionistic representation of the open sky placed in the dome above the architectural entablature and the figures of the Evangelists in the pendentive, photo T. Tomaszek

In general, the state of preservation of the painting decor of the wooden church in Mięksiz Stary can be described as bad and vulnerable to further damage. The condition of individual fragments of the polychrome varies. This is primarily due to their location on the walls of the temple and, thus, the degree of destruction of individual fragments of the building.

Thus, there are noticeable differences in the state of preservation between the part of the painting decor located closer to the floor (approximately up to 1.5m high) and the rest of the polychrome made in the upper parts of the walls. This is related to the state of preservation of the lowest part of the building, where, as a result of the exposure of wood to the greater action of capillary moisture and other environmental corrosion factors, its most advanced structural destruction took place. Significant losses of wood occurring in these parts weakened the legibility of the painting composition. It is particularly visible on the walls of the women's porch. It is worth noting at this point that the polychrome layer is the most damaged or completely lost in the places where individual boards form the base for the painting layer. This is most clearly noticeable in the dome, although we also deal with this problem in other parts of the composition. These damages, resulting from weaker bonding of the mortar and the paint layer with the substrate in these places (or their complete detachment), were most likely caused by natural movements of the wood during changes in humidity inside the building. As a result of these movements, the layer of mortar cracked together with the paint layer, and then they crumbled at the contact point of the base boards [19].

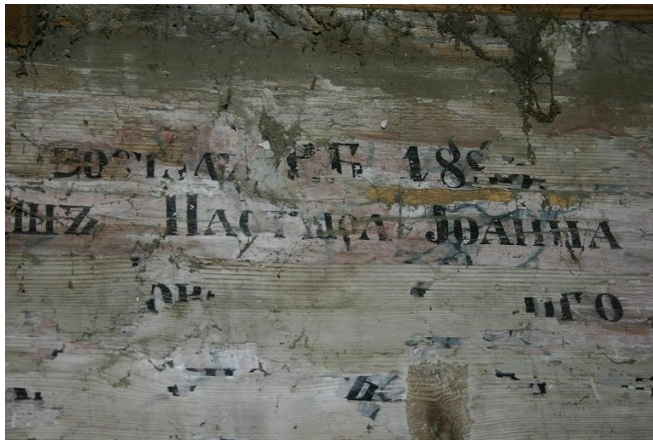
On the southern wall of the women's porch there is a depiction of the *Good Shepherd* signed with the text *Examination of Conscience*. On the northern wall, *The Return of the Prodigal Son* is signed *Father I have sinned*. On the southern wall of the women's porch there is also a foundation inscription (much of it is destroyed; a fragment is obscured by a pillar supporting the choir)" (Fig. 16). According to an archival note from the field penetration carried out by the Depository of Movable Heritage in Łańcut [18], the full text originally read: *This church was built in 1880 under the patronage of Jan Czyrneński, thanks to the efforts of Jan Furczyn and Wasyl Halas. It was polychromed in 1885* (all inscriptions in Ukrainian, translation T. Tomaszek).

Fig. 16. The foundation inscription on the southern wall of the women's porch, photo T. Tomaszek

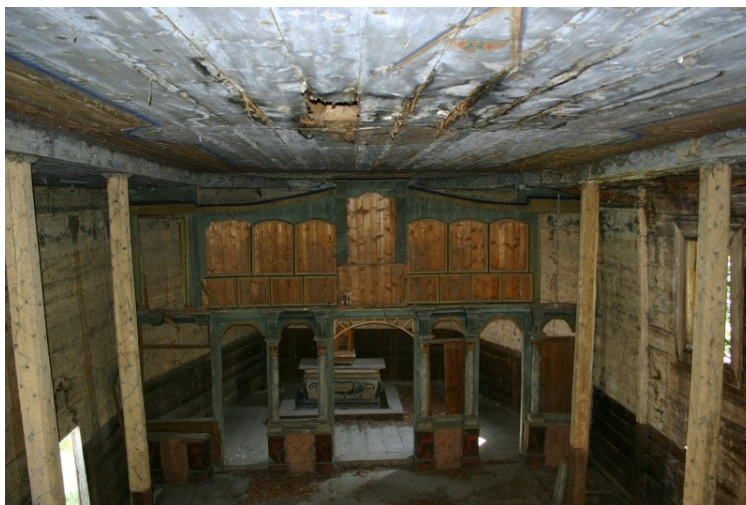
Originally, inside the church in Babice, there was a richly decorated iconostasis. Its basic construction structure, in the form of a curtain wall made of planks (the iconostasis frame),

Fig. 17. The Greek Catholic Church in Babice – the iconostasis curtain wall without icons, which is separating the sanctuary from the nave, photo T. Tomaszek

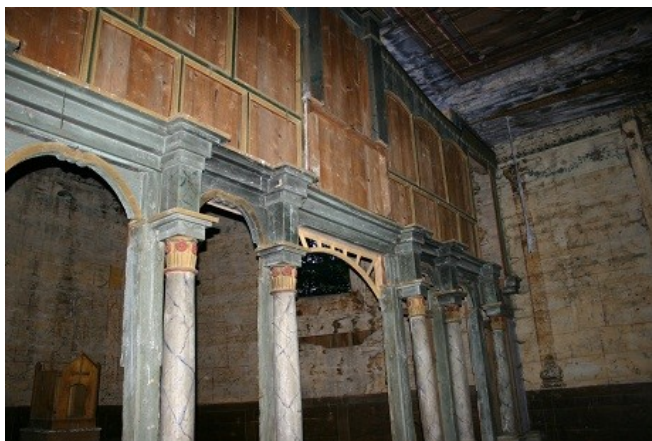
Emmanuel medallion The protocol written on October 22, 1966, shows that the frame of the iconostasis with elements of woodcarving (which was not transported to the collection of the Department of Orthodox Art of the Castle Museum in Łańcut in 1963) remained in the church [23]. Its disassembly was probably not planned at that time because it also serves as a structural "curtain wall" separating the sanctuary from the nave. This element has been preserved in the church to this day (Figs. 20 and 21).

Fig. 20. The Greek Catholic in Babice - the frame of the iconostasis with elements of woodcarving (fragment) constituting the remains of the original equipment of the temple (and at the same time serving as a structural "curtain wall" separating the sanctuary from the nave), photo T. Tomaszek

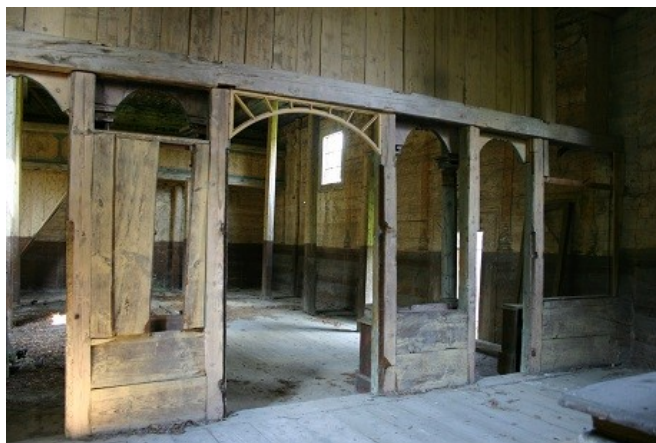
Fig. 21. Greek Catholic Church in Babice – the frame of the iconostasis with elements of woodcarving (view on the back, i.e., from the side of the sanctuary), photo T. Tomaszek

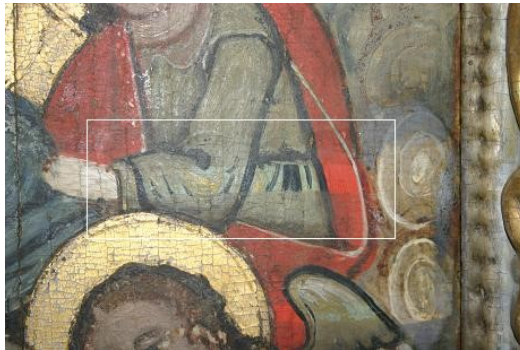
Apart from partial uncovering of the paint layer, they also carried out some tests on cleaning the surface of the icon by using ecological type of solutions [26]. More tests need to be done to determine the best method for cleaning similar icons from that area (Fig. 22).

Fig. 22. A fragment of the one of the icons from the 'namiestnych' tier – the place of the excavation to the original layer of paint (marked in white box), photo T. Tomaszek

The information obtained through the excavations described above suggests that the original layer of paint is reasonably well preserved and that the original composition has greater artistic merit than the later paintings.

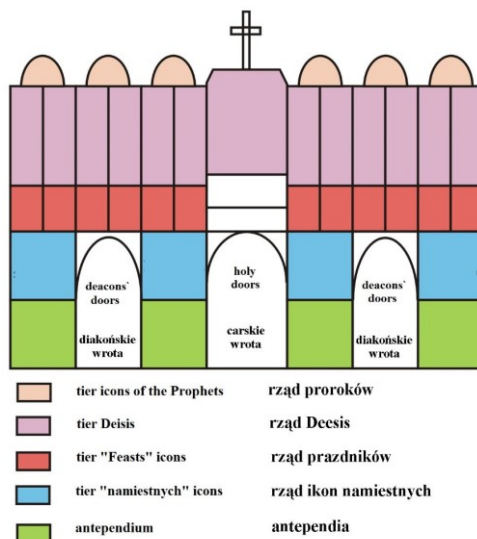
The iconostases of the churches in Babice and Mięksiz Stary are a reduced form of a typical form of the Ukrainian iconostasis, widespread in south-eastern Poland and appearing in wooden Greek Catholic churches in the Podkarpackie Province as an indispensable, characteristic element of their equipment (Fig. 23). Thus, the spatial arrangement and themes depicted in individual icons of the iconostasis of the Babice and Mięksiz Stary churches repeat, in a slightly modified configuration, the compositional and iconographic patterns of the iconostasis walls, probably finally established no later than at the end of the 18th century (Fig. 24).

Fig. 23. A diagram of a typical shape of the Ukrainian iconostasis, author: T. Tomaszek

The iconostasis from Miękisz Stary church is a typical example of 19th century iconostases developed in the border land of Podkarpacie (Fig. 23). It is built from the typical rows, following formal and ideological standards. In the bottom part, it has a high-tier "namiestnych" icon, dismembered by pilasters, with a *Holy Door* and the pair of the *Deacons` Doors*, extended to a two-row side "kioty". Above this, there are two rows of "Feasts" icons with the image of the *Last Supper* in the center. Traditionally, the tier of *Deisis* icons is located above it. And finally, in the crowning on the top of the iconostasis, there are icons of the Prophets, the Mother of God (*Panagii*), and a large cross with a carved figure of Christ.

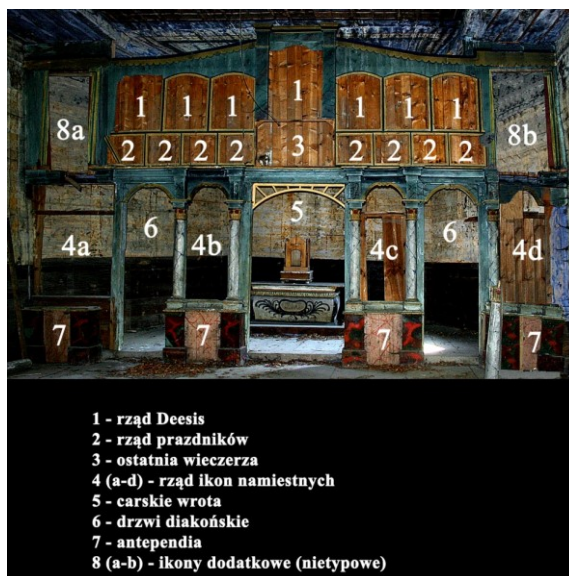
Fig. 24. Formal and iconographic arrangement of the iconostasis from Babice (diagram), author: T. Tomaszek

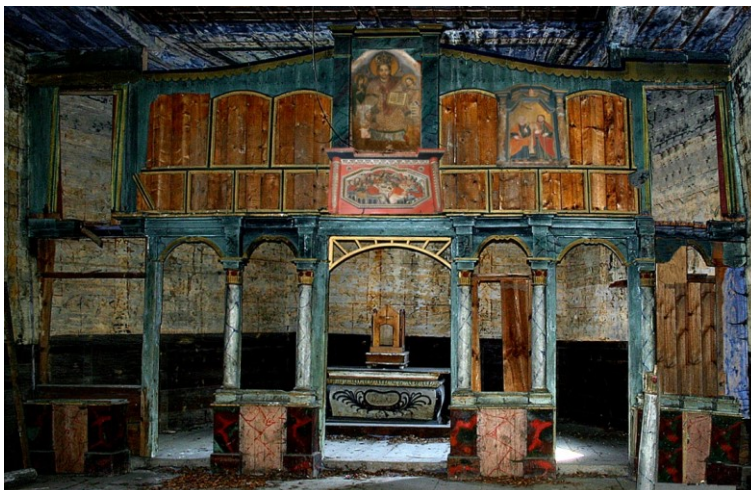
Preliminary conservation research allows us to assume that at least three of the icons stored currently in the Department of Orthodox Art of the Museum of the Castle in Łańcut are elements of the original iconostasis from the church in Babice. These icons are: The Deesis Icon (registration number MZŁ-SZR-895) is the central image of the Deesis row; the Icon of the Two Apostles (St. Peter and Saint Paul) depicts two of the twelve apostles of the Deesis row; and the Icon of the Last Supper (registration number MZŁ-SZR-898) is located above the tsar's doors. Their probable original arrangement is depicted in the illustration below (Fig. 25).

Fig. 25. Reconstruction of the probable original arrangement of the preserved icons in the iconostasis frame (diagram), author: T. Tomaszek

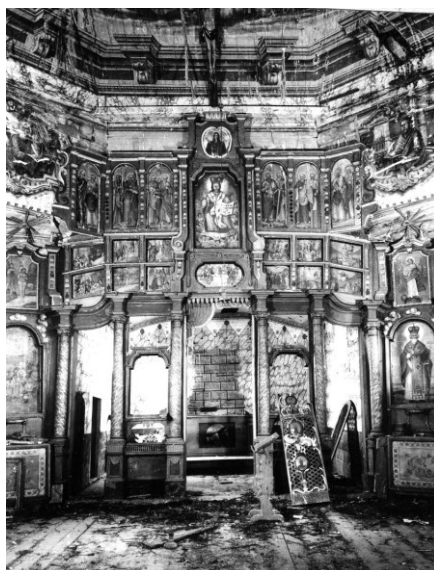
The archive photo, showing the interior of the church together with the iconostasis before its removal to the warehouse of the museum mentioned above (Fig. 26), as well as the sketches made during its subsequent demolition (Fig. 27), make a unique documentation of conservational importance. It is a determinant of how the structure of the iconostasis was constructed and shows how it was located in the church.

Fig. 26. The archival photo showing the interior of the church in Miękisz Stary along with the old iconostasis, 1964; source: the archives of the Department of the Eastern Church Art in the Museum of the Łańcut Castle

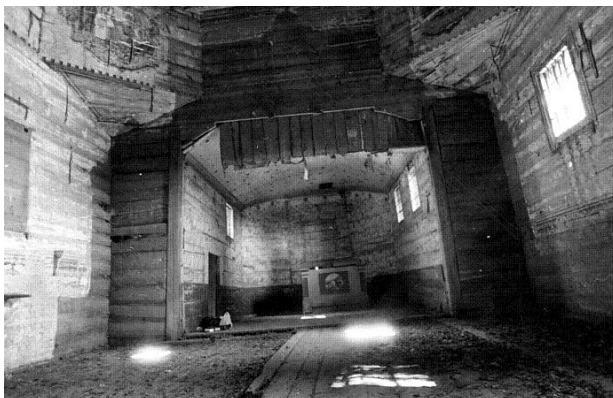
(Fig. 28). Most likely, it was attached to the wall by the hooks. This type of construction of the iconostasis, namely as a self-supporting structure that is an autonomous part of the equipment of the church and at the same time is independent of the wall structure, is very common in the Podkarpacie region [28].

Fig. 28. Interior of the church in Mięksisz Stary (from the side of the nave towards the sanctuary) after the dismantling of the iconostasis—see the traces showing where the iconostasis was supported by the wall, 1987, source: the archives of the Department of Eastern Church Art in the Museum of the Łańcut Castle

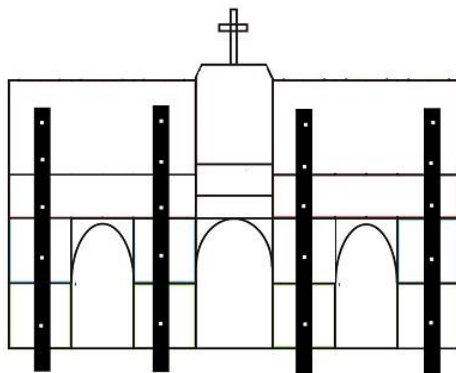
Fig. 29. The diagram of the strengthening and stabilising structure proposed for the iconostasis (made from its back) – noticeable the vertical slats, slightly lower than the height of the iconostasis, recessed into the ground – white "spots" on the slats indicate the proposed place of the movable connection (e.g., hooks) between the individual parts of the iconostasis and this moulded, stabilising structure. Author: T. Tomaszek

There is no doubt, however, that the iconostasis, if in any case it is returned to the church in Mięksisz Stary, would need extra structural reinforcement. This reinforcement could strengthen it with additional vertical support and provide protection against a possible loss of stability [30]. Thus, at this stage of conservation analysis, it is proposed to make a vertical support structure in the form of vertical slats permanently mounted in the floor. Their height should be slightly lower than the height of the iconostasis. These slats should be located on the back of the iconostasis, and all the individual elements of the iconostasis should be attached to these slats in a movable way, allowing their easy removal from the structure (dismantling) and allowing the natural work of the wood and its possible natural deformations over time and in a yearly cycle (Fig. 29).

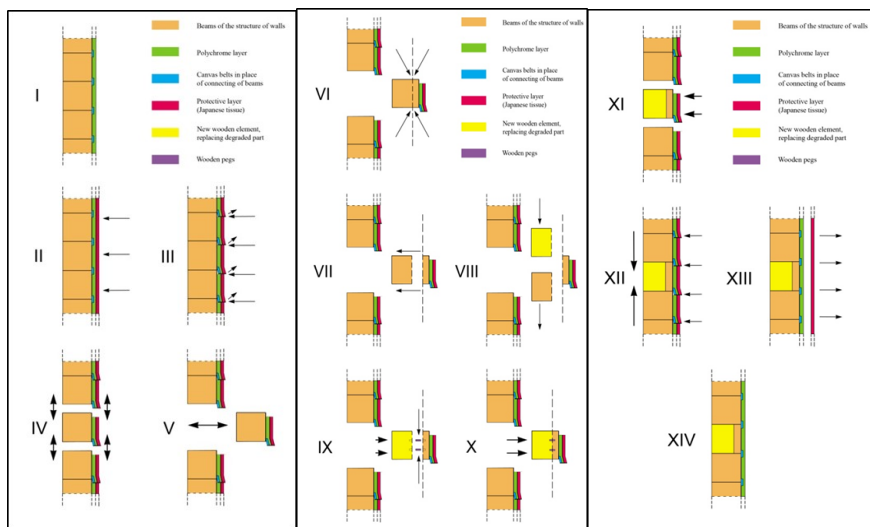
Fig. 31. The diagram of the execution of the transfer of polychrome to a new base (to the new elements, replacing degraded items); [I-XIV], author T. Tomaszek

Due to the significant weakening of mechanical strength caused by the advanced deterioration of wood, the remnants of the surface layer of the original substrate that are transferred together with the layers of paint and grounding require structural reinforcement. It is proposed to perform it using a structural impregnating with a solution of synthetic resin (Paraloid B72) [32]. After this intervention of strengthening the transferred remains of the surface layer of the wooden element (which is a direct substrate for the transferred paint layer), the transferred items should be fixed "anew" in their original place to the previously exchanged elements in the architectural structure.

It is necessary to maintain the original composition of the paintings (polychrome). With a view to the unforeseen deformations of the temple's architectural structures caused by the natural variations in timber volume and the possibility of having to disconnect in the future the transferred parts from the elements to which they will be fixed, it is assumed that the transferred elements will be fixed to the walls only by means of the wooden pegs.
