## AN INSIGHT INTO THE GREEN DETERIORATED PAINT LAYERS OF THE MARITIME STATION OF ALCÂNTARA (LISBON): AN ARCHEOMETRIC STUDY

*This study reports the first results of the analysis carried out in 2022 on deteriorated green paint layers from the mural paintings made by Almada Negreiros at the Maritime Station of Alcantara, in Lisbon (Portugal). These murals painted in 1945 are one of the most emblematic painting sets done by the modernist artist and exhibit a bright chromatic palette that displays different states of conservation, with the green paint layers particularly damaged, showing severe flaking and powdering in the lightest shades.*

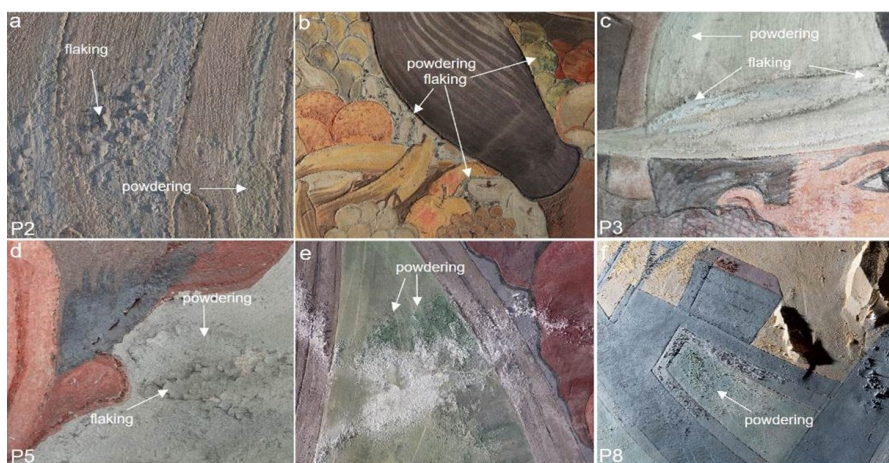
**Fig. 1.** Details of green deteriorated paint layers in visible (c and d) and in visible raking light (a, b, e, and f). The references P2, P3, P5, and P8 in the bottom right corner of each picture indicate the paintings from which these images come. The location within the paintings is indicated on Fig. 2 (ALMADA2021/22© all rights reserved).

The widespread presence of Ca as a main element and the detection of calcite by XRD are associated with lime-based painting techniques and lime-based mortars used by Almada and have already been reported in a previous study [7]. On the other hand, the presence of S in all samples is correlated with the identification of barium and calcium sulphates (Tables I and II). Barite ( $\text{BaSO}_4$ ) and gypsum ( $\text{CaSO}_4 \cdot 2\text{H}_2\text{O}$ ) were identified by XRD in deteriorated paint layers and in paint layers in better condition, raising the hypothesis that both materials may have been originally used as fillers or extenders (Table 1). Unlike barite, the occurrence of gypsum as a neoformation salt is also considered given the high level of disruption of paint layers observed in-situ, especially in the lighter green hues (Fig. 1).

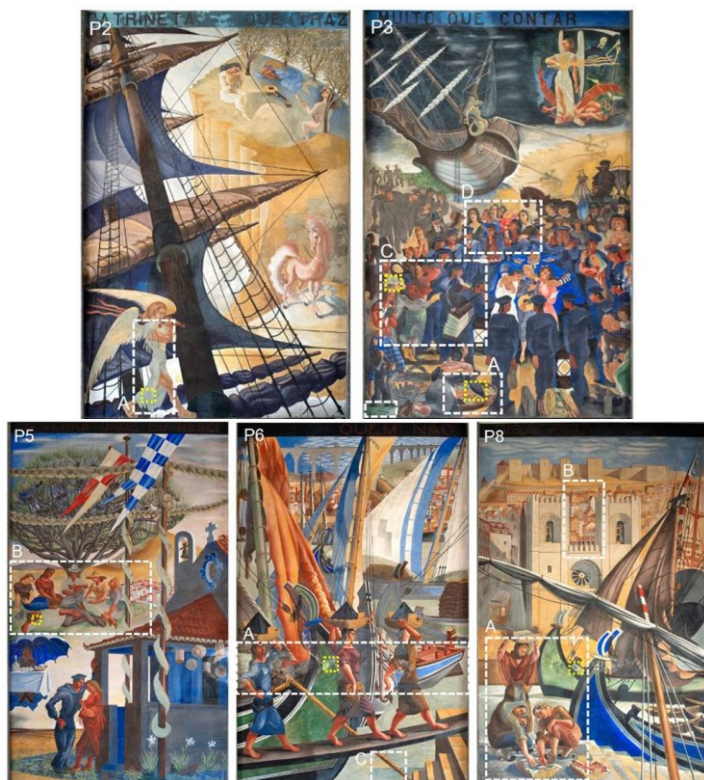
**Fig. 2.** Panels under study from the Maritime Station of Alcântara.

The rectangle with white dashed lines shows the areas with deteriorated green paint layers selected for in-situ and laboratory analyses in 2022. The yellow rectangles indicate the location of the images present in figure 1. Images adapted from Guta de Carvalho, June 2020 © all rights reserved

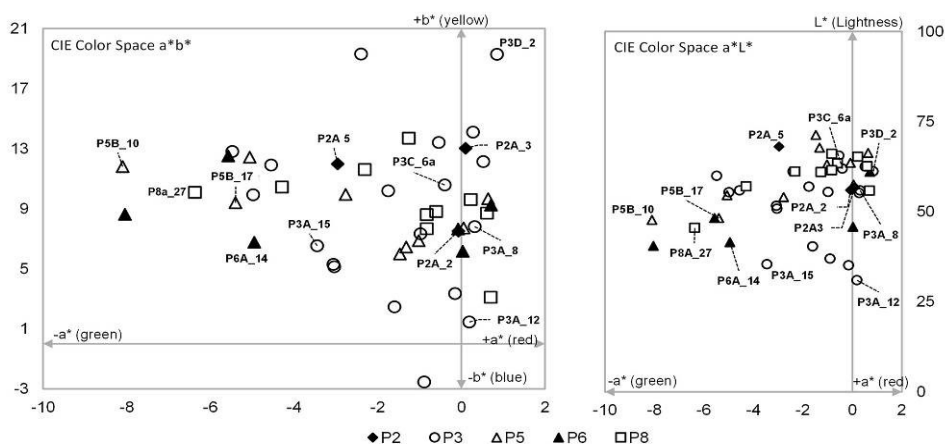
**Fig. 3.** 2D projection of colorimetric coordinates in the CIE  $a^*b^*$  and CIE  $a^*L^*$  colour spaces with the indication of 12 of the fifteen paint layers that were sampled for further analysis and that are mentioned in the results discussion. The missing three are stated on Table I and come from paint layers that were difficult to access (P3C\_22) or presented a high degree of visible decay (P8A\_31a and P8A\_35)

An overview of the current green colour palette projected in the CIE  $a^*b^*$  and CIE  $a^*L^*$  colour spaces is shown in figure 3. The 47 green hues measured in the five mural paintings span from -0.07 to -8.1 in the  $-a^*$  axis (green) and from 1.45 to 19.30 in the  $+b^*$  axis (yellow). The  $L^*$  parameter ranges from 30 to 71, with 35 paint layers exhibiting light hues ( $L^* > 50$ ). The yellow shades indicated by the  $+b$  values in figure 3 are due to the presence of yellow, brown, and red pigment particles within, under, and on top of the paint layers analysed, as can be seen in the h-OM of figure 4 and in the paint cross sections of figure 5. The same accounts for the layers showing 0 and  $+a^*$  values, such as P2A\_3, P3A\_8 and P3A\_12.

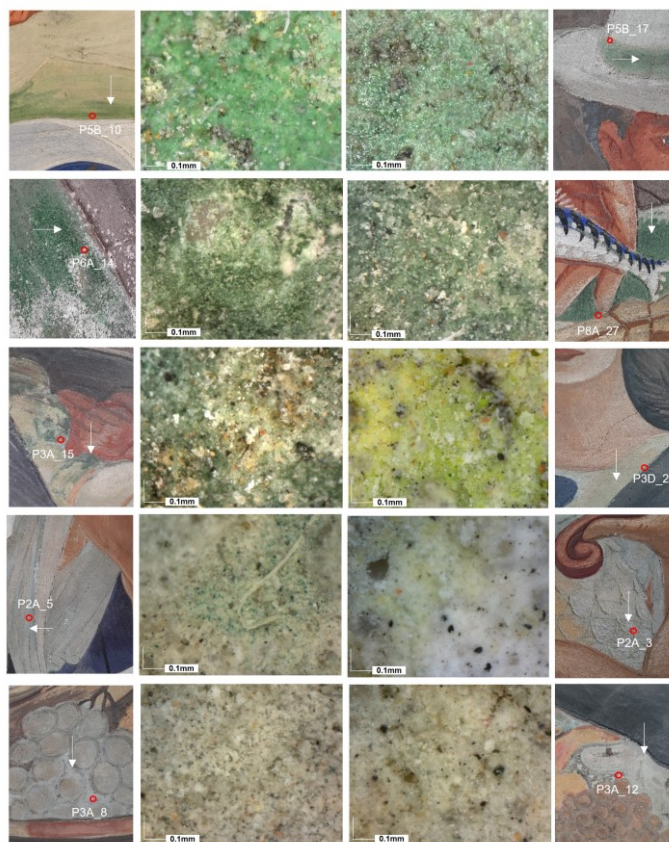
**Fig. 4.** Examples of the green hue variations found in the trichromatic coordinates ( $L^*a^*b^*$ ) in the green paint layers. On the inside, the OM-Vis images at 430 $\times$  and, on the outside, the location of the colorimetric measurement taken (white arrow) and of the sampling place (red circle)

The results reveal a restricted range of green hues on the backgrounds for shading and highlighting areas. In figures 4 and 5, some examples of the green hue variations found are shown, revealing the green pigments were laid down in a single or in two layers, the latter tending to be more fluid, darker, and saturated in colour (e.g., P5B10, P5B\_17, P8A\_27 and P3A\_15). The opaque and lighter greenish hues were mainly found as background tones, and, in some cases, they are what is left as the top layers of paint have disappeared (e.g., P2A\_3, P3A\_8 and P3A\_12 of figure 4).

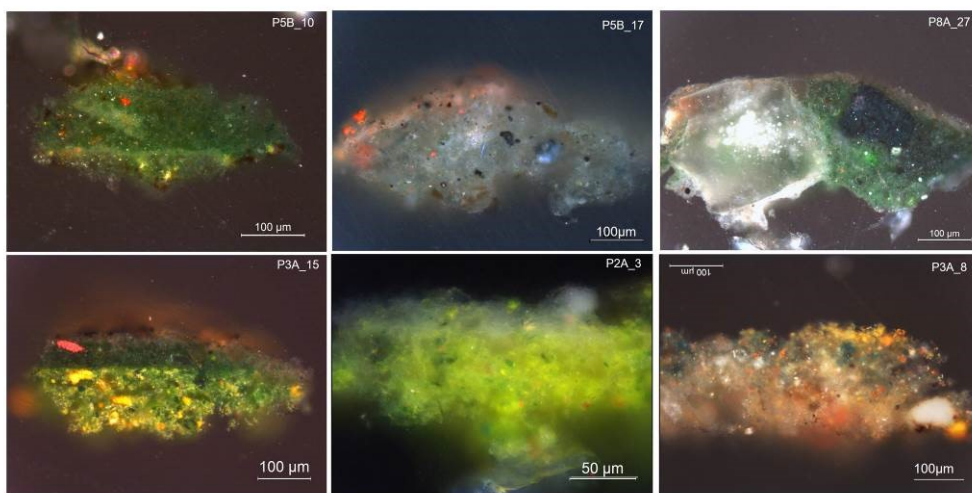
**Fig. 5.** OM-Vis of paint layer cross sections collected from the dark mid and light hues of figure 3. The green pigments were laid down in one or two layers, and were used alone or in mixtures with black, yellow, red, brown, and white chromophores. Only in P3A\_8 can a brownish underlayer be seen.

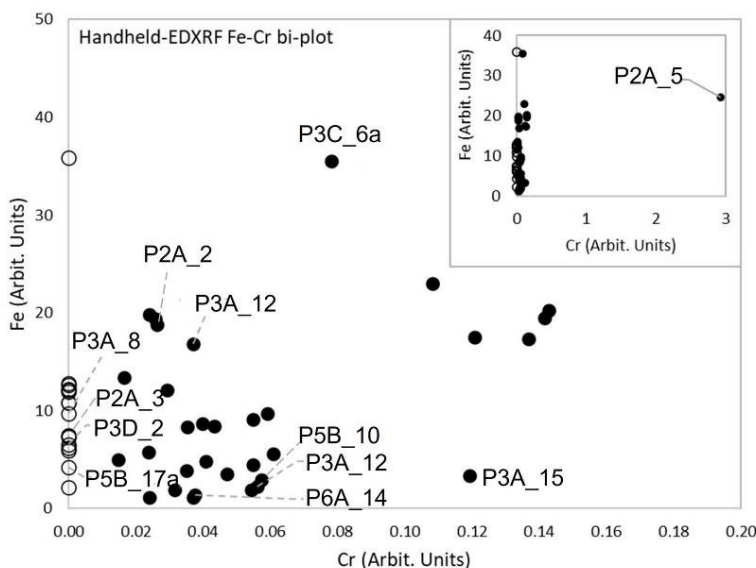
**Fig. 6.** Handheld-EDXRF Fe-Cr bi-plot of the 47 green paint layers revealing the presence of two main groups: one in which Fe is exclusively detected (empty circles) and another with Fe and variable amounts of Cr (black circles)

The elemental composition of the 47 green paint layers was first studied in-situ by h-EDXRF (Table I and Fig. 6). The main elements identified in all samples, as shown in Table I, were calcium (Ca), iron (Fe), barium (Ba), and sulphur (S), chromium (Cr), potassium (K), titanium (Ti), strontium (Sr), and silicon (Si) were also occasionally detected in significant amounts. h-EDXRF also enabled the detection of other elements in minor or trace amounts, such as chlorine (Cl), manganese (Mn), and zinc (Zn).

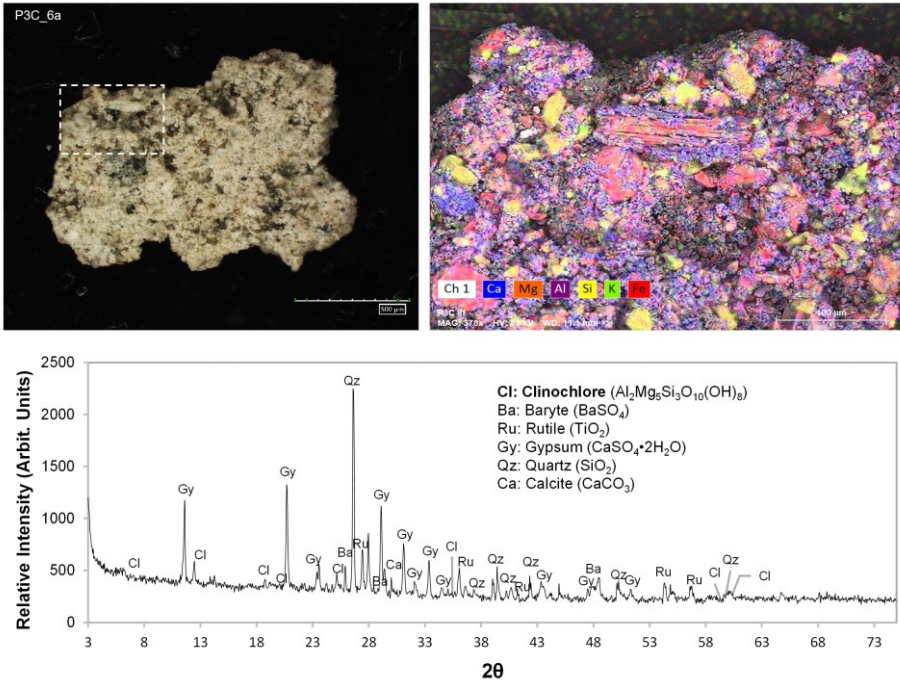
**Fig. 7.** On top: OM-Vis of the paint surface of P3C 6a at 140× magnification, and corresponding VP-SEM-EDS elemental map distribution of Ca (in blue), Mg (in light red), Al (in pink), Si (in yellow), K (in green) and Fe (in red). On the bottom: μ-XRD diffractogram, showing the presence of clinochlore likely associated to the presence of green earth pigments

Micro-XRD analyses enabled the identification of the mineral phases that may impart green hues in only two samples: P3C\_6a and P3A\_12 (Fig. 7, Table 1). In both cases, the identification of clinocllore, an aluminosilicate of Fe and Mg, suggests the use of a green earth pigment. The amounts of silicon and potassium identified by h-EDXRF as well as the identification of Fe, Al, Mg, and K in microsample P3C\_6a by VP-SEM-EDS also corroborate this hypothesis (Fig. 7).

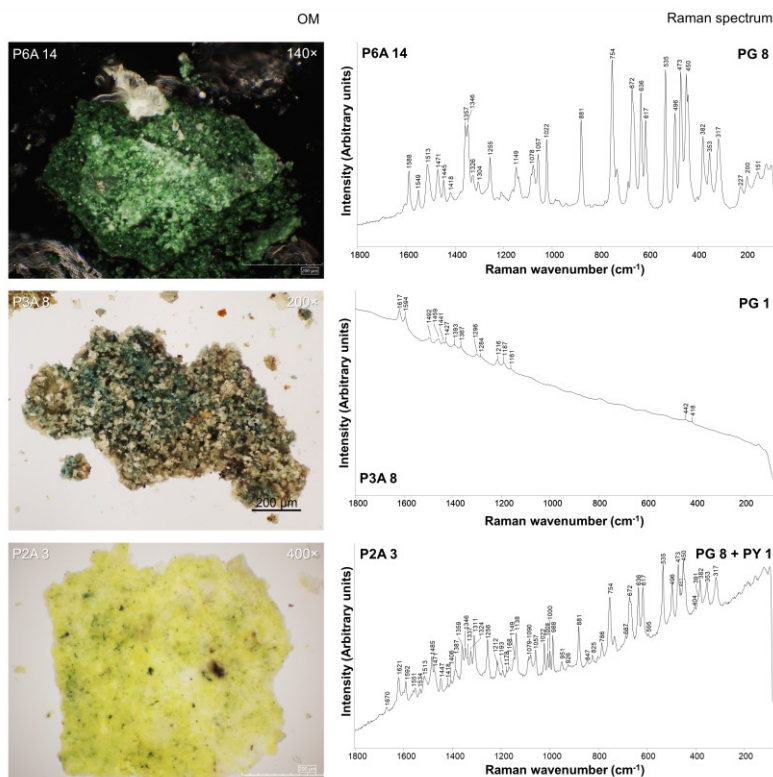
**Fig. 8.** On the right, OM-Vis of the paint surface of microsamples P6A\_14, P3A\_8, and P2A\_3. On the left, Raman spectra of samples P6A\_14, P3A\_8, and P2A\_3. The bands were attributed to the synthetic organic pigments PG8, PG 1, and PY1

Micro-Raman spectroscopy, on the other hand, enabled the identification of synthetic organic pigments in seven microsamples: P2A\_3, P3A\_8, P3A\_15, P5B\_10, P5B\_17, P6A\_14, and P8A\_31a. With the exception of P3A\_8, all the aforementioned samples contain an Fe-based modern synthetic organic pigment known as Pigment Green 8, or PG8, identified by the characteristic Raman bands at 151, 200, 227, 317, 353, 382, 450, 473, 496, 535, 617, 636, 672, 754, 881, 1022, 1057, 1078, 1149, 1255, 1304, 1326, 1346-1357, 1418, 1445, 1471, 1513, 1549-1551 and 1588-1592 $\text{cm}^{-1}$  (Fig. 8) [16]. The likely presence of pigment PG8 had already been reported in one microsample on the first survey of the paint layers from the Maritime Station of Alcântara in 2020 [7]. In the current research, PG8 was identified in the green samples from the five panels under study, which makes this discovery by itself a case study to be further explored in the future considering that, as far as the authors know, this colourant has never been reported before in modern mural paintings.

- a) Hansa yellow (PY1) mixed with PG 8 was detected in microsample P2A\_3 (Fig. 8). PY1, a yellow synthetic organic pigment with a generic chemical formula C<sub>17</sub>H<sub>16</sub>N<sub>4</sub>O<sub>4</sub>, was identified based on the characteristic Raman bands at 391, 461, 595, 687, 786, 825, 846, 926, 951, 988, 1000, 1138, 168, 1178, 1193, 1212, 1256, 1311, 1337, 1359, 1387, 1406, 1447, 1485, 1534, 1621 and 1670cm<sup>-1</sup> [23, 24]. PY1 was the first pigment of Hansa Yellows synthesised in 1909 and led to the synthesis of other possible combinations from 1910 onward [17].

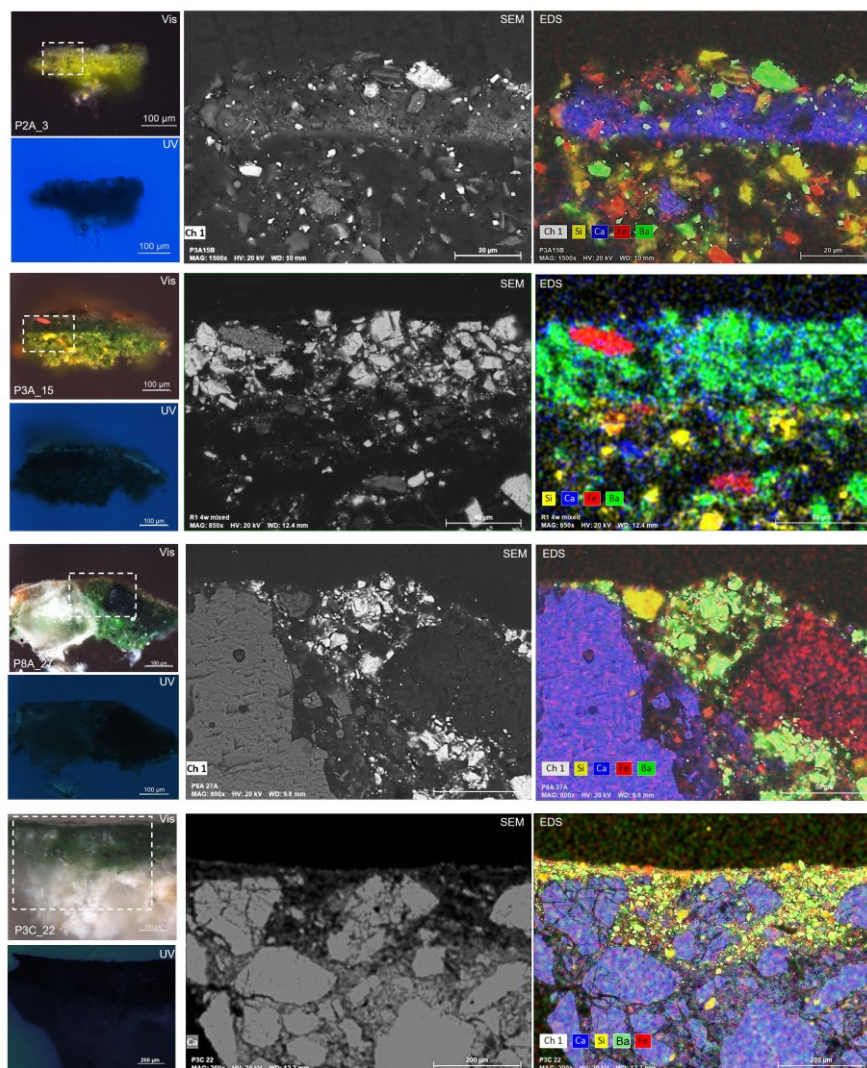
**Fig. 9.** From left to right: OM-Vis-UV of paint layers cross sections P2A 3, P3A 15, P8A 27 and P3C\_22 with 200× magnification; BSE-SEM image and VP-SEM-EDS elemental map distribution of Ca (in blue), Si (in yellow), Ba (in green) and Fe (in red)

Considering the dimensions of the mural paintings as well as the fact that Almada Negreiros executed the paint work alone, doubts remain as to the use of the fresco technique in all paint layers. In a previous diagnostic study, *M. Gil et al.* [7] identified the fresco technique in red, brownish, and blue paint layers. In the greens, the authors did not reach conclusions due to the poor conditions of the microsamples collected [7]. The same difficulty was also felt in the current research. Figure 9 shows BSE-SEM images and VP-SEM-EDS of calcium elemental distribution on the paint cross sections of samples P2A\_3, P3A\_15, P8A\_27, and P3C\_22. In a fresco painting, the pigment particles should be embedded in a calcium matrix, which does not occur in the paint layers analyzed. On the VP-SEM-EDS elemental map distribution, Ca is mainly found as aggregates in P8A\_27 and P3C\_22. As a binder, Ca is only clearly perceived on the mortar of P3C\_22 and on a white brushstroke over the yellow green in P2A\_3 (Fig. 9).

BSE-SEM images of all cross sections show a highly disruptive stratigraphy with loose particles of Ba, Si, and Fe. The same deterioration feature was also noticed in the microsamples analysed as micro-fragments, as shown in figures 10 and 11. No additional information about the painting technique was provided by UV observations onsite or by the OM-UV images of paint cross sections. In figure 9, only a thin layer on top of P3A\_15 shows a whitish fluorescence in UV, which can be attributed to vinyl polymers applied as adhesives in past interventions to fix the paint layers. So far, these are the only organic materials found by  $\mu$ -FT-IR (Table 1).

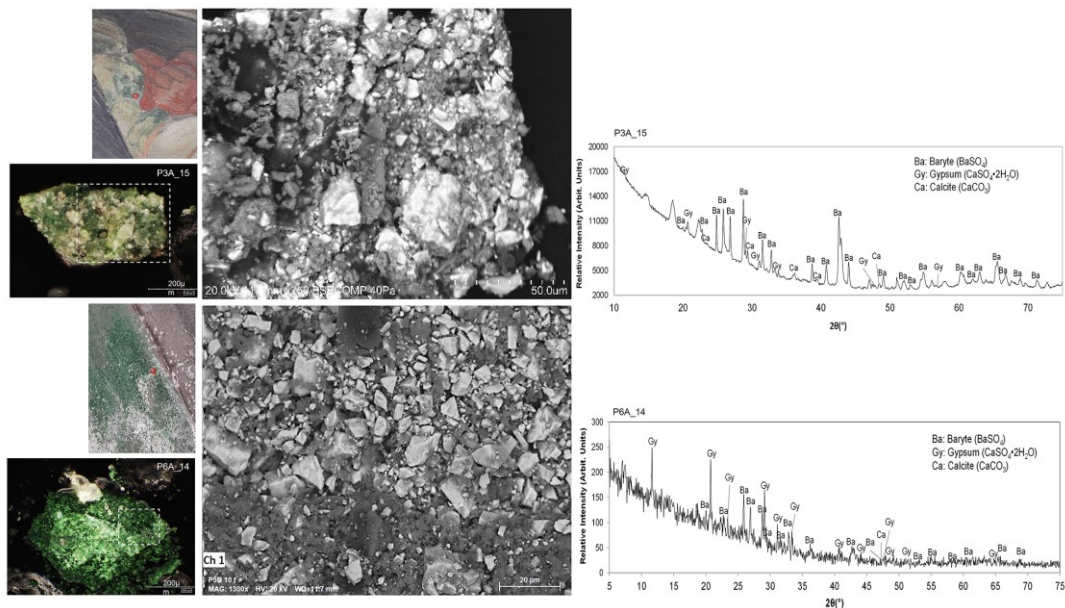
**Fig. 10.** On the outside, sampling location and OM-Vis of the paint surface of microsample P3A\_15 and P6A\_14 at 200 $\times$ . On the center, BSE-SEM image of the paint surface showing particles (pigments and fillers) loose and exposed

Based on the results of the analyses carried out by VP-SEM-EDS, micro-Raman spectroscopy,  $\mu$ -DRX and  $\mu$ -FT-IR, the main hypothesis raised for the powdering and flaking of the green paint layers is the disruptive activity of calcium sulphates. Gypsum ( $\text{CaSO}_4 \cdot 2\text{H}_2\text{O}$ ) was found in all the microsamples analysed from the dark, mid, and lighter green hues collected from deteriorated and stable paint layers (Table I). Fig. 10 shows two examples of the surface appearance of powdering paint layers from P3 and P6, the last being collected from an area severely affected by salt efflorescence's. VP-BSE-SEM image reveals that most particles on the paint surface are exposed to the environment.

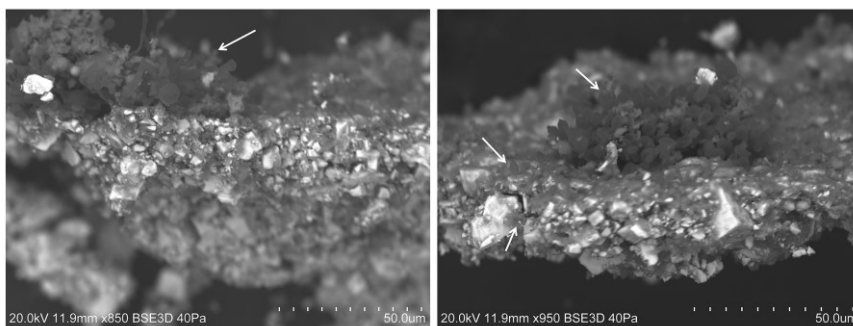
**Fig. 11.** Detail of microsample P5B\_10 in profile by VP-BSE-SEM image showing signs of bio-contamination on the paint surface and near a loose particle (white arrows)

Beyond the presence of salts, it must also be noted that signs of bio-colonisation were observed by VP-BSE-SEM in one paint layer (Fig. 11). High relative humidity, pH, temperature, light, and biodegradable materials are the main factors that can trigger the appearance and growth of microorganisms [31-33]. Although a more in-depth study on the topic could not be carried out at this point, the traces of bio-colonisation may be linked to the past occurrence and permanence of humidity in the paintings [7]. The roughness of the paint
