## A MULTI-ANALYTICAL STUDY OF BUILDING MATERIALS AND DETERIORATION PRODUCTS OF THE ROYAL TOMBS TO TANIS (SAN EL- HAGAR)

### Abstract

**Keywords:** Sanjar Al-Hajar; Royal tombs; Limestone; Groundwater; Deterioration; Analysis

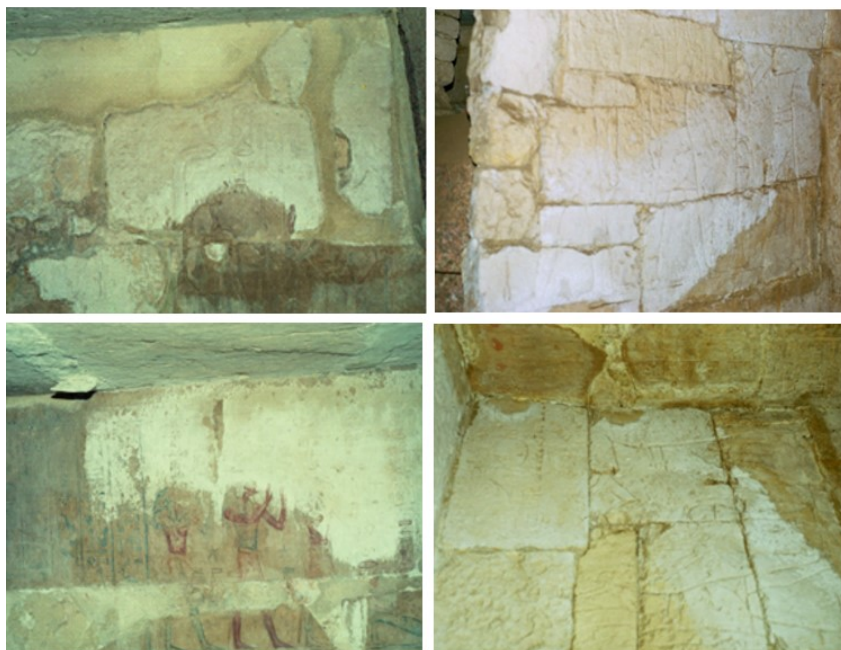
Fig. 4. The salt crystallizes thickly on the surfaces of the wall inscriptions in the royal tombs in San El-Hagar

grains instead of. In addition, complete penetration of salt crystals into the stone were noticed clearly, which causes severe and destructive pressure to the stone resulting in cracks and separation of the layers of the stone. This explains the presence of a thick layer of *Halite* salt covering the wall reliefs in the tombs (Fig. 4).

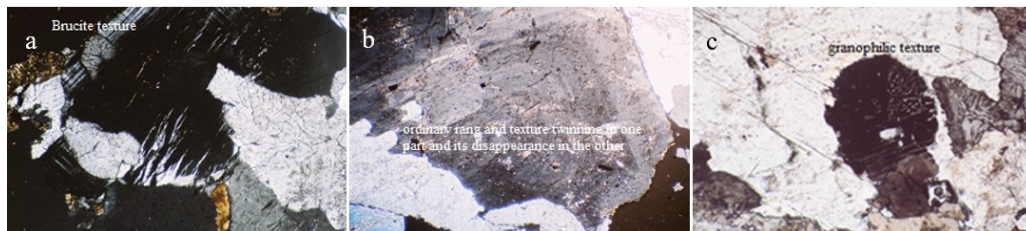
Petrographic study for the samples revealed *Brucite* texture of (*Microcline - Brucite*), this texture takes the shape of the veins and vermiform (Fig. 6a), which is the result of the mineral growth of the *Quartz* inside the *Brucite* in the form of the vermiform texture (*Mermiyikitic*). It is caused by the growth of *Quartz* inside the plagioclase. Ordinary rang texture in plagioclase mineral and the appearance of twinning in one part and its disappearance in the other (Fig. 6b).

**Fig. 6.** Petrographic view of the texture of granite in the tombs of Sun El-Hagar: a - Brucite texture; b - ordinary rang texture; c-gianophilic textyre

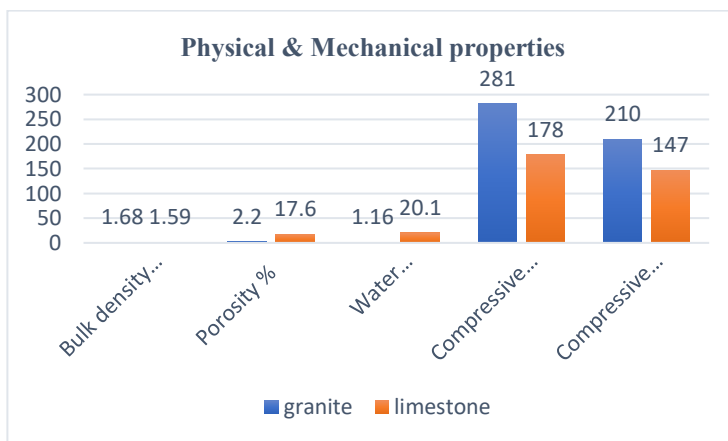
The physical properties (bulk density, water absorption, porosity) detected that the granite in royal tombs in San El-Hager is characterized by high porosity (1.16%), which gives the stone a high-water absorption rate (2.2%) and its consequent ability to absorb water with salt solution and this is the main cause of deterioration. The bulk density of the samples gives  $1.68\text{g/cm}^3$ .

Mechanical properties (Compressive strength) were determined for granite samples (Fig. 10), the results showed that the strength of granite characterized by poor mechanical characteristics by 281kg/cm<sup>2</sup> Dry and 210kg/cm<sup>2</sup> Wet. The changes of physical and mechanical properties of the stone were a result of weathering process.

Fig. 10. Physical and mechanical properties of granite and limestone samples from royal tombs in San El-Hager

The physical properties (water absorption, porosity) detected that the limestone in royal tombs in San El-Hager is characterized by high porosity (20.1%), which gives the stone a high-water absorption rate (17.6%) and its consequent ability to absorb water with salt solution and this is the main cause of deterioration.

Mechanical properties (Compressive strength) were determined for untreated limestone samples, the results showed that the strength of limestone in the royal tombs characterized by poor mechanical characteristics by 178kg/cm<sup>2</sup> Dry and 147kg/cm<sup>2</sup> Wet (Fig. 10). The changes of physical and mechanical properties of the stone were a result of weathering process.

The physical and mechanical properties tests of granite indicated that, the stone can be classified as weak to medium strength according to the standard tables. This is the result of the effect of various damage factors, especially the effect of subsurface water and its dissolved salt ions.

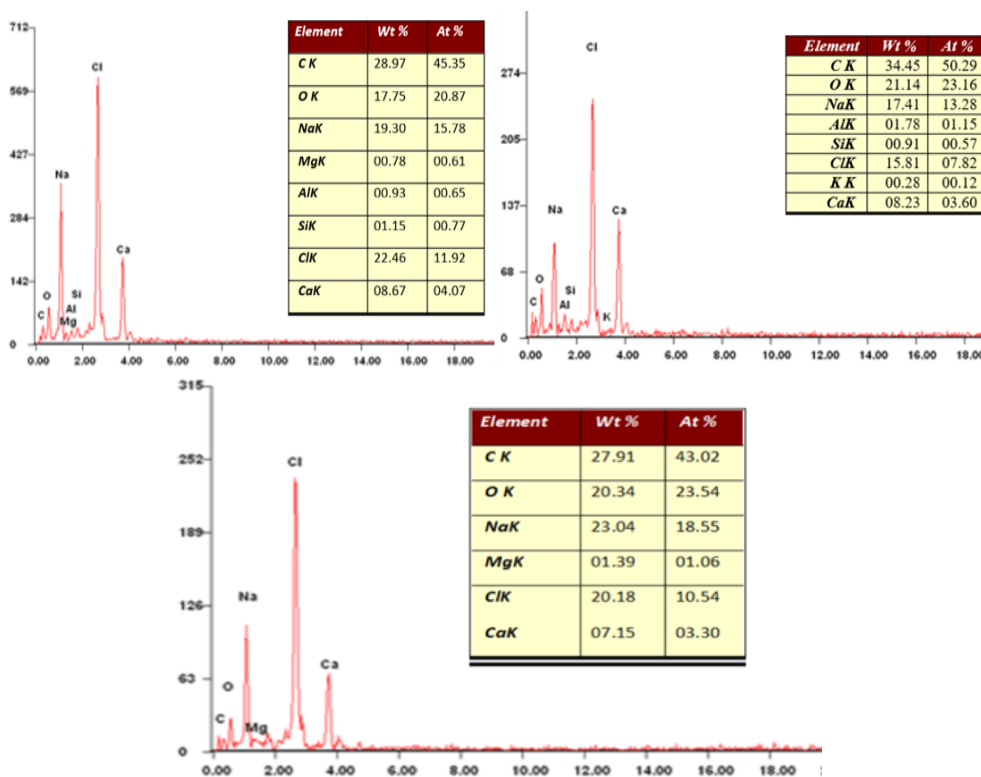
The EDX analysis of the limestone indicated the presence of calcium, silicon, aluminum, potassium, and high percentage of sodium and chlorine (Fig. 13a-c).

Fig. 13. EDX pattern of limestone samples: a - from Osorkon II, b - sample from Psusennes I, c - sample from Shoshenq III

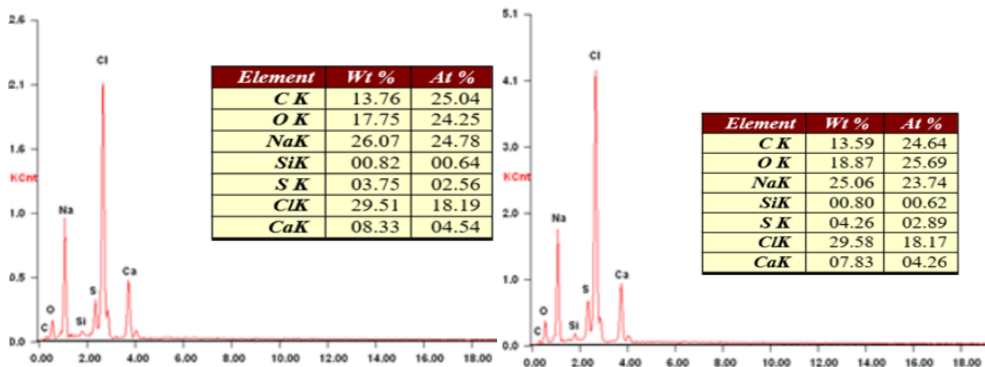
Considering the EDX results (Fig. 15a and b), it can be concluded that, the mortar between limestone blocks in royal tombs, were prepared with lime and *Gypsum*. The presence of chloride and sodium reflects the *Halite* salts which play an active role in the deterioration of the building materials in royal tombs in San El Hager.

Fig. 15. EDX pattern of mortar samples, a- from Osorkon II, b-sample from Psusennes I

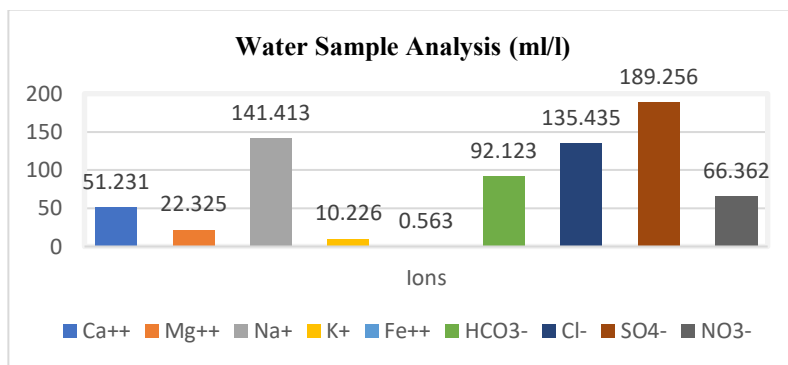
The chemical analysis of the water samples taken from under the foundation of the royal tombs in San El -Hager showed that the water sample is rich in sodium (Na<sup>+</sup>), chloride (Cl<sup>-</sup>), potassium (K<sup>+</sup>), magnesium (Mg<sup>2+</sup>) ions. The water also has a high content of bicarbonates (HCO<sub>3</sub><sup>-</sup>) sulphates (SO<sub>4</sub><sup>2-</sup>) and nitrate (NO<sub>3</sub><sup>-</sup>). pH was 9 and the temperature was 24°C, the electrical connection (CND) 44.7mL/L and TDS (28.608mL/L). the investigations results are shown in (Fig. 16).

Fig. 16. Show the chemical analysis and ASS results of groundwater analysis from under foundation of tombs at San El-Hager

It was also clear through the atomic Absorption that the subsurface water in the area around the tombs very salty (24g/L), which gives the impression that it is the main source of salts affecting the deterioration of the condition of the tombs. The concentration of some elements was determined such as sodium (141.5mg/L), calcium (51.55mg/L), magnesium and potassium. The percentage of soluble solids in this water reached (28.6g/L), which led to the high electrical connection coefficient of that water, reaching (44.7mg/L). It was also clear through chemical analysis of soil and groundwater samples that the percentage of chlorine and bicarbonate was high, as sulfate and silica were determined in the soil and groundwater and the pH was 9. The most significant chemical process employing salinity ground water to degrade stone is the production of salt crusts on calcareous stone. On a porous stone, these crusts cause it to crumble into a powder, while on limestone, they cause thick crusts to form [24].

The presence of potassium and magnesium in a high percentage in the groundwater explains that it is likely to be the result of the seepage of agricultural drainage water from drains and agricultural lands surrounding the archaeological site, where potassium is used as fertilizer for agricultural lands. The high percentage of these elements can also be attributed to the intrusion of saline water from Lake Manzala. As for sulfates, their presence is largely due to their leakage from the surrounding agricultural lands, where farmers use them to treat saline soil and it is called agricultural *Gypsum*.
