## RESEARCH FOR BANKSY MURAL ‘JUDOKI’ IN BORODYANKA

The task of the research was to characterise a specific mural, namely the "Judoki" mural in the town of Borodyanka, and the results of its research as a basis for conclusions regarding the possibility of its preservation.

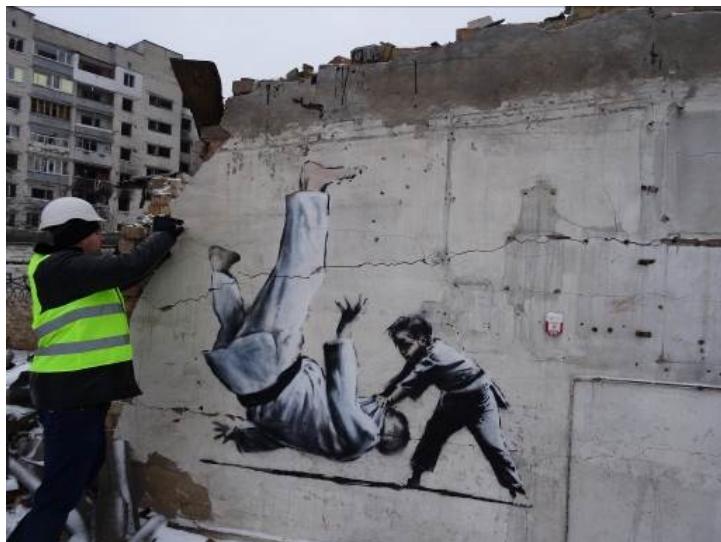
**Fig. 3.** Mural 'Judoki' in Borodyanka.

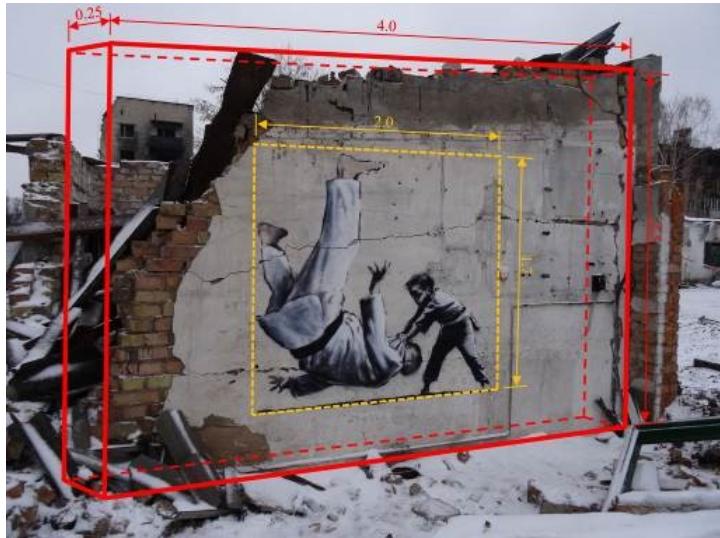
Another visual inspection was carried out in December 2022, this time focusing primarily on the wall on which the mural had been made. It was found to be a 250mm thick hollow block, in cement-sand mortar, with a 14mm thick layer of cement-sand plaster and then painted, probably with water-emulsion paint (Fig. 4). Overall dimensions of the wall: length 4.0 m, height 2.5 m. Graffiti dimensions: width 2.0 m, height 1.7 m.

**Fig. 4.** Dimensions of the Banksy mural 'Judoki' in Borodyanka.

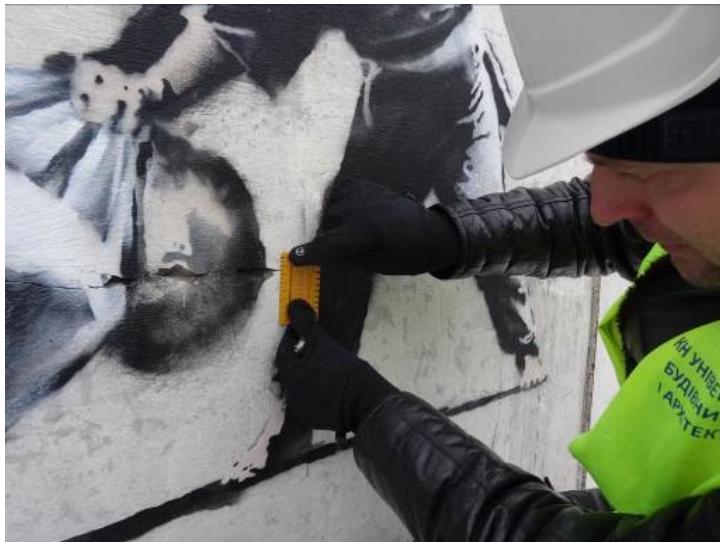
The left part of the wall is damaged along an oblique line with a larger area of damage upward. Also in the same part, a plaster layer has fallen. There are about five horizontal cracks

on the wall, which also cut through the mural, and one vertical crack on the side. Two horizontal through cracks with an opening width of up to 7mm outside and three hairline cracks with an opening width of up to 0.2mm (Fig. 5).

**Fig. 5.** Research of the Banksy mural 'Judoki' in Borodyanka.

There are also localized areas with lost plaster and areas where the plaster has taken the form of 'blisters', that is, it has flaked off. Under the influence of external factors, the exposed bricks of the masonry become delaminated and fall off. After wet snow and a temperature drop below 0°C, a layer of ice forms on the surface of the plaster and painting, negatively affecting the durability of the building structure and graffiti. There are also remnants of electrical appliances and networks on the surface of the masonry.

As part of the proposed restoration works, the wall structure on the rear (inner) side should be subjected to structural strengthening, and on the front (outer) side, where the mural is located, it should be subjected to cleaning, strengthening of the plaster structure, hydrophobisation and protection with chemicals preventing algae growth. The purpose of hydrophobisation is to prevent water from penetrating deep into the structure of the material. Solvent-based water-repellent impregnating agents for absorbent mineral substrates are used for this purpose. The advantages of this type of agent are resistance to harsh atmospheric and chemical agents, reduced susceptibility to soiling, and facilitation of self-cleaning of the material under the influence of precipitation, hindering the formation of algae, fungi, and lichen, which are one of the most frequent causes of corrosion of building materials.

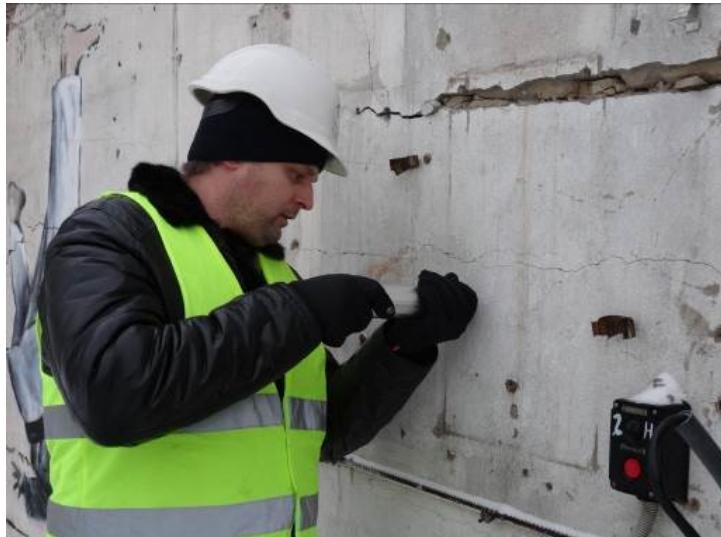
Using non-destructive methods, the mural strength of the bricks was determined using a Schmidt hammer (MSch 75), which is 6-8MPa, and the strength of the plaster layer, which is 4 -5MPa (Fig. 6).

**Fig. 6.** Research of the Banksy mural 'Judoki' in Borodyanka.
