RESEARCH AND CONSERVATION ISSUES REGARDING THE SOUTHERN FACADE OF WROCLAW TOWN HALL. A CASE STUDY

Abstract

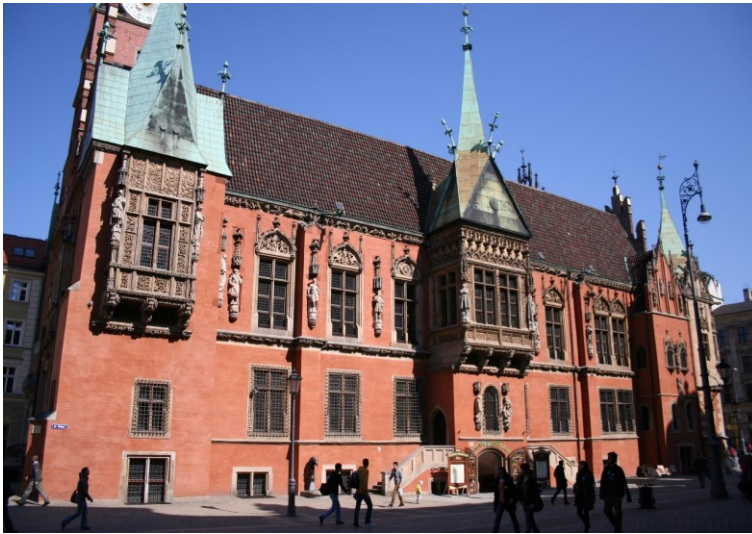
Fig. 1. Wrocław Town Hall, southern façade after restoration

However, it was only the extension carried out from the late 1570s that gave the town hall the form (with a representative southern facade) that can be seen to this day. Conservation works on the southern facade, conducted in the years 2004-2007, gave an opportunity for interdisciplinary research, which brought new findings within the context of changes in its architecture (similar research and conservation issues on other sites are presented in, among others [4-7]). Based on architectural and conservation research, a new arrangement of the facade was proposed, which significantly differs from the existing aesthetics, and refers to its look from the Middle Ages (Fig.1) [8].

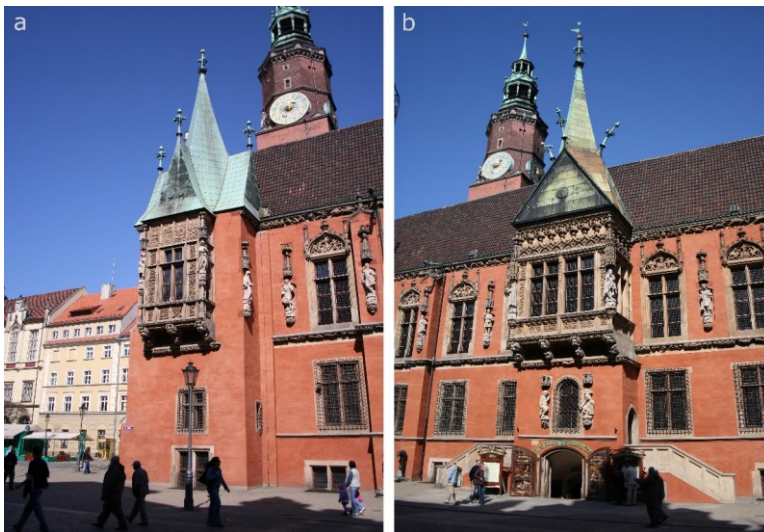
Fig. 2. Wrocław Town Hall, southern façade after restoration, (a) western risalit, (b) central risalit

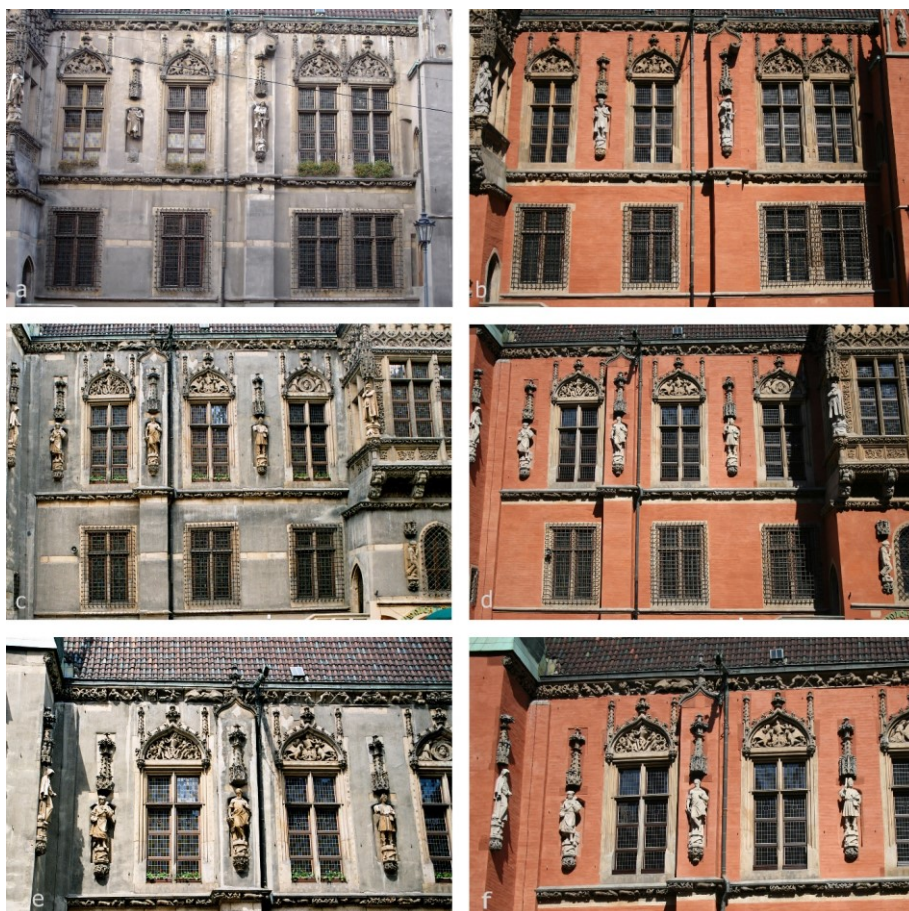
Fig. 3. Wrocław Town Hall, southern façade,
on eastern part: a. before restoration; b. after restoration;
on western part: c. before restoration; d. after restoration;
first floor of western part: e. before restoration; f. after restoration

The wall of the southern facade is strengthened by three buttresses: two located between the avant-corpses and one by the south-western corner. The facade is plastered, painted in a rusty red color and has stone details. The first floor, the grandest one, is distinguished by high windows, rich ornamentation and decorative bay windows located on three avant-corpses (Fig. 3a-f).

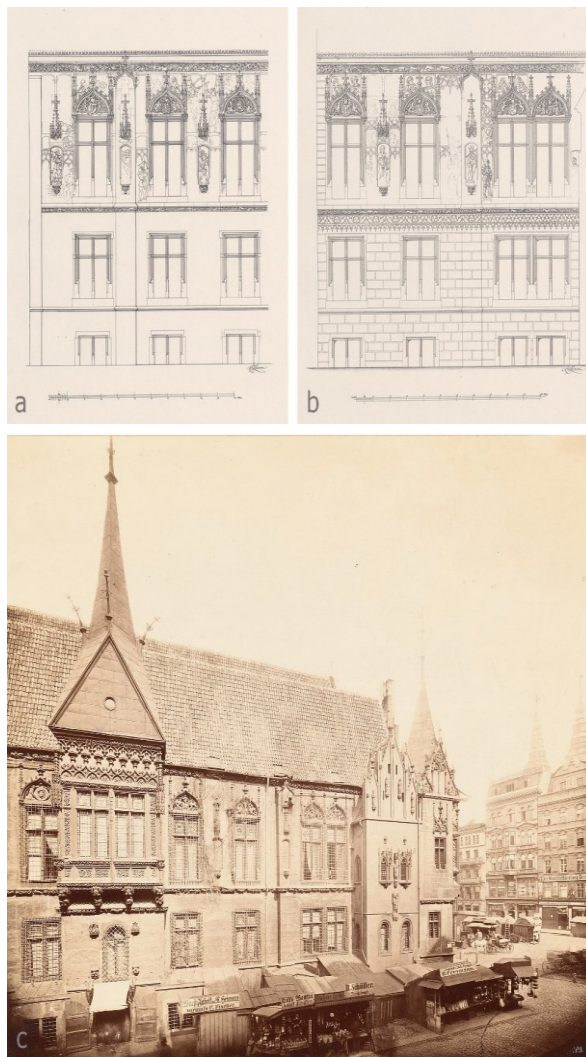
Fig. 4. Wrocław, Town Hall: a. part of the southern façade (western part) and inventory of the painting decorations from 1510, which was drawn up by Carl Lüdecke [10]; b. part of the southern façade (eastern part) and inventory of painting decorations from 1510, which was drawn up by Carl Lüdecke [10]; c. the eastern section of the southern façade in 1858 photo by Eduard Willem van Delden (Architekturmuseum TU Berlin)

In turn, Carl Lüdecke's inventory drawings (Fig. 4a and b) are important with regards to considerations about the design of the southern façade. They were made during the renovation of the town hall, which was carried out under his supervision in the years 1884-1891 (Fig. 4c).

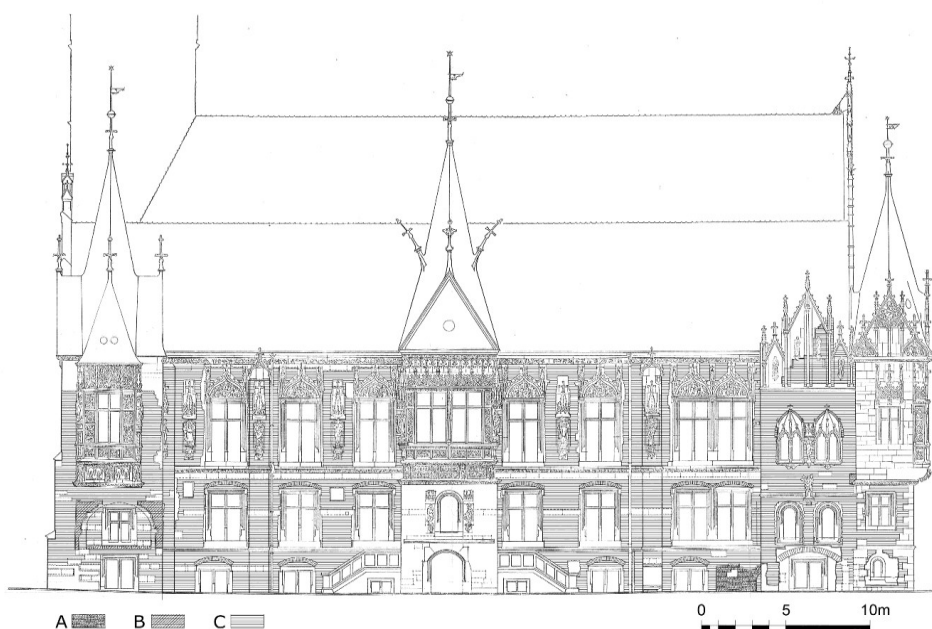
Fig. 5. Wrocław, Town Hall, southern façade with chronological stratification of its walls:

- A. eastern part of the southern part of the Town Hall with the eastern avant-corps (first phase of constructing the façade from around 1330)—dismantled wall;
- B. western part of the southern part of the Town Hall with the western avant-corps (second phase of constructing the façade from the period after 1330);
- C. phase of constructing the façade from 1471–1486), created by the authors—adapted a drawing from [2]

The oldest fragments of the walls found within the current southern facade (discovered on its edges), which was rebuilt in the years 1471-1486, were made in two phases. The first building was constructed in the vicinity of the eastern edge of the facade. It was a single-nave, two-bay building arranged on the east-west axis. It was added to the eastern facade of the town hall, which was extended in around 1330 [3, 13]. This building had a rectangular plan, and its southern facade was decorated with a slanted avant-corps located in the south-eastern corner of the present town hall. The preserved remains of the avant-corps include fragments of a demolished wall measuring approx. 1.70 x 2.80m, which are located near the most outer eastern window of the basement (Fig. 5).

research conducted in 1997. Studies of the lower parts of the outer western, southern and eastern walls were carried out by [13] in cooperation with a team led by Cezary Buśko. At the turn of 1999 and 2000 Rafał Czerner and Czesław Lasota [14], both teams conducted research in the interiors of Piwnica Świdnicka. Rafał Czerner [2] and Rafał Czerner and Czesław Lasota [13, 14], described the aforementioned layout of the eastern avant-corps. At the western wall of the present eastern avant-corps and on the adjacent edge of the facade of the southern aisle, two fragments of the imposts of the brick semi-circular barrel vault, with a thickness of 1 brick, were found (Fig. 5).

The composition of its southern facade is partly known due to the later transformations of the town hall. On the ground floor of the present western avant-corps, there were probably ogival windows. On the southern facade, an opening of about 3.60 meters wide and about 2.50 meters high was placed. The base for the probable stone framing was a ceramic windowsill made of bricks arranged vertically in the so-called row lock. It is still preserved in the form of hammered bricks. There was a narrower opening on the eastern facade. Its windowsill was at the same level as the southern window and the height of both windows was also similar. The south-western corner of the building was reinforced with a corner buttress - currently visible on the ground floor of the western facade of the western avant-corps (Fig. 5).

However, it was definitely narrower and was about 90cm wide. The perimeter walls of this wing were buttressed along the entire length, which is confirmed by the traces of buttresses found under the floor of the market square during research in 1997 [13]. The south-western corner was reinforced with a corner buttress - currently visible on the ground floor of the western facade of the western avant-corps. The texture of the wall in this part of the seat of the municipal authorities was made of bricks arranged in a regular stretcher pattern with carefully formed triangular joints. The arches of the western avant-corps window openings were made of bricks and were one brick thick (Fig. 5).

The construction of the current southern aisle of the town hall and the central and western avant-corps was probably carried out in the years 1470-83 [2, 3]. The facade had seven axes: three axes in the western part and four in the eastern part, with this division being accentuated by a central bay window (Fig. 5).

The current southern facade was erected between the avant-corps in the western and eastern corners of the town hall after demolishing its former southern section to the basement level. The wall was built at the same time as the central avant-corps (in one construction action), which is confirmed by the interconnections between the walls. The erection of the brick walls began with the construction of pillars between the windows. The stone profile frames of the rectangular windows were placed in the openings prepared in this way. The window openings on the ground floor and first floor were divided by a stone muntin and a transom in the form of a Latin cross. In some places, brick toothings were clearly cut during the setting of the sandstone frames. Over the window openings on the basement and ground floor level, arches (one brick thick) were built. The areas above the tympanums of the first-floor windows were filled with bricks after the stonework was implemented (Fig. 5).

floor. On the rest of the walls, the plasters were removed to a height of about 1.70 meters and new plasters were then made. The same was done with the vault, the opening of which was bricked up. The perimeter walls were raised to their present height. The southern facade of the avant-corps on the first floor was shaped as a two-axis composition with two ogival window openings that were probably decorated with stone traceries. It was crowned with a triangular gable that had lesenes decorated with pinnacles. In turn, from the east, a richly decorated bay window was placed on prominent corbels. A similar form was given to the bay window crowning the central avant-corps and a slightly more modest form to the western avant-corps (Fig. 5).

The brick pillars between the windows, as well as the buttresses on the level of the first floor, were enriched by introducing recesses with segmental arches, the frames of which were made of ceramic fittings (with a concave). The recesses were decorated with stone consoles and canopies. They were probably intended to embed sculptures, which are not preserved today. In the middle of the width of both sections of the facade, between the avant-corps, two narrow buttresses topped with stone caps in the form of an ogee arch were added. In the upper part of the western buttress, a stone gargoyle with a simple form was implemented in order to drain water from the gutter on the roof (Fig. 5).

Changes in the articulation system of the facade were only found within the range of the southern facade of the eastern bay window. In place of the two ogival windows, two stone bay windows were introduced. Under their windowsills, depictions of monkeys and fanciful animals were placed and St. John the Baptist was assembled on the post between the openings (Fig. 5).

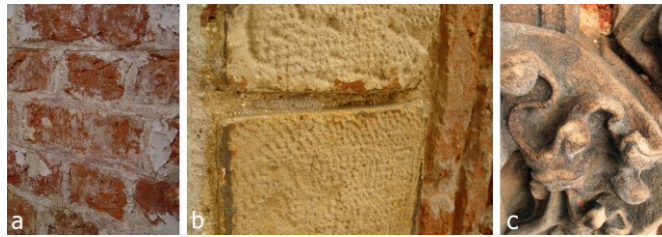
Fig. 6. Wrocław, Town Hall, southern façade, remains of colors: a. red monochrome on the joint and a brick surface; b. red monochrome on the stone block; c. red lead on the pinnacle

On the walls of the southern facade, two zones were distinguished, which differed in the way the bricks were bonded. On the ground floor, up to a height of about 5.20 meters above the ground level (i.e. up to the height of the window transoms), a stretcher bond pattern with stone blocks was used. Sandstone quoins were inserted to reinforce the corners of the lower part of the south-western bay window. Some stone elements were machined with a bush hammer. The walls of the upper part of the ground floor and the entire first floor were erected in a homogeneous stretcher bond pattern. The joint on the facade between the bricks was flat with a crack, with excess mortar being applied on the wall surface (Fig. 6a).

Relics of the color scheme recorded on the surface and stone detail give an idea of the colorful design of the facade. Traces of red that were found in many places on the bricks, mortar surfaces in joints, stone elements aligned with the wall and stone blocks indicate that the facade plane was painted red with the use of iron red as a pigment and that probably casein was used as a binder (Fig. 6b). Next to the crockets on the pinnacles flanking the tympanums and in the bends of the profiled frames, traces of red lead pigment were found directly on the stone (Fig. 6c).

Sample No. 2 - mortar from a joint in a brick wall (Fig. 6a)					
Thickness	Structure	Color	Filler	Binder	Comments
1 cm	fine-grained; homogeneous, compact and non-directional texture; compact mortar; does not crumble and does not delaminate; smooth surface with a visible layer of red	light creamy color; in some places light other discoloration on the surface	light quartz sand; grain diameter: 0.1 - 1 mm with a predominance of finer grains; rounded; not many grains with a diameter of up to 2 mm, a few lime particles	contact binder, evenly filling the sample space	no solid organic additives; in some places larger lime particles and larger filler crumbs

Table 3. Samples of color layers (sample No. 5 and No. 6) (Fig. 6c, 6b)

Sample No. 5 - red color from the surface of the detail (Fig. 6c)				
Slight remnants of red preserved mainly in the hollows of the sculptural detail and in the pores of the stone				
Color	Layer	Thickness	Chemical and instrumental analyses	
			Filler	Binder
orange-red	hard, compact; directly on the stone	0.3-0.8 mm	Red lead pigment (Pb304), ceruse	iron red, protein
Sample No. 6 - red color from the surface of the detail (Fig. 6b)				
Slight remnants of red that is mainly present in the pores of the stone, on the surfaces of the stone blocks aligned with the wall, and on some parts of the detail.				
Color	Layer	Thickness	Chemical and instrumental analyses	
			Filler	Binder
red	hard, compact; does not form a continuous coating; in the form of spots; residues mainly in the near-surface pores of the stone	0.1-0.5 mm	iron red	protein

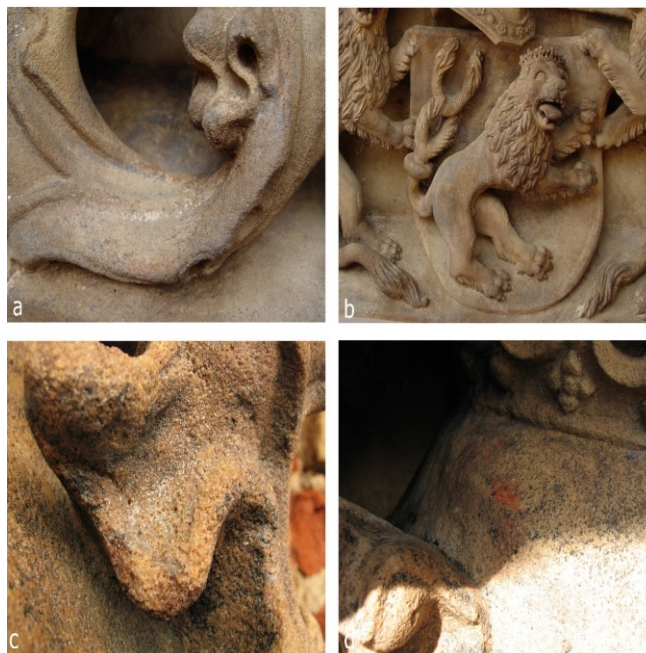
Fig. 7. Wrocław, Town Hall, southern façade, color remains: a. white and red paint layer on the tail of the griffin supporting the Silesian coat of arms; b. white monochrome on the lion in the coat of arms of the Kingdom of Bohemia and on the two lions supporting it; c. white monochrome on the surface of one of the griffin's labrums supporting the Jagiellonian coat of arms; d. red monochrome on the surface of the griffin's labrum supporting the Jagiellonian coat of arms

In addition, at least three colors were found on the surface of the stone within the tympanums and the heraldic representations composed in them (Figs. 7a-d). Iron red was also captured in the backgrounds of the tympanums, the folds of the sashes and on the shield with the representation of the Lion with a split tail (the coat of arms of the Kingdom of Bohemia) (Figs. 7a and b). Black was registered on the folds between the feathers of the Eagle with a crescent on its chest (the coat of arms of Silesia). In turn, traces of a white layer of paint were found between the feathers of the Eagle on the shield, on the two feathers supporting it (the Jagiellonian coat of

arms) (Fig. 7c), in the folds of the robes of the angels supporting the tray with the head of St. John the Evangelist and in the folds next to the outer edges of the sashes.

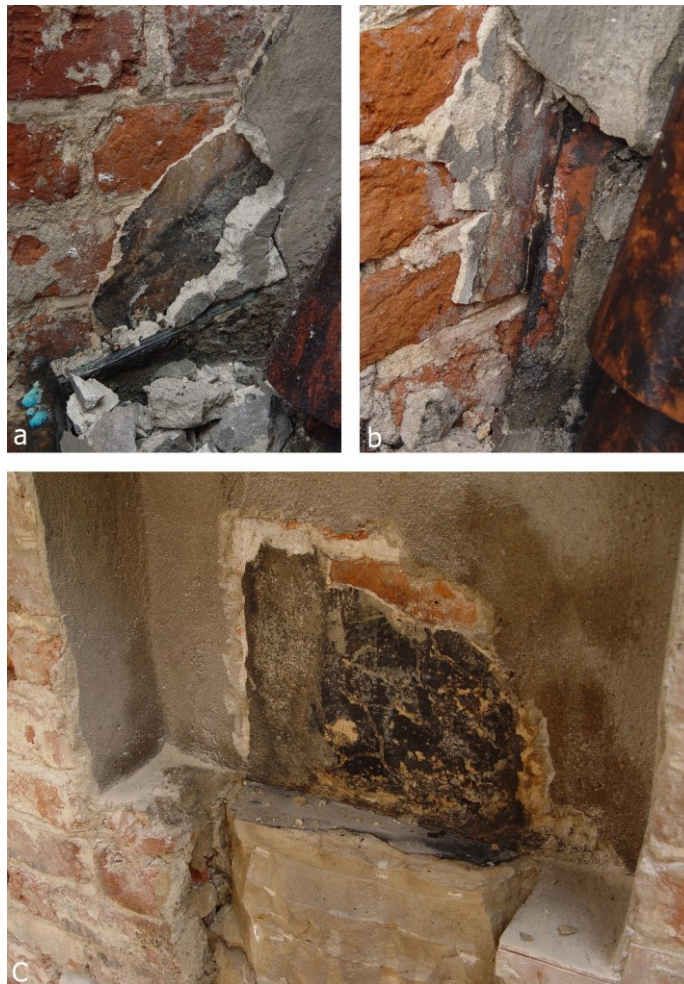
Fig. 8. Wrocław, Town Hall, southern façade:
 a. and b. remnants of plaster with traces of painted decoration
 above the roof of the eastern risalit (red, black and white);
 c. background of a niche in a buttress in the eastern part
 of the façade with traces of painted decoration (black)

with the stone frieze, created a clear horizontal accent. The part of the facade of the ground floor with the bossage was a high plinth for the first floor, which had rich iconographic painted decorations that complemented the composition of the stonework. The theme of the illustrations in the eastern part was made up of multicolored views that symbolized the city in times of peace. It had representations of various urban states (burghers drinking wine or playing with a falcon and a dog, a street musician and a guard leaning on a halberd) and also a bear playing bagpipes. In turn, in the western part, the city was shown during the war, with images of the walls being conquered (a soldier climbing a ladder or shooting a bow and arrow and people aiming a crossbow and throwing stones). The content of the painting representations is only known from the 19th century inventory, because after removing the layers of cement plasters made in the 20th century, only a few fragments of the plaster coatings from this phase were found. Two areas of about 40 x 40cm were discovered in recesses between the windows of the first floor. In one of them, a fragment of a red stripe circling the area of a black painted recess, which was originally the background for the figural decoration, was exposed (Fig. 8c). Small strips of plaster have also been preserved above the roof of the eastern avant-corps, at the edge of the roof flashing (Fig. 8a and b).
