THE DESTRUCTION OF THE ESTABLISHED URBAN ENVIRONMENT OF BORODIANKA AND IRPEN AS A RESULT OF THE RUSSIAN-UKRAINIAN WAR

Keywords: Destruction problem; Russian-Ukrainian war; Borodianka; Irpin; Urban environment; Transformation

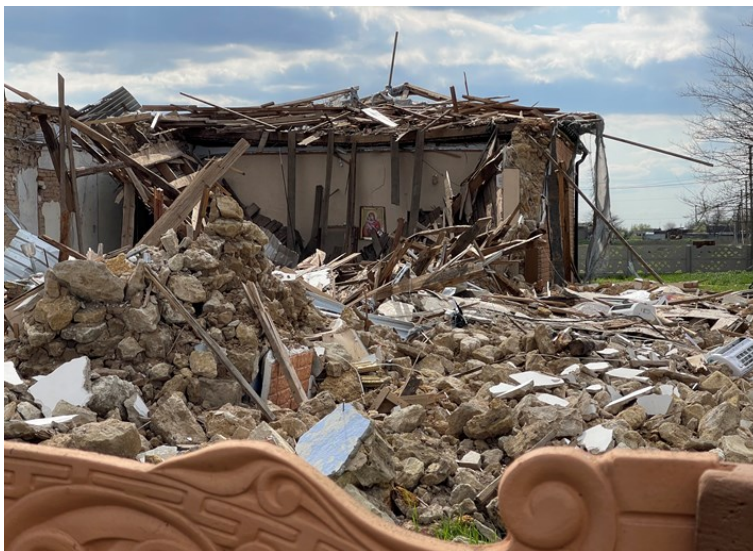
Fig. 1. The ruined church in the village Prybuzke, Mykolaiv region.

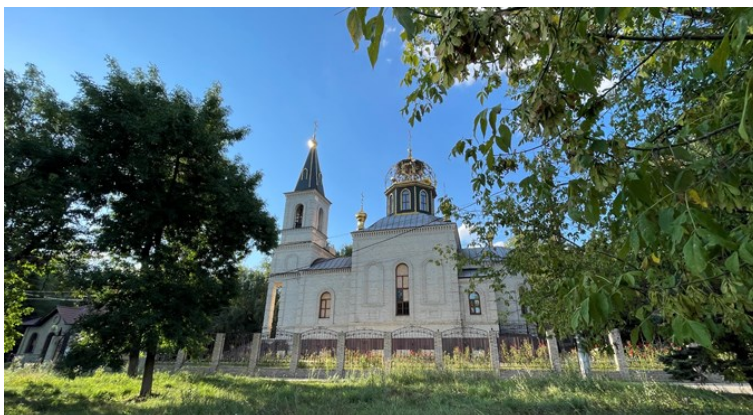
Fig. 2. The damaged church in Toretsk, Donetsk region.

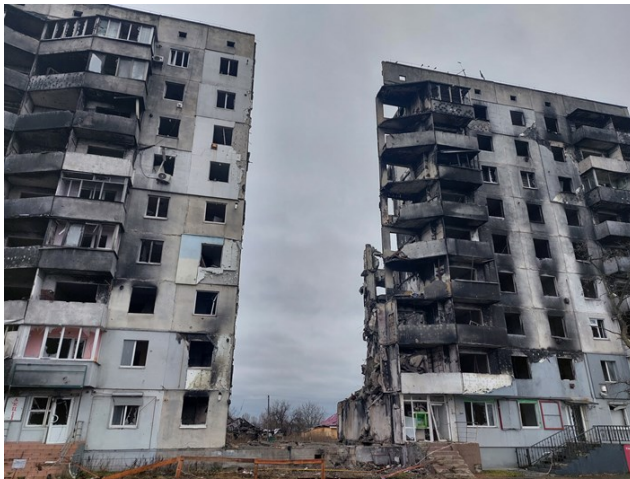
Fig. 3. The house destroyed by an aerial bomb, 353 Tsentralna Street

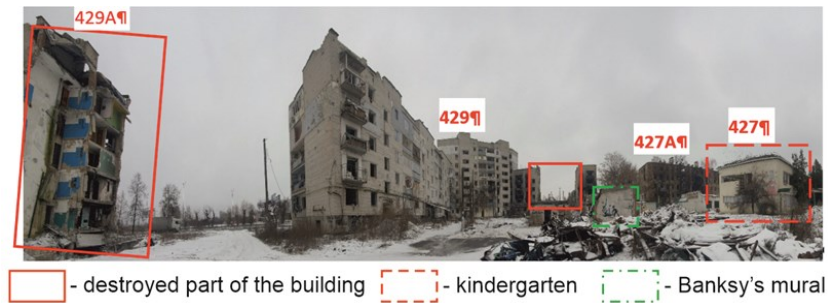
Fig. 5. Panoramic shot of the development (with a note of the damaged buildings) around the Banksy's mural. Photo by O. Molodid, 2023

The features of the established urban environment in Borodianka are that it is mainly a building of the Soviet period, microdistricts and residential groups are formed by multi-story prefabricated panel and brick houses of the years 1970 – 2000, mainly with concrete block foundations, occasionally with pile foundations, with ceilings from prefabricated reinforced concrete slabs (Figs. 5 –7).

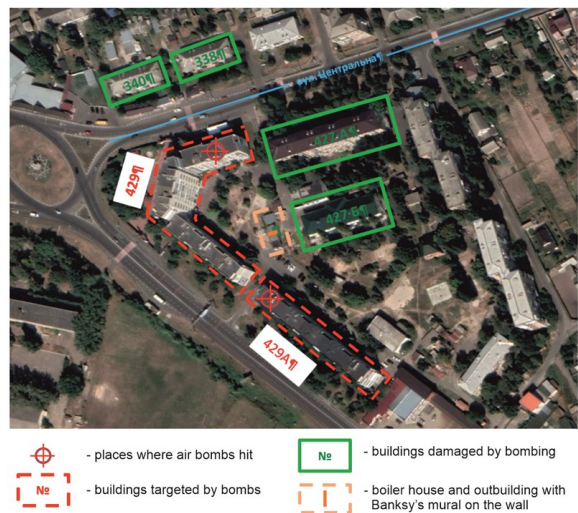
Fig. 6. Site plan of the area with damaged buildings marked around Banksy's mural. The scheme by O. Molodid

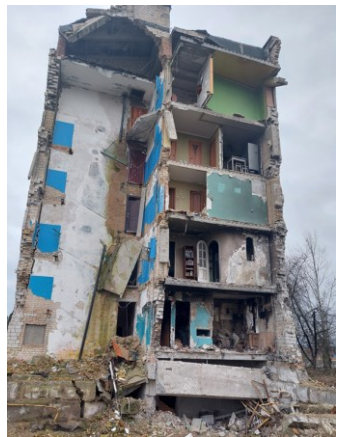
As already mentioned, the greatest destruction was caused by the hit of an aerial bomb, regardless of the type of structure. Such houses generally have to be completely dismantled. The shock wave also destroyed the filling joints between the structures.

Fig. 7. A brick residential building with a floor made of precast hollow-core slabs at 429A Tsentralna Street after an air bomb hit. Photo by Y. Ivashko, 2023.

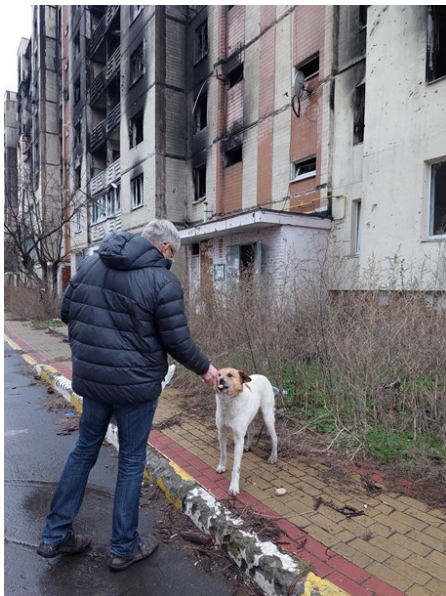
Fig. 8. House at 158 Severynivska Street

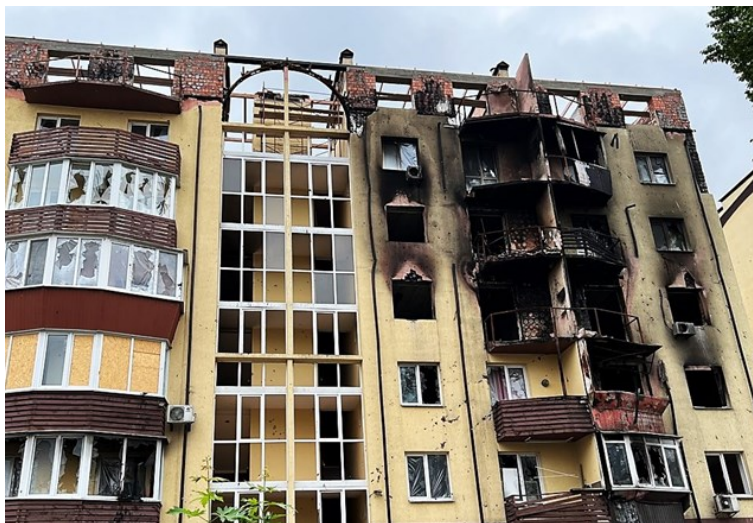
Fig. 10. A house at 1-K Novo-Oskolska Street damaged by a tank shell.

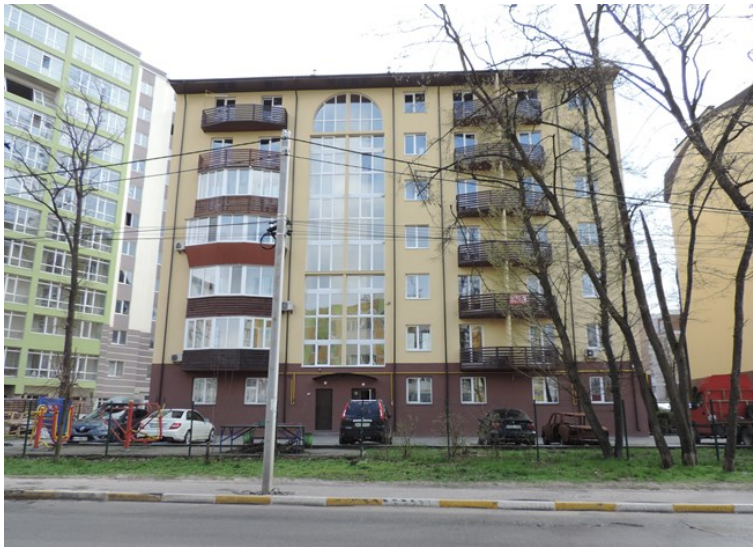
Fig. 11. The house at 1-K Novo-Oskolska Street after restoration

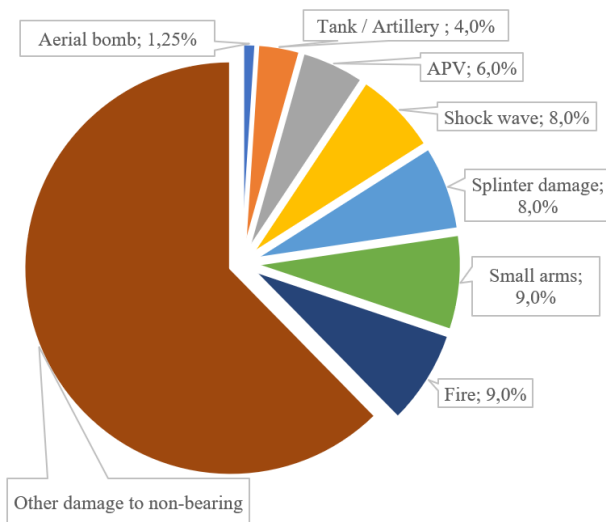
The main recorded types of destruction from the blast wave were the destruction of enclosing load-bearing structures, internal non-load-bearing structures, violation of the stability of the building, damage to slots with fillings, and spillage of seams between structures (Fig. 12).

Fig. 12. Damage to construction sites with various types of weapons
