DETERMINATION OF THE APPLICABILITY OF SEISMIC CONTROL METHODS TO THE HISTORICAL BUILDINGS OF ELAZIĞ-PALU DISTRICT

Ayşe Gülce KARAKAYA^{1*}, Asena SOYLUK², Esra ÖZKAN YAZGAN²

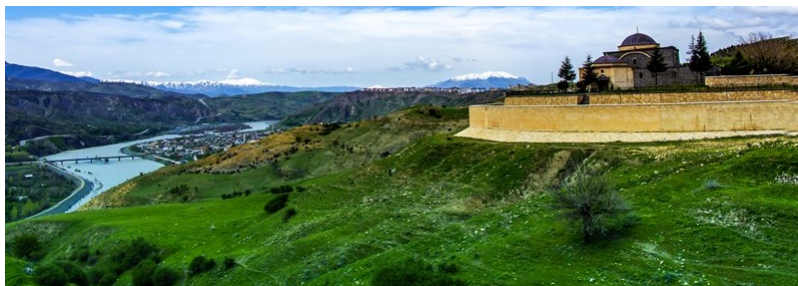
Fig. 4. Cemşit Bey Kulliye

Cemşit Bey Kulliye was built in the 16th century at an altitude of approximately 500 meters above the Murat River (Fig. 4). The Kulliye consists of four parts. These are the mosque, the tomb, the madrasah and the graveyard. The current domes of the mosque are not original and were rebuilt after they collapsed. The General Directorate of Foundations completed the restoration of Cemşid Bey Kulliye in 2017. Kulliye has been restored and strengthened in 2017. Therefore, risks have been eliminated.

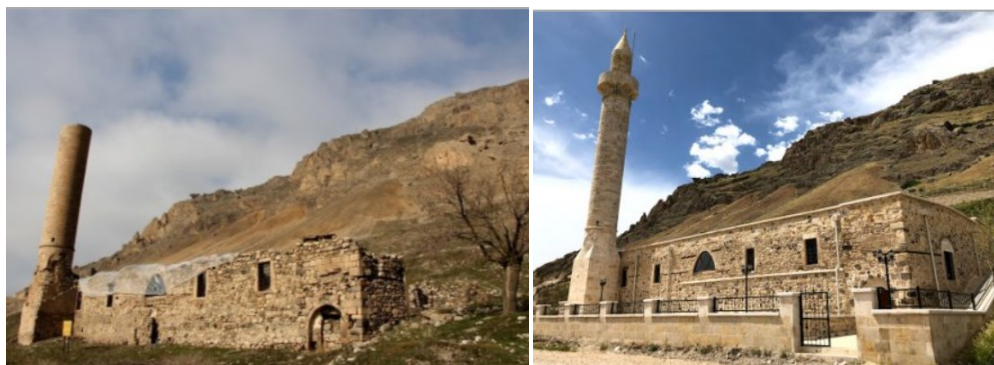
Fig. 5. Palu Grand Mosque before and after Restoration

The Grand Mosque, located in the Çarşıbaşı Neighborhood of Old Palu, is understood to have been built in 1852 to its inscription (Fig. 5). The Grand Mosque has a rectangular plan, the upper part of which is domeless and has the shape of a terrace roof. The roof of the mosque completely collapsed and has been repaired today after the restoration works started in 2014. The minaret has a square plan. The upper part of the mosque was also destroyed and has been restored today. Black-and-white cut stone was used in the arch of the building. The building was built with rubble stone.

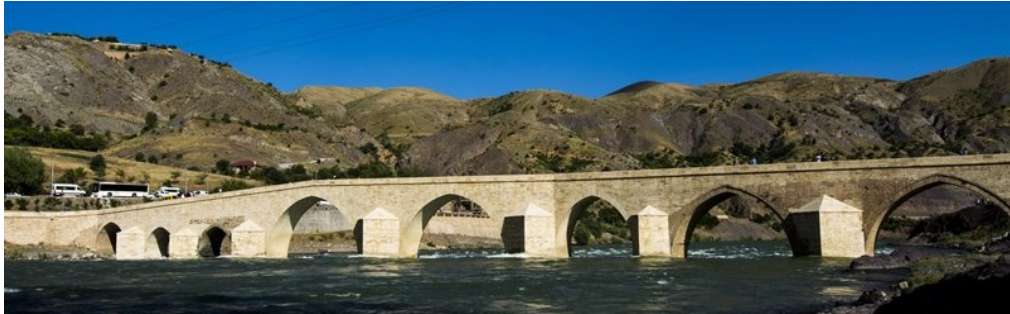
Fig. 6. Historical Palu Bridge

The Historical Palu Bridge, located on the Murat River, was built during the Roman Period according to the rumour and was restored during the Byzantine and Artuqid Periods. the bridge, which is 156.50 meters long and 3.5 meters wide, was restored in accordance with the original by the General Directorate of Highways in 2010 (Fig. 6). The bridge, which was the only transportation and crossing point that provided the south-north connection at the time, was

passed as the bridge connecting Istanbul to Baghdad in historical sources. This bridge also has great importance in the development of Palu and the formation of a commercial centre.
