CONSERVATION AND RESTORATION WORKS IN THE BALLROOM OF THE OFFICERS' CASINO IN THE MODLIN FORTRESS IN NOWY DWÓR MAZOWIECKI

Abstract

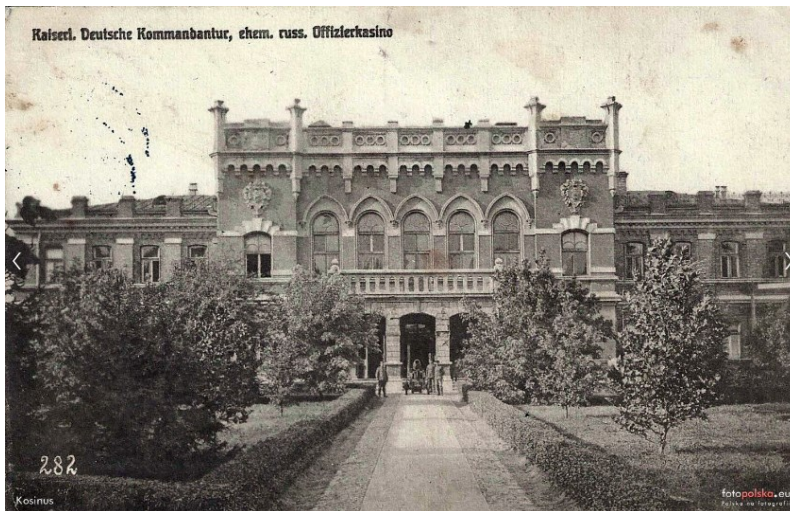
The casino was built for Russian officers who were stationed in the Modlin fortress around 1905-1906. The four-story, partly with basement building in the form of a palace was designed by a Russian architect (name unknown), probably with the participation of the Polish architect Piotr Leon Karasinski. The building has a T-shaped plan and a fifteen-window facade, which is oriented to the south. Nearby is a passage with an arcaded portico covered by a terrace with a concrete openwork balustrade. The Neo-Gothic front facade was extended as a risalite, surmounted by an attic with buttresses and false windows, supported by a muscular cornice, also encircling the rear wing [23, p. 44]. The building is built in a traditional style for barrack buildings, which is based on a facade wall made of red smooth and profiled ceramic bricks with seams filled with lime-sand mortar [28]. Decorative elements had to imitate natural sandstone. They were made of cement mortar with a smooth surface. The entrance portico is made in the same technique of monolithic and drawn elements: rusticated pillars and pilasters with profiled bases, beams, a terrace, and a balustrade. The facade risalite was originally decorated with coats of arms depicting the patron saint of warriors – St. George (Fig. 1).

Fig. 1. General view of Officers' Casino around 1917. (Archive photo <https://fotopolska.eu/785455.foto.html>)

The reconstruction of the frontal risalite was carried out after the restoration of independence in 1918 and the capture of the Modlin Fortress by the Polish army. As a result, the main facade acquired features of the Neo-Renaissance. It can be assumed that the goal was to distinguish the casino building from others and to disassociate from the Russian origin of the building. The flat surfaces of the brick facade were covered with rectangular ceramic tiles of an other color, the cartouches with the Russian coats of arms were removed and replaced with

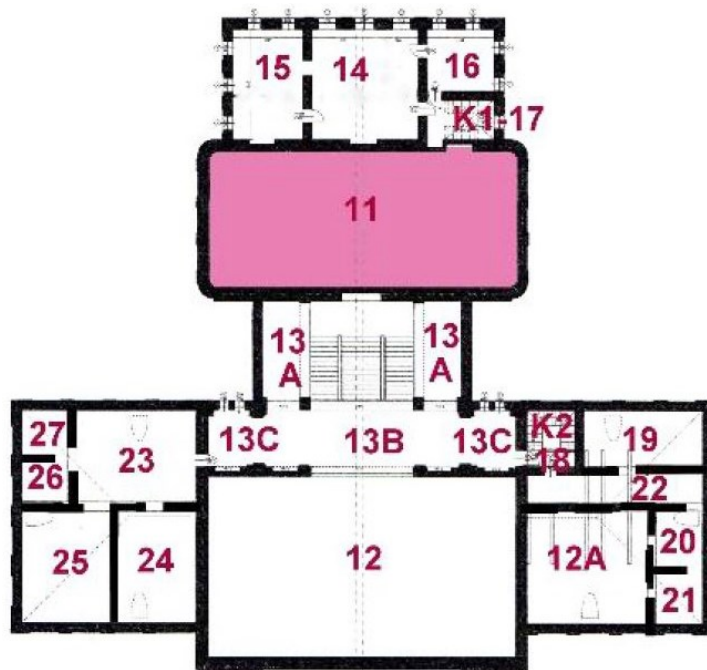
The ballroom is located on the ground floor of the building, on the north side of the facade. It has a rectangular plan measuring 12×26m (Fig. 2).

Fig. 2. The ground floor plan of Officers' Casino. Ballroom is marked in colour

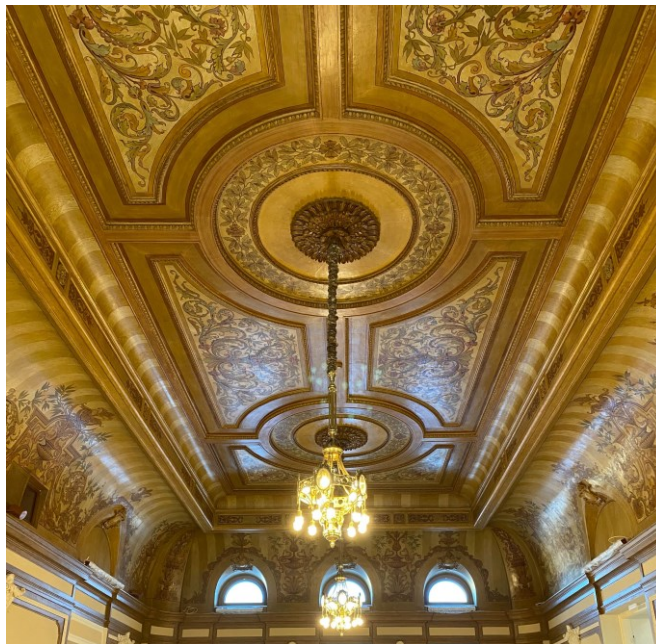
The ceiling was symmetrically divided into three fields, defined by stucco frames with an ovary and pearl motif, between which are placed paintings of plant tendrils on a grainy background. Inside the central fields, there are richly decorated rosettes with acanthus leaves, and the center of the rosettes is the place where the candelabras are attached (Fig. 3).

Fig. 3. General view of the Ballroom ceiling

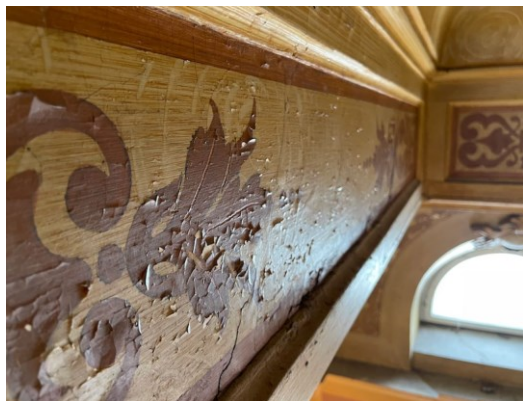
Unstable humidity and temperature conditions that prevailed at the site, as well as technological errors related to the production of the painting layer, affected the general poor condition of the exquisite paint coatings. The wooden ceiling structure was weakened by wood-feeding insects and rotted by rainwater from the leaky roof, especially in the ceiling corners. Examinations revealed the imposition of new layers of faux wood grain finishing surfaces on the previous ones without considering the loss of the layer of mortar and paint. Retouching was carried out carelessly, without attention to color and shape. The secondary polychrome decoration was also carelessly applied, with cracks and flaking in many places that threatened to ruin it.

Studies have shown that the use of hygroscopic gypsum as a primer for oil-based paints was a technological error. Wetting the ceiling, excessive humidity and lack of heating caused water to be absorbed by plaster and, as a result, cracking of the paint layer (Fig. 4).

Fig. 4. The damaged wood texture imitation by means of painting. Photo by M. Paździora Sattler.

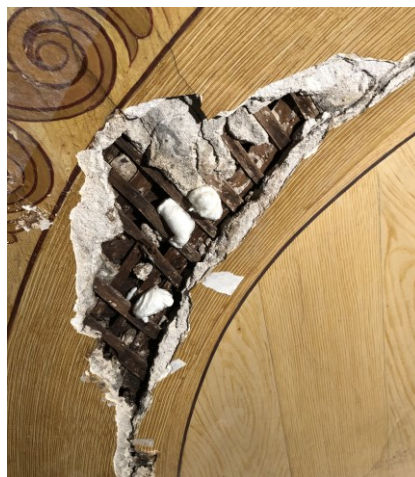
In addition, as a result of the action of water under the surface of the polychrome decorative painting, salt crystallized, which also led to damage by growing crystals (Fig. 5).

Fig. 5. Damage from growing salt crystals due to overwetting

At the first stage of conservation works, surface dirt was removed, and fragments of polychrome decorative painting were removed along with mortar in parts of the salt deposits. The paintings were then disinfected, and the stucco was fixed with pins and glued so that they would not fall off. Work was carried out to recreate the missing stucco details in accordance with the original form, the wooden structure was strengthened in the open parts of the ceiling (mainly in the corners most damaged by the penetration of rainwater).

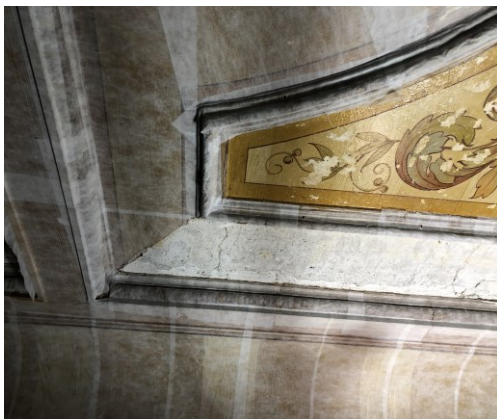
Fig. 6. The process of painting restoration.

The next stage was gluing and leveling the scales of the painting layer by wetting and pasting Japanese cigarette paper moistened with methyl cellulose and pressing it with a stone (Figs. 6 and 7). Then the paper was removed, excess methylcellulose was removed, and protruding scales were glued.

In order to protect the surface, the paint layer was permeated, and its losses supplemented. The final work was retouching the losses of the polychrome decorative painting made with resin paints, according to the preserved original parts. Retouches were protected with varnish in a spray bottle, and then with two layers of satin varnish. Finally, the polychrome decorative painting was covered with paste wax, and then the waxed surfaces were polished with flannel.

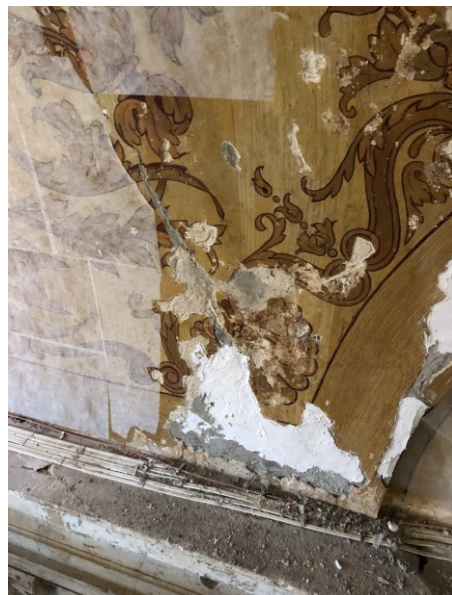
Fig. 7. The process of painting restoration.

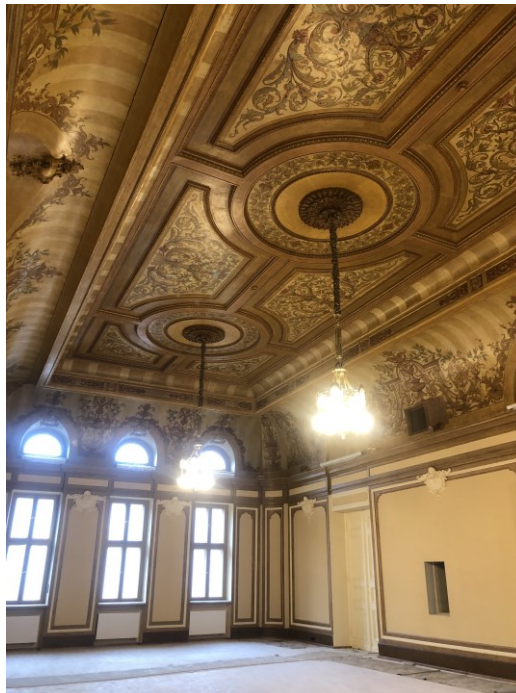
Fig. 8. The restored interior of the Ballroom

Wall surfaces and stucco details were primed and then treated with mineral paints with high vapor permeability in colors according to conservation instructions. The cartouches and strips of decor at the final stage of painting were patinated in a darker shade.

imitating various types of wood. After cleaning the surface of the walls and profiles, options for faux wood grain finishing in various shades of beige were proposed, and then submitted for approval to the protection commission. On the basis of accepted samples and conservation recommendations, the original imitations of wood were reconstructed on the profiles in the wall parts and plinth.

In the profiles that frame the stucco panels and the plinth, the technique and colour of the faux wood grain finishing of the selected fragment of the richly decorated ceiling are used. Faux wood grain finishing of wall surfaces are made using water technology. Steel combs, special brushes, brushes, and sponges were used. The smooth, primed surface of the drawn parts was covered with a primer in colours adapted to the grain finishing on the ceiling (Fig. 8).
