PRESERVING AUTHENTIC DECORATION IN THE ENTRANCE SPACES OF RESIDENTIAL BUILDINGS IN EASTERN GALICIA FROM THE LATE 19TH TO THE FIRST THIRD OF THE 20TH CENTURY: RESTORATION EXPERIENCE

Abstract

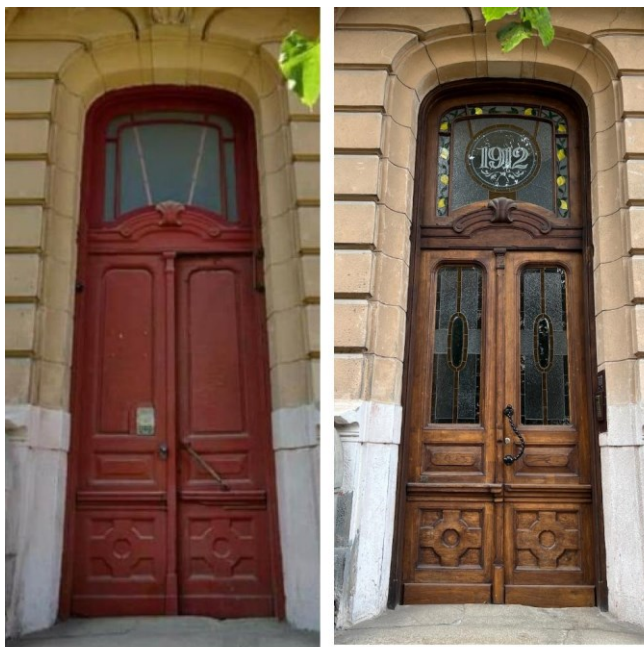
Fig. 1. Entrance doors in a residential building located at 1 Korolya Danyla Street, Ivano-Frankivsk (before and after restoration).

cities in Eastern Galicia, the "Frankivsk, which must be protected" initiative in Ivano-Frankivsk promotes the preservation of authentic doors and gates in the city for several years in a row. During this time, several dozen entrance doors in residential buildings in the city have been restored, including those on M. Hrushevsky Street, 17, 38, 42; V. Chornovola Street, 26, 28; Korolya Danyla Street, 1 (Fig. 1) and others. In Ternopil, there are plans to restore the gate of the building on Hetmana P. Sahaidachnoho Street, 11. In 2023, as part of the "Circle of Gates" project, craftsmen started the restoration of gates in Kolomyia at V. Chornovola Street, 9 and V. Chornovola Street, 49. Additionally, entrance doors were restored in a functionalist style building in Kolomyia at Teatralna Street, 23.

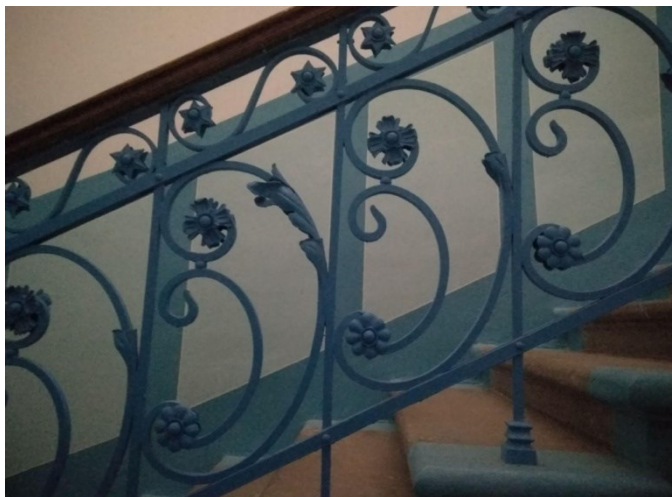
Fig. 2. Fragment of the main staircase in a residential building located at 1 O. Kulchytska Street, Ternopil.

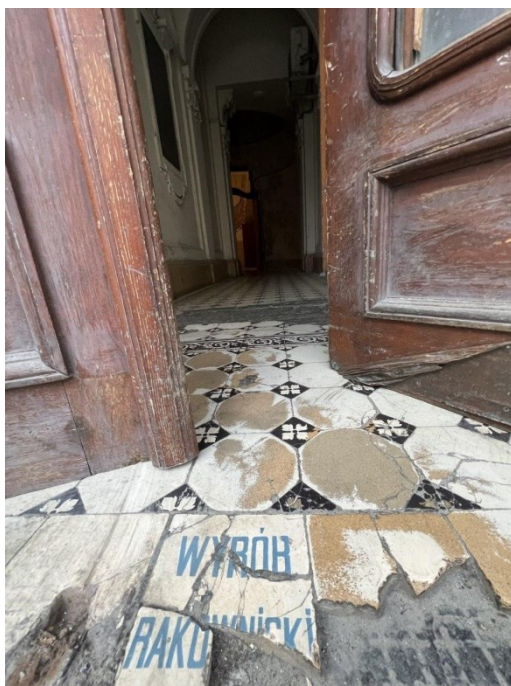
Fig. 3. Ceramic Mettlach tile in the entrance space of a residential building located at 8 Acad. V. Hnatiuka Street, Lviv.

To distinguish similar products from different companies, special protective marks were introduced during production. In Galicia, as well as throughout the territory of the Austro-Hungarian Empire, they were legalized by an imperial decree in 1880. The protective mark was the so-called signature of the enterprise in the form of its full name, conditional abbreviation, acronym, or graphic symbol on ceramic tiles. Most enterprises included their branded tiles with the inscription in the vestibule floor composition (firms like "Przedsiębiorstwo Henryka Ebera we Lwowie", "Bracia Mund Lwów", "Adolf Kampel", "A. Gruber", "Wyrób Rakownicki", "Wilh. Arnold. Stanisławów", "Samuel Freudmann Tarnopol" and others). Since the branded tile served as a kind of advertising for the manufacturer, it was deliberately placed so that residents and visitors could see it as soon as they entered the interior, such as in the building at 8 V. Hnatiuka Street in Lviv (Fig. 3).

In conclusion, it can be argued that Mettlach tiles are much stronger and more durable than other decorative elements, which is why they have been preserved in good condition to this day. In our time, during the restoration of entrance doors in a residential building at 1 Korolya Danyla Street, Ivano-Frankivsk, the solution for the flooring inspired specialists to decorate the stained-glass windows of the entrance doors with numerous lemons according to the concept of interaction of arts in the entrance space (Fig. 1). However, in modern conditions, asphalt is often laid in driveways on damaged sections of flooring, or authentic tiles are replaced with modern ones without maintaining the integrity of the conceptual idea in the building's interior.

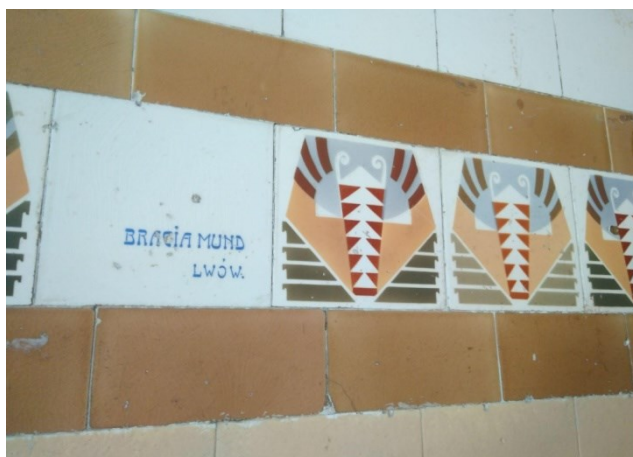
Fig. 4. Ceramic facing tiles in the decoration of walls in the entrance space of a residential building located at 31 Volynska Street, Lviv.

Therefore, in interiors, ceramic tiles were mostly used in entrance corridors on walls in strips up to 1.5 meters wide. They were predominantly monochromatic or polychromatic with a simple pattern. Sometimes, entire surfaces of the baseboard or ornamental panels were created from such patterned tiles. Ceramic facing tiles can also be found in the upper part of vestibule walls or passageways or from the bottom to the middle of vestibule walls. Lower and upper tile friezes were predominantly unrelated in thematic imagery.

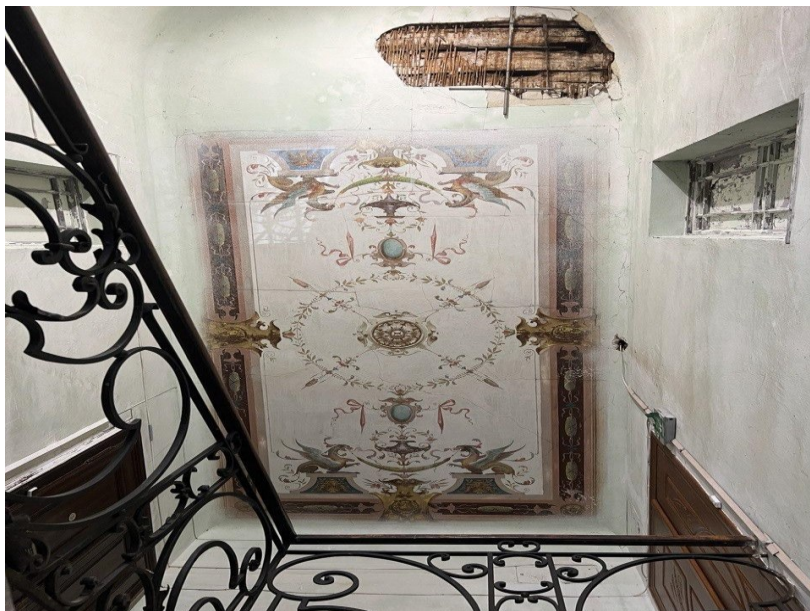
Fig. 5. The artistic mural on the ceiling in the entrance space of a residential building located at 48 Pekarska Street, Lviv.

The preserved artistic murals in residential buildings to this day are characterized by high-quality execution, diversity of themes and richness of color solutions. Unfortunately, the number of artistic murals in entrance spaces of residential buildings and villas decreases every year due to unskilled repair work, during which murals are often whitewashed or improperly restored. As a result of these factors, the authentic color palette of murals is lost and their artistic value is significantly reduced. Moreover, mural paintings are not long-lasting and often deteriorate due to the destructive effects of time, as seen in the building at 48 Pekarska Street, Lviv (Fig. 5).

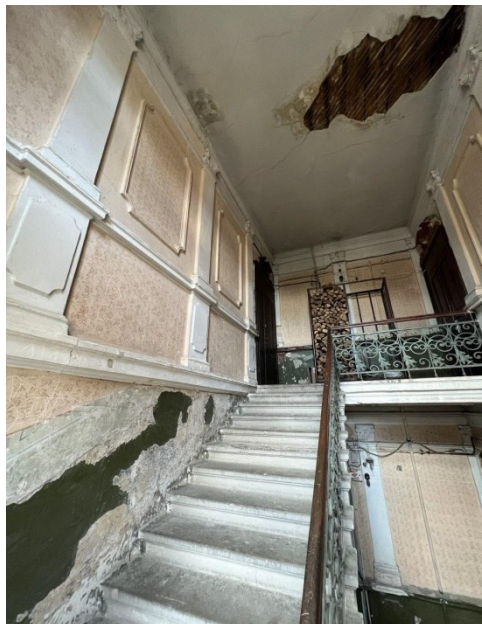
Fig. 6. The dilapidated condition of the entrance space of a residential building located at 28 Hetmana I. Mazepy Street, Ivano-Frankivsk.

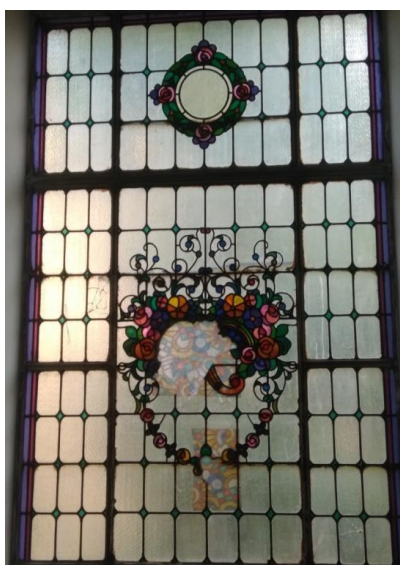
Fig. 7. Stained glass window in the entrance space of a residential building located at 2 Y. Malaniuka Street, Lviv (manufactured by "Krakowski Zakład Witrażów, Oszkleń Artystycznych i Fabryka Mozaiki Szklanej S.G. Żeleński").

has been lost or partially lost, as seen in the building at 2 Y. Malaniuka Street (Fig. 7) and this trend continues.
