## CERTAIN ASPECTS OF RESEARCH WORK IN THE RESTORATION OF THE KYIV VELODROME

*Kyiv Velodrome is the oldest sports facility in Ukraine and one of the oldest in Europe. In 2016-2017, the restoration of its track, administrative building, construction of an underground parking lot and reorganization of the adjacent territory were carried out. As part of the scientific and technical support, an examination of the velodrome track was carried out to determine all existing defects and damages and as a result, recommendations for their elimination were provided. In particular, solutions have been developed to repair cracks and recommended measures are aimed at preventing their appearance in the future. Also, within the scope of research work, some experimental studies were carried out with the designed constructions of the bicycle track for their compliance with the technical documentation and to establish durability (in laboratory conditions). The article analyzes and researches the structural and technological solutions proposed in the project documentation for the restoration and arrangement of the bicycle track, providing solutions and recommendations that will ensure the necessary qu

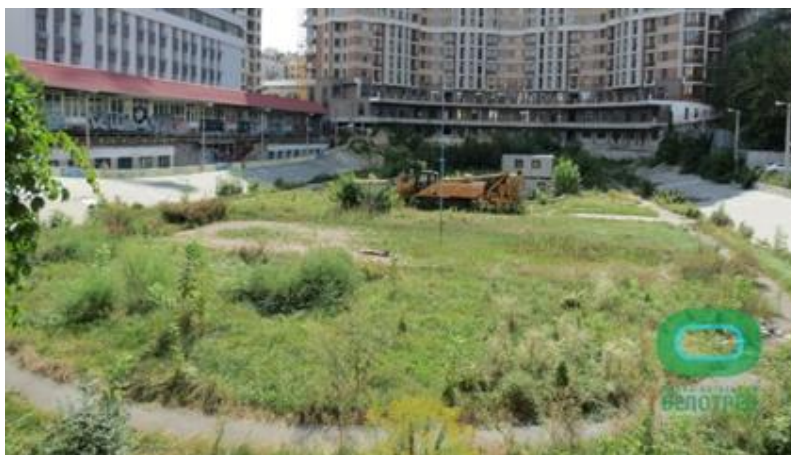
**Fig. 3.** View of Kyiv Velodrome before restoration [2]

In 2004, the last official competitions were held before the closure of the sports facility and the start of full-scale construction work. However, in 2007, the building was deprived of its protective status, having been deemed unfit for further use [2]. On March 20, 2009, the velodrome began to be demolished due to the construction of a 4-section, 20-story residential building, which surrounds the velodrome on one side and is less than 1 m away. Fortunately, thanks to loud publicity among the public and Mass media managed to stop the new construction. But the dilapidated velodrome has turned into an abandoned wasteland and garbage dump. Over time, it was overgrown with trees and grass and the walls were painted with hundreds of graffiti [1, 2] (Fig. 3).

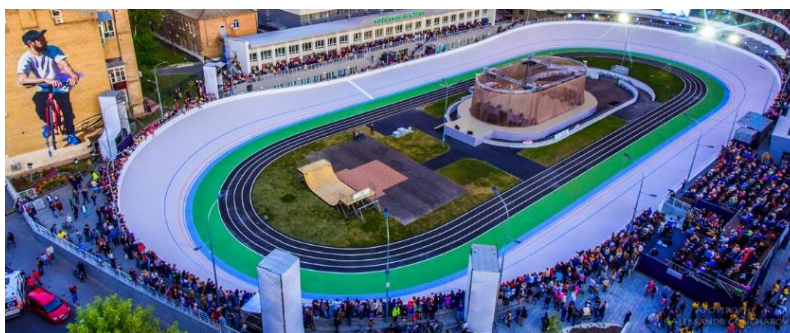
**Fig. 5.** View of Kyiv Velodrome after restoration in 2017. [Source: <https://apostrophe.ua/> ]

In 2016, the restoration of the track surface, the administrative building, the construction of an underground parking lot and the reorganization of the adjacent territory began. In 2017, the residents of Kyiv saw an updated bicycle track, which is considered one of the best in Europe. The cost of its reconstruction amounted to UAH 96 million. The view of the Kyiv Velodrome is shown in Fig. 5.

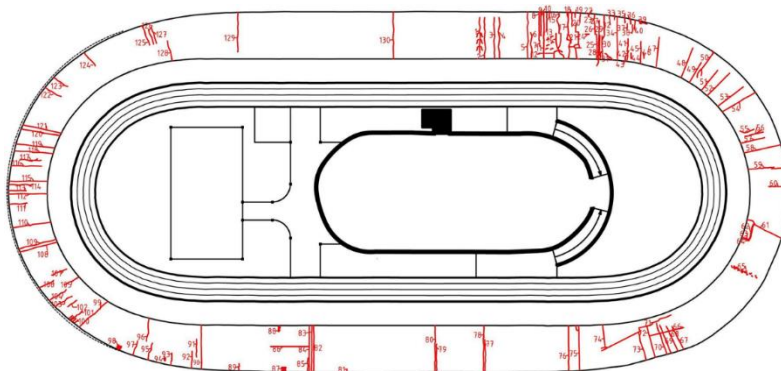
**Fig. 6.** Scheme of placing cracks on the bicycle track

Prior to the start of the restoration work, a visual and instrumental survey of the existing bicycle track surface was performed, as a result of which a large number of cracks (Figs. 6 and 7), bumps and depressions were revealed. Insignificant depressions and humps were proposed to be closed during the installation of leveling layers, so additional actions for their elimination were not foreseen. Instead, the existing cracks had to be repaired.

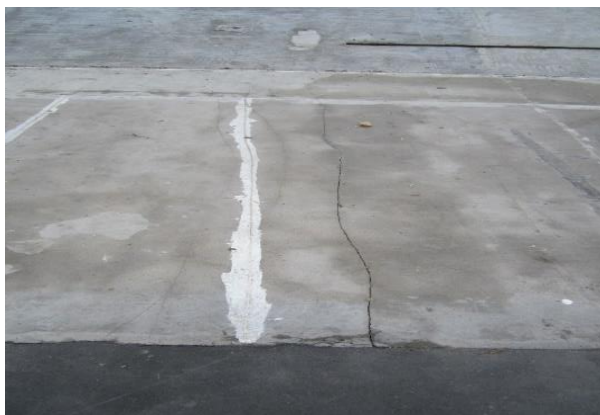
**Fig. 7.** Cracks on the bicycle track

In addition, technological solutions were developed, which involved injecting cracks with high-flow epoxy glue. The permissible crack opening width, which can be considered insignificant, is 0.3mm. Such cracks are called *hairline cracks*. If the width of the crack is greater, moisture penetrates it. At sub-zero temperatures, water turns into ice and wedges the edges of the crack. This will occur with each cycle of freezing and thawing and lead to the destruction of concrete throughout the thickness of the slab. In addition, water through the crack enters the foundations of the soil under the slab and provokes its subsidence. To prevent such negative effects, even hairline cracks must be eliminated.

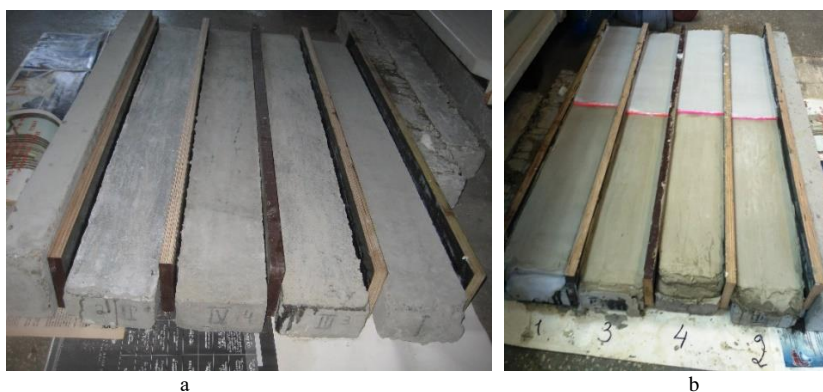
**Fig. 9.** Lintels for the study of the layers of the structures covering the bicycle track: a – lintels without coating; b – coated lintels

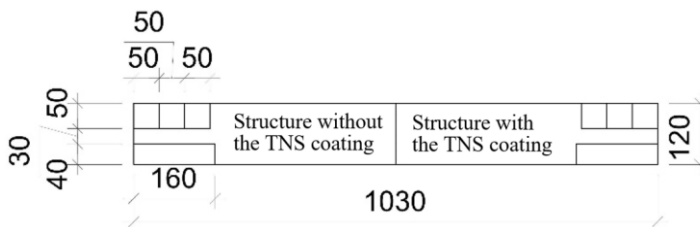
**Fig. 10.** The design of the coatings cut for testing

The constructions of coatings on membranes were cut into samples for further tests using an angle grinder with a disc on concrete (Fig. 10). Cutting was performed to the full depth of the samples with a 5–7mm slit in the membrane structure.

Thus, after cutting the coating, three fragments with dimensions of 50x50mm were obtained on two parts of each membrane and one beam with dimensions of 160x40mm. Lintels were cut from the membranes for further studies. After the planned experimental studies were carried out with the first batch of prepared samples, the fragments of the layers remaining on the lintels were tested for frost resistance.

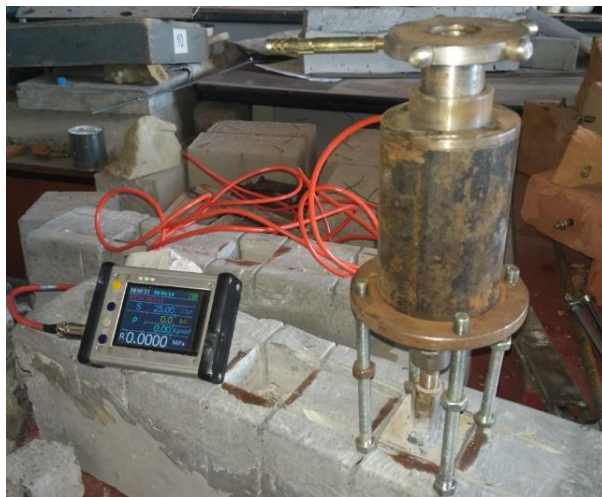
**Fig. 11.** The process of determining the adhesion strength of structure layers

With the help of the test setup (Fig. 11), using tear-off plates, a tensile load was applied perpendicular to the tested area. The load was applied at a uniform speed, avoiding shocks. When tearing off a fragment, the device automatically records the effort and displays it on the screen.

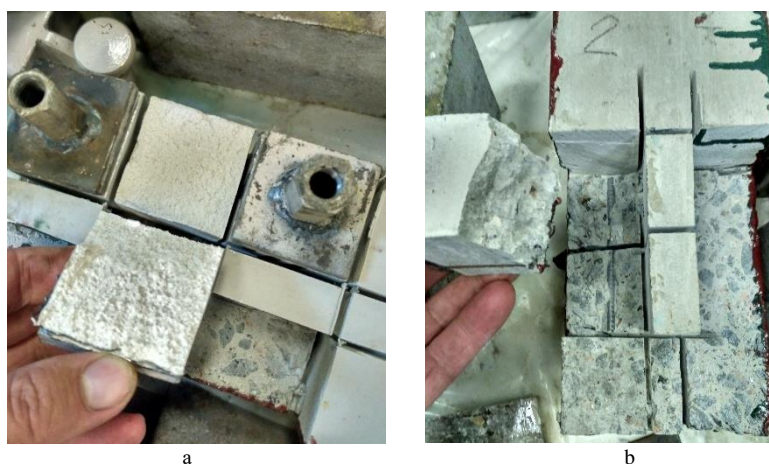
**Fig. 12.** Cohesive destruction: a – material in Mapecoat TNS Base Coat layers; b – concrete material of the bridge

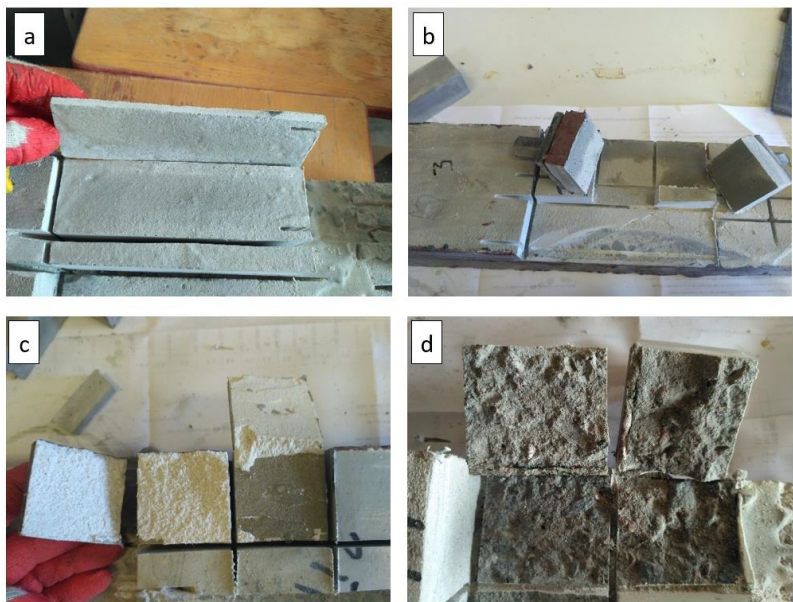
**Fig. 13.** Characteristic types of breaks in the materials of system solutions: a – detachment of Ceresit CD24 (5mm) when cutting sample No. 1; b – detachment of the Ceresit CD24 adhesive layer from Nivoplan Plus on sample No. 3; c – cohesive and adhesive rupture of the Mapecoat TNS system on sample No. 3a; d – cohesive destruction of the bridge concrete material when determining the adhesion on sample #2

After determining the adhesion of the cut samples covered with the Mapecoat TNS system, the remaining protective layers were cleaned and adhesion plates were glued to the surface of the samples. This action was performed to establish the bond strength of leveling layers that were protected by the Mapecoat TNS system during frost resistance tests. The results of these studies are given in Table 3 and figure 13.

Characteristic types of breaks in the material of structures are shown in figure 13.

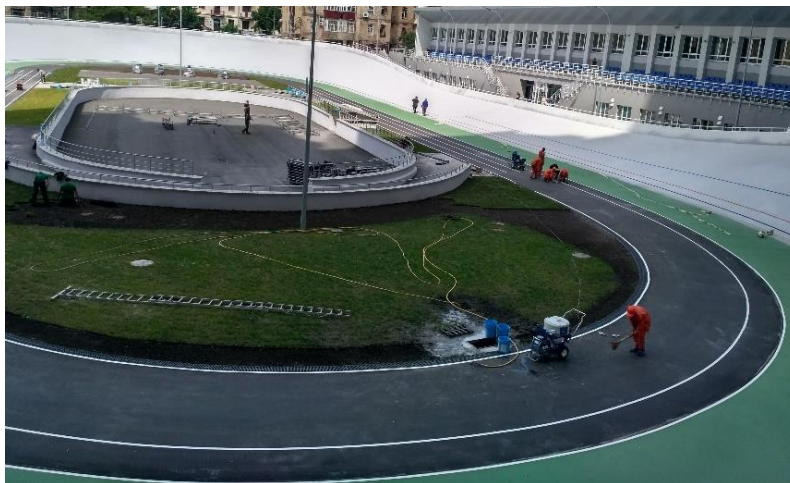
**Fig. 14.** The Kyiv is in the final stage of work.

After the reconstruction, the Kyiv Velodrome is 286 meters of concrete-surfaced bicycle track with a width of 8m in bends. The angle of maximum inclination is  $38^\circ$ ; transverse angle in a straight line –  $11^\circ$ ; the length of the transition curve is 21.5m; permanent turning radius – 21.7m; permissible speed – 73.58km/h. In the centre there is a ramp for performing tricks and around the perimeter there are several tracks with different surfaces [2].
