SEISMIC VULNERABILITY ASSESSMENT OF AN HISTORICAL UNREINFORCED MASONRY BUILDING OF THE XIXTH CENTURY: EL FETH HIGH SCHOOL IN BLIDA, ALGERIA

Keywords: School building; 19th century architecture; Unreinforced masonry "URM"; Seismic vulnerability; Macro element; Pushover analysis

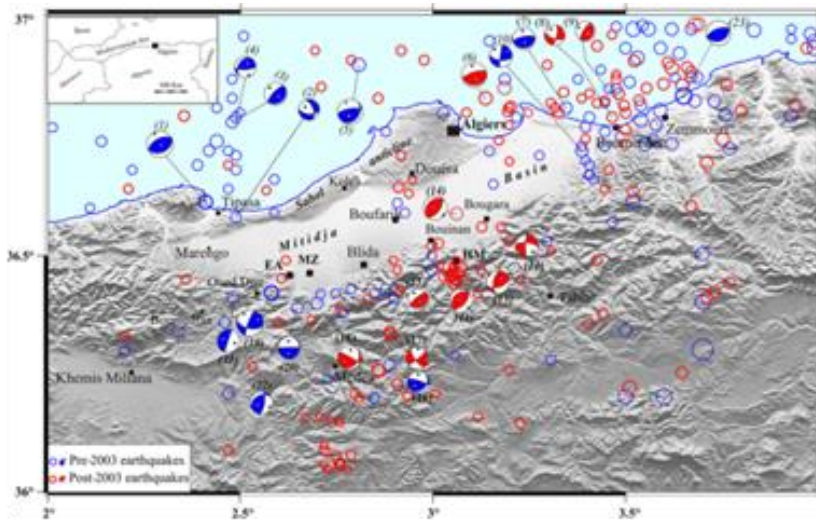
Fig.1. The spatial distribution of earthquakes from 1900 to 2014 (dark, $M \geq 4$: 1900–2003; light, $M \geq 3.5$: 2004–2014), after the continuous recording of Algerian seismic events by Center of Research of Astronomy, Astrophysics and Geophysics.

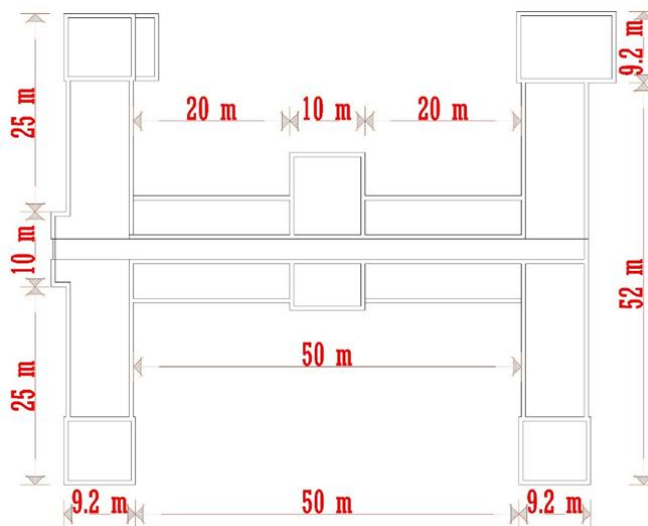
Fig. 4. Plan view of the El Feth High School. Source: Design office Bouras

The high school, built in the shape of an “H” (Fig. 4), is composed of two storeys and a roof space which stretches over the whole building (Fig. 5). The central building is easily identifiable and it links two almost symmetrical pavilions, punctuated with large evenly-spaced openings. It is of neo-classical style (Fig. 7) and is covered with a red tiled roof.

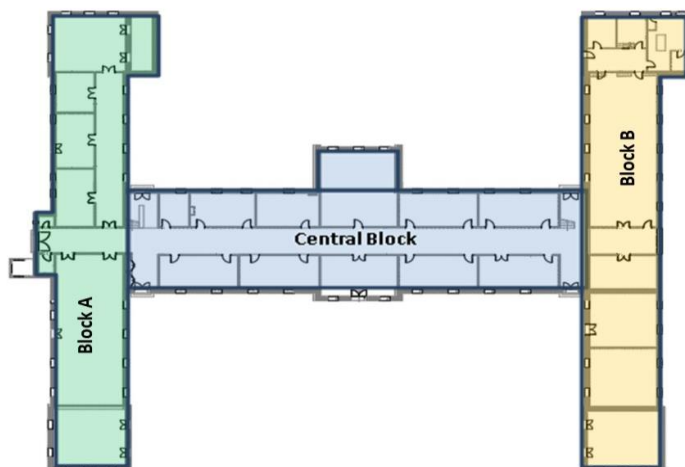
Fig. 5. Description of the plan.

- That the thrust along the -Y axis of the central block (Fig. 5) caused a rotation of the two blocks (A and B), which brings us back to our primary deduction in (section 2.1),
- The "H" is a shape that does not satisfy the standards of the current anti-seismic design, especially with the absence of seismic joints.

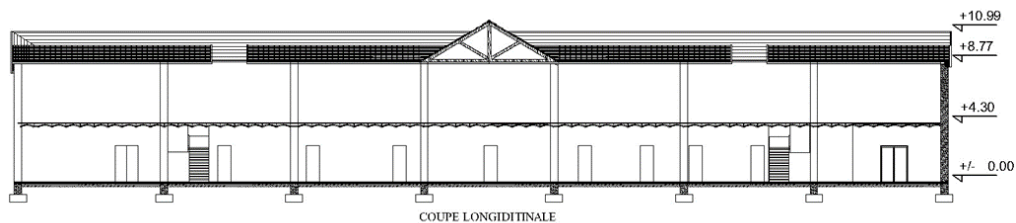
Fig. 6. Longitudinal section of the central block. Source: Design office Bouras

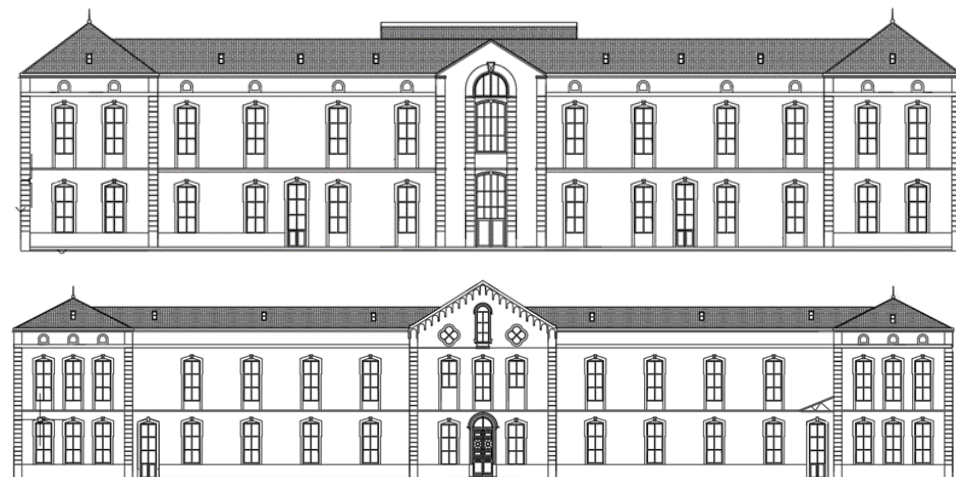
Fig. 7. The two main façade of the High school. Source: Design office Bouras

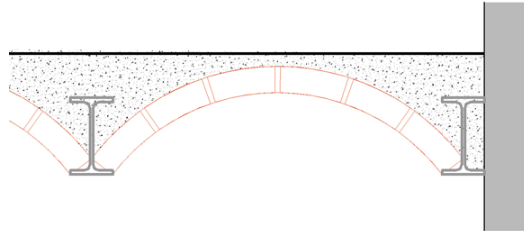
Fig. 8. Detail of vaulted floor. Source: The author

The ceiling of the first storey is made of a brick vault with metallic beams (see fig 8); the attic ceiling is wooden and is supported by metal profiles.

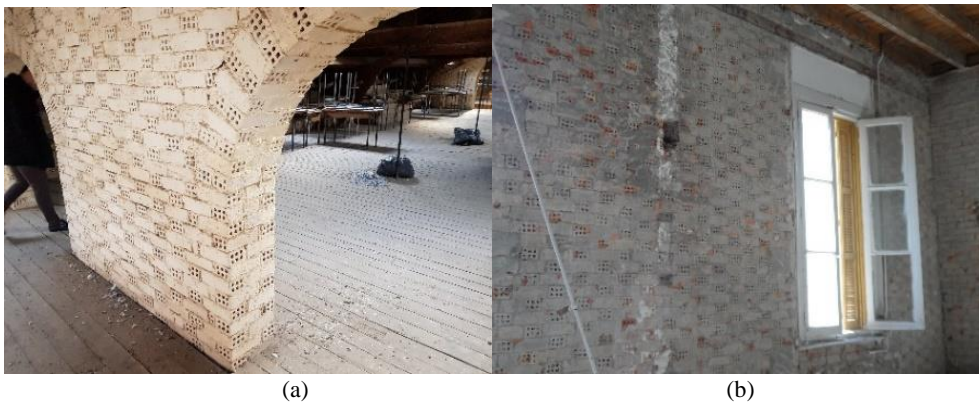
Fig. 9. Perforated, baked earth bricks: a) Secondary load-bearing wall; b) Main load-bearing wall

It is a structure of load-bearing masonry walls, composed of a rubble base and a wall of perforated, baked earth bricks (Fig. 10). There are two different wall thicknesses:

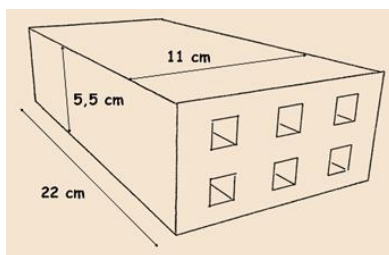
Fig. 10. Shape and dimensions of the hollow brick with 06 holes. Source: author

The dimensions of these bricks vary considerably. However, to make construction easier, builders everywhere make a connection between the three dimensions [24] using a ratio between the length, the width and the thickness (Fig. 10). In our object of study, the El Feth High School, the pattern most commonly found is that of the «Flemish bond». It consists of alternate rows of headers and stretchers (Fig. 8).

Designation	Length (cm)	Width (cm)	Thickness (cm)	Dimensions of holes (cm)	Volume including holes (cm ³)
Borie and Co Bricks, 06 holes	22	11	5.5	1.2·1.2	1331

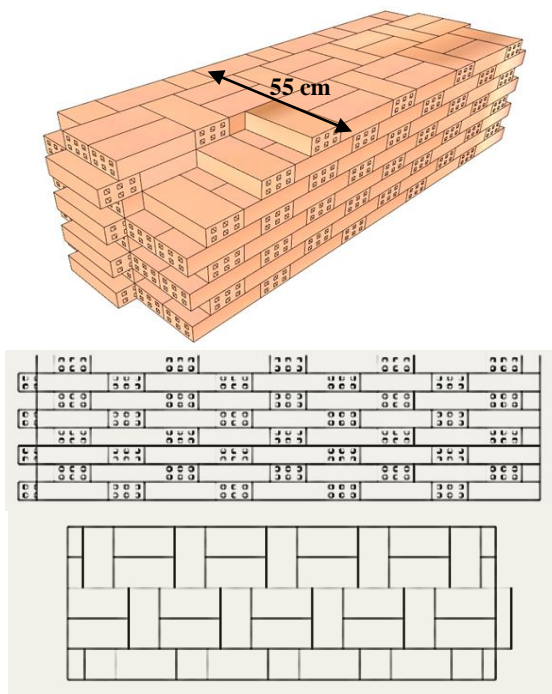
Fig. 11. 55cm thick main load-bearing wall device

- Facade wall: 55 cm thick (Fig 11)
- Shear wall: 38 cm thick

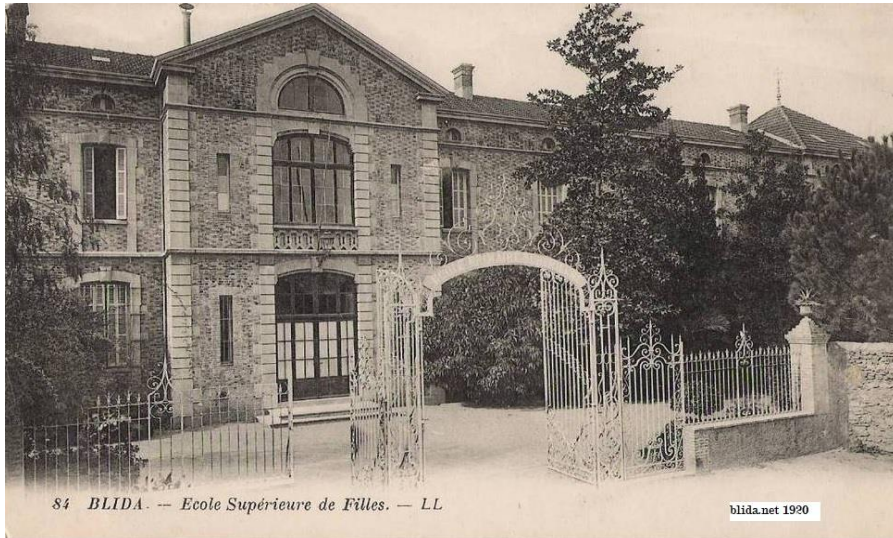
Fig. 12. The main façade without plaster shows the hollow and full faces of bricks on the original construction. Source: www.Blida.net [27]

It makes the creation of beautiful, decorative motifs possible, with a 10mm joint. In fact, the façades of the high school were, formerly, bare (not covered with mortar) (Fig. 12) and the play between the hollow and filled surfaces could be clearly seen.

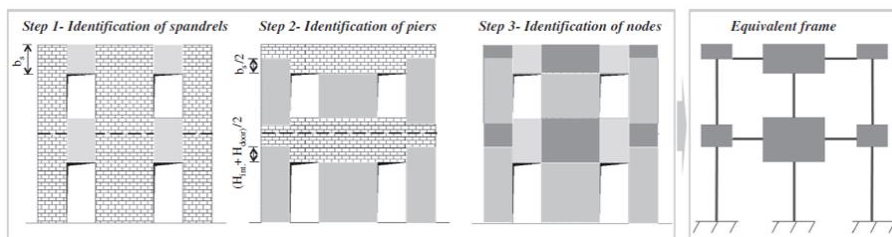
Figure 13 shows the basic steps in the idealization of the analogous frame of a masonry wall, marked by a regular distribution of openings: from the identification of posts and beams to that of the rigid zones.

Fig.13. Idealized image of analogous frames in the case of evenly distributed openings. Source: [30].

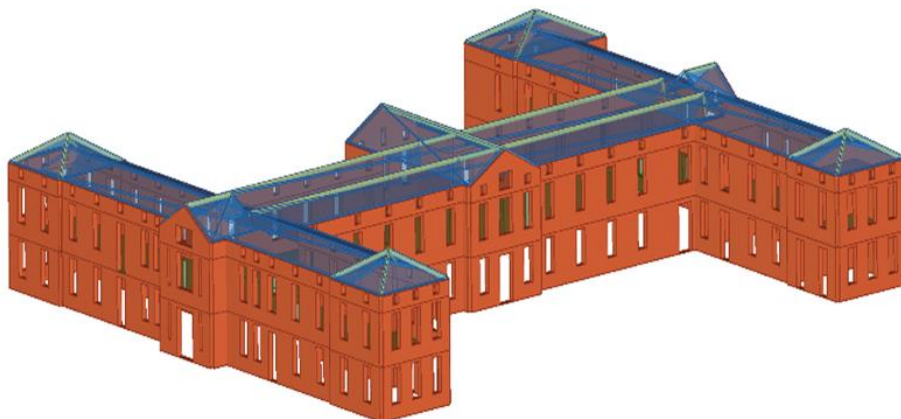
Fig. 14. Modelling of the model from the Tremuri software program

The modelling work was undertaken (Fig. 14) by using the Tremuri software program [30] (academic licence), developed by the company S.T.A DATA.

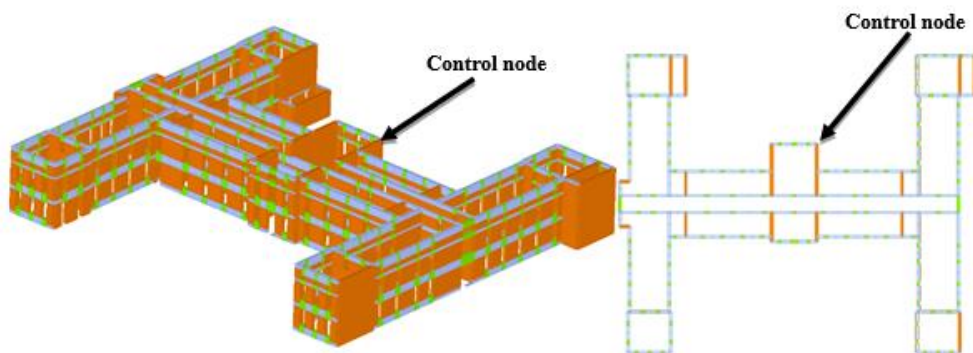
The three-dimensional structure of the building is transformed into an analogous frame model of three defined dimensions – Spandrel beams; Piers; Rigid elements – (Figs 15 and 18) by means of the software auto generation function.

Fig. 15. 3D model created by 3Muri [30]

The numerical model is composed of three types of macro-elements: pier elements, spandrel elements and rigid nodes (858 elements, 816 rigid nodes, that are rigid elements connecting the resisting elements “pier” and “spandrels”).

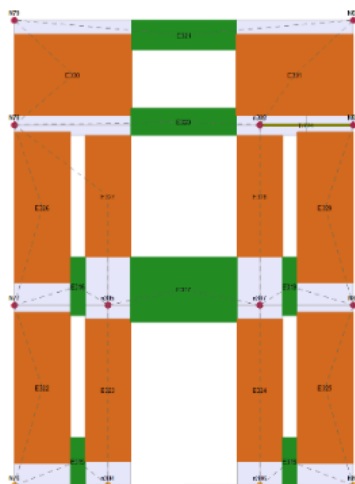
Fig. 16. Analogous frame of the load-bearing wall at the main entrance

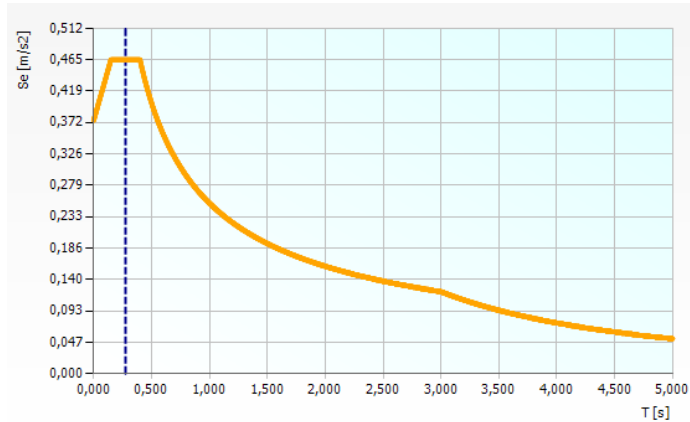
The following spectrum graph is the outcome of four factors: A (area amplification coefficient), D (dynamic amplification factor), Q (quality factor), and R. (behaviour coefficient). According to the RPA2003 code (Fig. 17), it indicates the connection between S_a/g and the period T (s).

Fig. 17. RPA 2003 Response Spectrum for the Site of El feth high school

In this paper, the spectrum response was calculated following the Algerian seismic code RPA 2003 [14], the 2008 version using equation (1). The spectrum response (Fig. 17) is determined based on the following concepts:

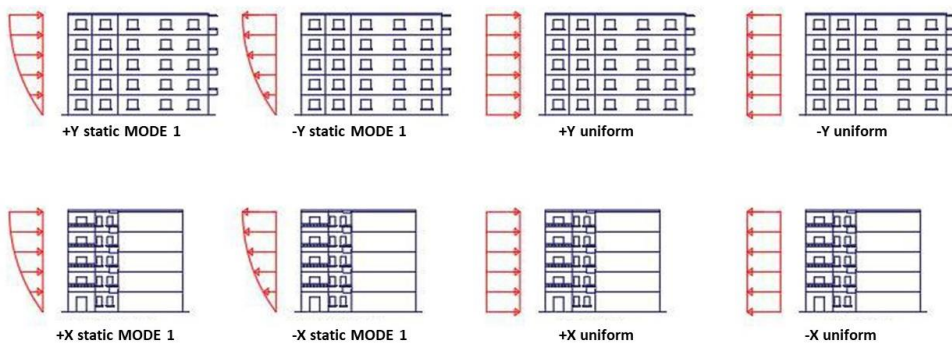
Fig. 18. Load patterns and different cases of pushover analysis, source: Hysenlliu [37]

According to *S. Lagomarsino and S. Cattari* [34] in pushover analysis, the structure will be load with a proper distribution of lateral loads that are gradually increased with the aim of “pushing” the structure into the non-linear field. Two load patterns are taken into consideration, first mode shape distribution based on the fundamental mode shape of the structure, and uniform load distribution to all stories as recommended by different authors for the N-2 and 3muri approach [34, 35]. The load shapes are proportional to mass; The principle consists in subjecting the structure to monotonic loading until it collapses which gives us a force

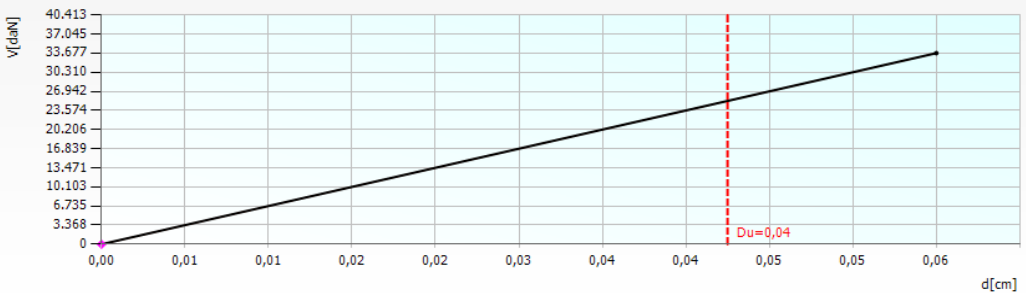
Fig. 19. Capacity curves, corresponding equivalent bilinear curves, and maximum available displacement D_u . Pushover in direction +X

In Figures 16 and 17 the capacity curve along the +X and -Y axis respectively represent the two most significant and unfavorable cases in our analysis, the ultimate displacement (D_u) as well as the bilinear curve is demonstrated.

The capacity curve shown in Figure 16 along the +X axis demonstrates that the maximum displacement (D_{max}) has exceeded the ultimate displacement (D_u), so we have $D_{max} = 0.39 \text{ cm} > D_u = 0.04 \text{ cm}$ with D_u being in the elastic sequence of the curve.

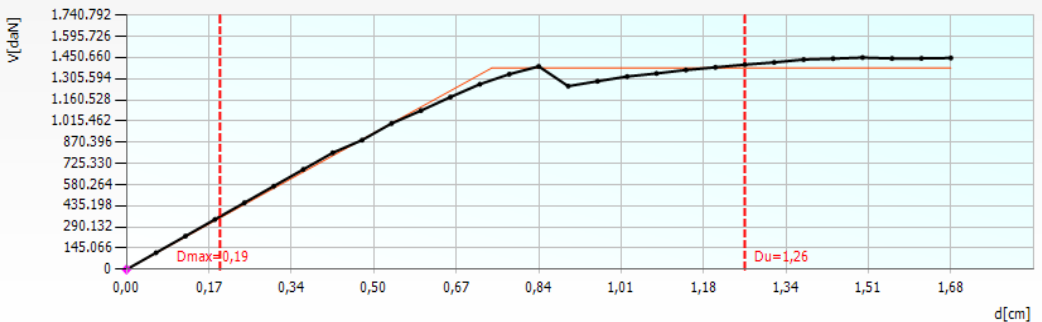
Fig. 20. Capacity curves, corresponding equivalent bilinear curves, and maximum available displacement D_u . Pushover in direction -Y

The capacity curve in Figure 20 indicates that the maximum displacement (D_{max}) of the structure did not reach or exceed the ultimate displacement (D_u) due to the elasticity of the structure in the -Y direction, because $D_{max} = 0.19\text{cm} > D_u = 1.26\text{cm}$, however, the walls were severely damaged. Figure 22 shows that the walls (P1 and P32) were only damaged by bending for the "spandrels" and "piers". However, there were bending failures of the walls (P11, P10, P16 and P6), cracks and shear failures occurred on the "piers" of the walls (P8, P16, P6 and P22). The walls (P11 and P16) show the presence of some failures during the elastic phase in the "piers" part.

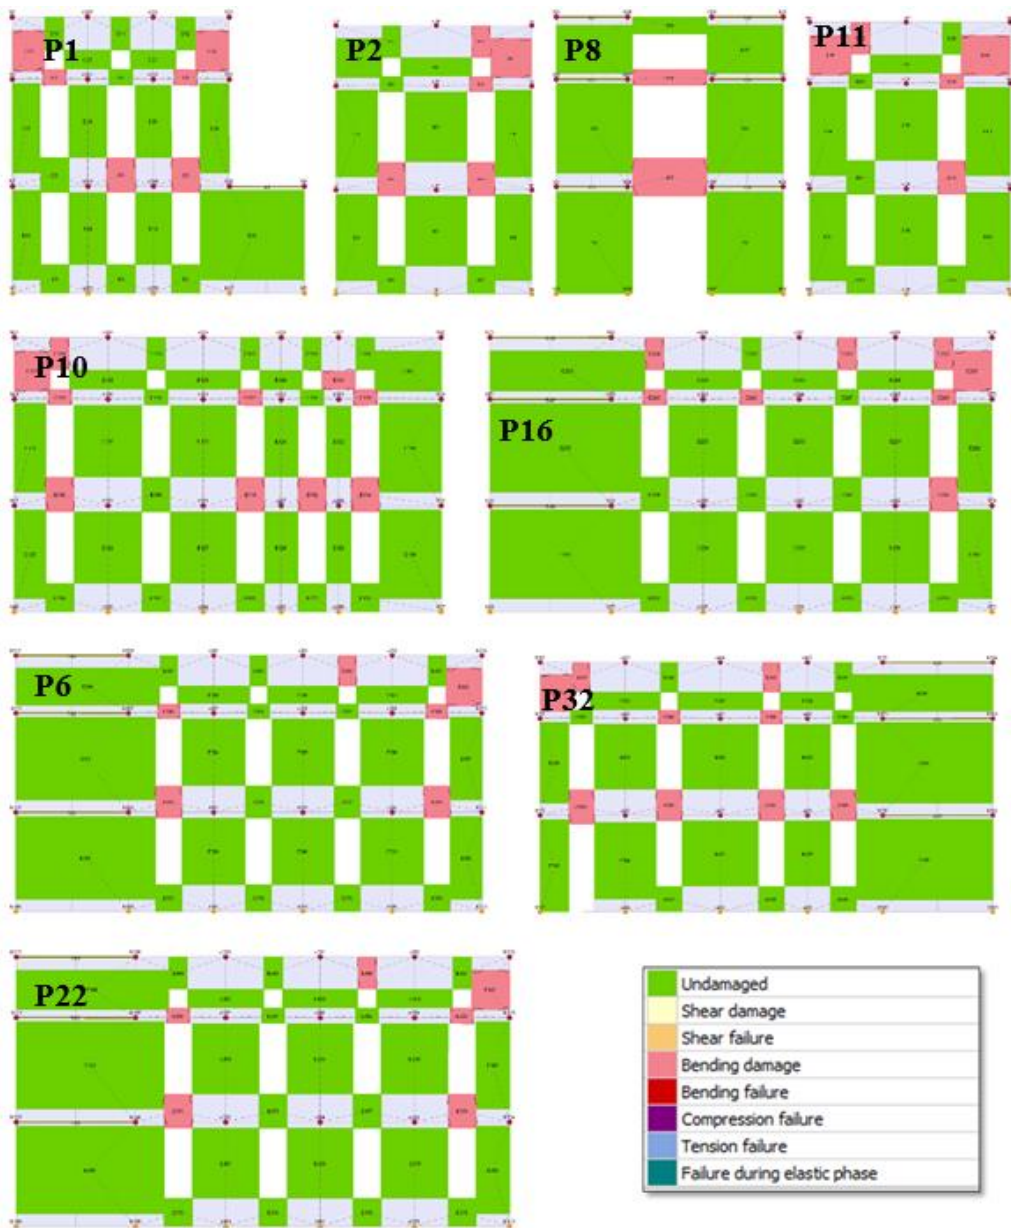
Fig. 22. Damaged walls after pushover analysis in direction +X

Figure 19 shows the damage to the main walls of the building, due to the rigidity of the building in the +X direction, the walls did not suffer any significant damage, although there was some bending damage to the spandrels and a little less to the piers, but the majority of the structure did not suffer any apparent damage.

Comparing figures 22 and 23, it can be seen that the same walls present in the two figures had totally different behaviours and damages, and therefore it can be supposed that the pushover analysis along the -Y direction is the most vulnerable.

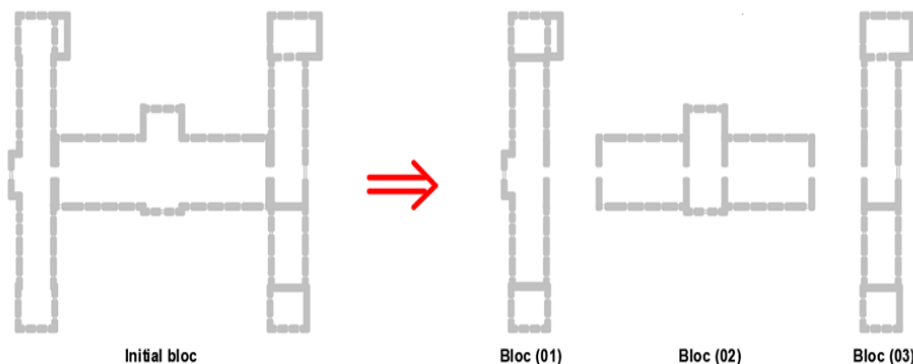
Fig. 25. Illustration of the separation into three blocks. Source: Author

1. All work will take place in the central block.
2. Cut from top to bottom a part of the wall (the part of the wall cut out = the dimension of the joint) of the central block which is 10cm.
3. Once the gap between the three blocks is obtained, a new load-bearing wall must be built on both sides of the central block
4. New load-bearing walls must participate in structural functions.

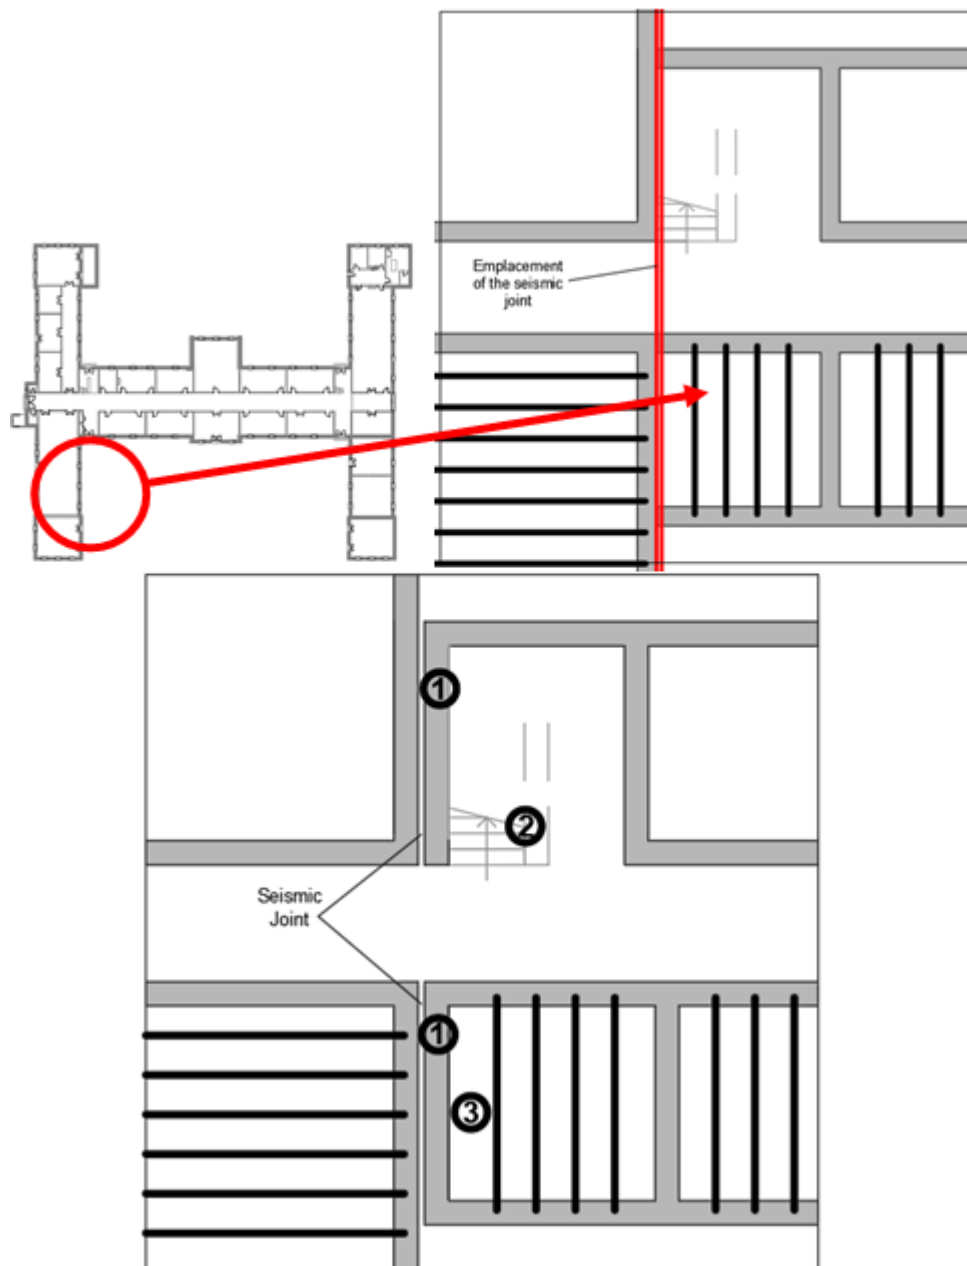
Fig. 26. proposed steps for the integration of the seismic joint between block A and the central block.

As shown in figure 26, the seismic joint will be executed at the junction between the centre block and blocks A and B. The first step would be to build a new wall (1) with the same physical and mechanical properties as the old one (55cm thick hollow brick). In the northern part of the building, we find a staircase (2) built-in stone that is not participating in the structural behaviour, so it must be demolished and rebuilt after the construction of the wall (1) (Fig. 27).

In order to proceed to the detachment of the two blocks by a seismic joint, with a maximum thickness of 15cm, the wall (1) must be finalized and connected with the IPN profiles of the vaulted floor (3) to make it participate in the support of the vertical loads.

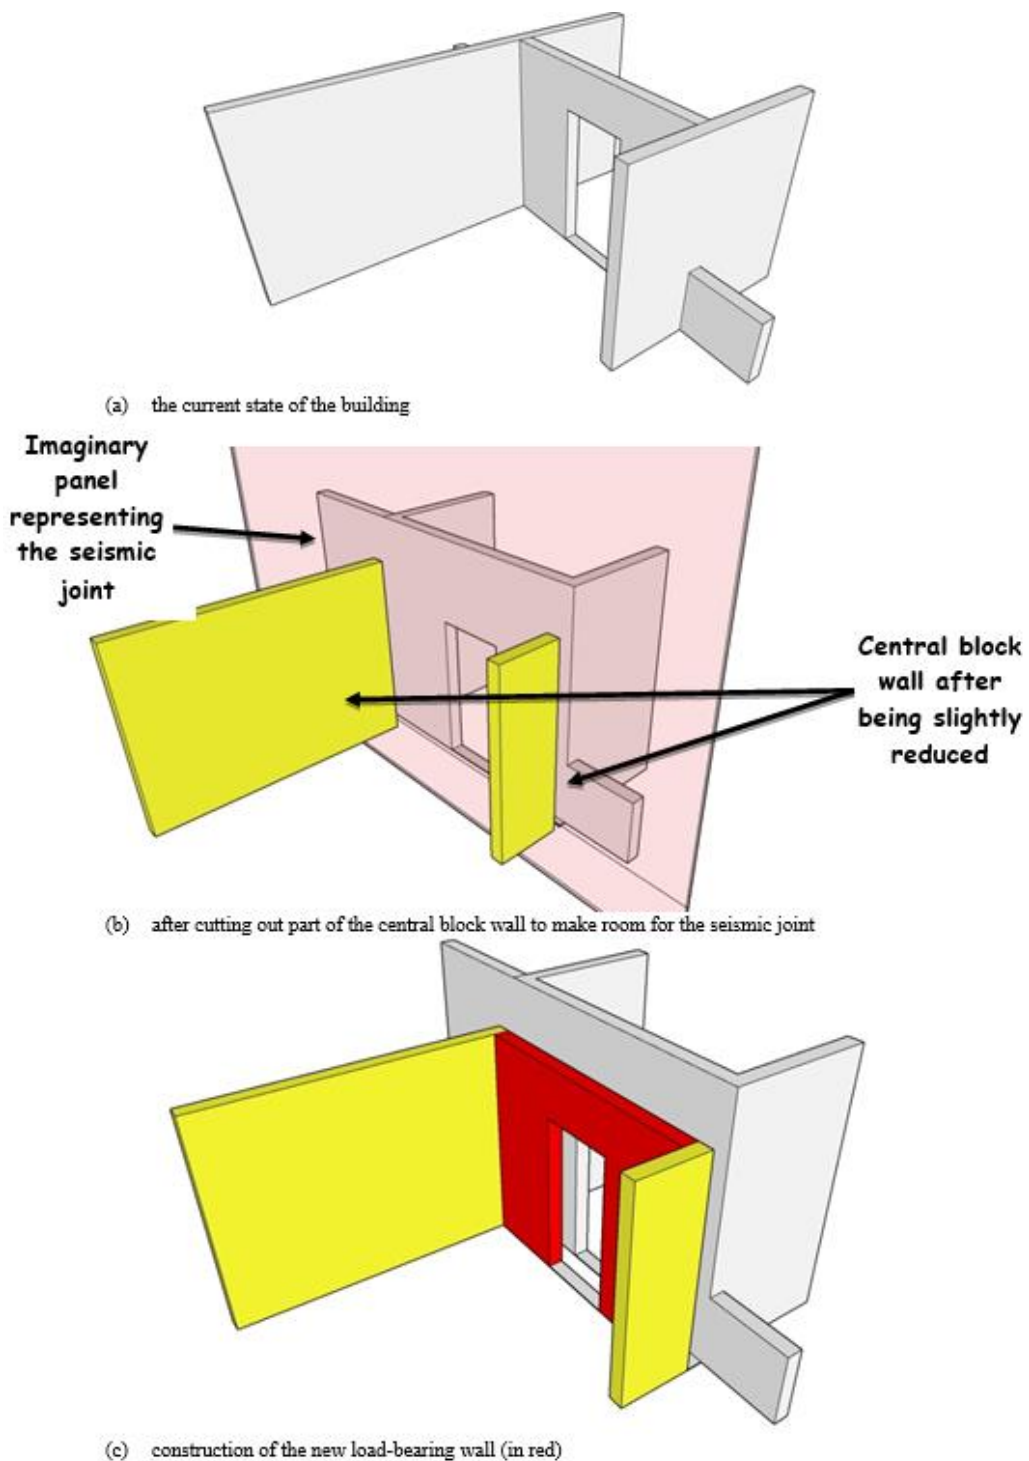
Fig. 27. Sketch of the integration of a seismic joint that will separate O2 blocks.

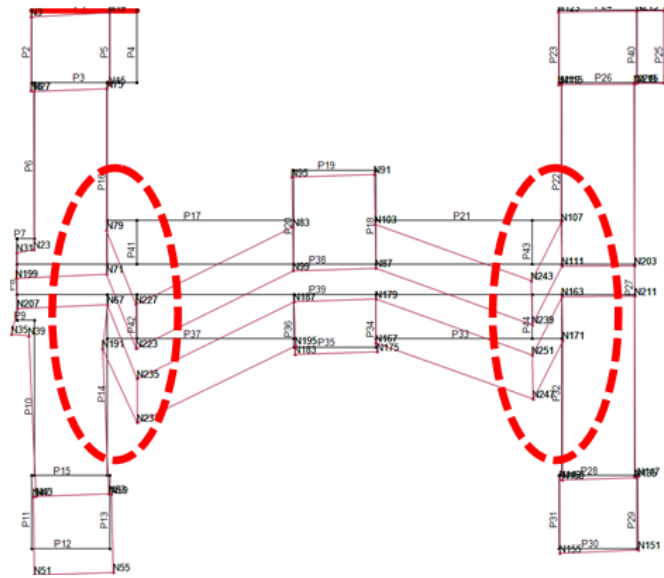
Fig. 28. Distorted plan in direction -Y

A comparison of the two drawings in the (Fig 28 and 29) shows a clear improvement in the behaviour of the central block at the re-entrant corners with and without a fracture joint, which considerably reduces the deformation and in-plane damage of the walls and eliminates the torsional movement of blocks A and B caused by the distortion of the central block.

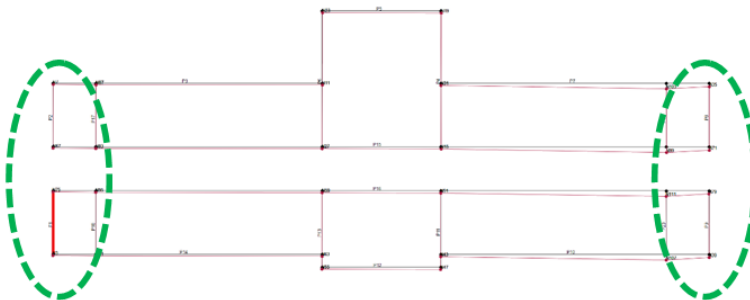
Fig. 29. Distorted plan of the central block in -Y direction
