STRUCTURAL AND TECHNOLOGICAL ASPECTS OF CONSERVATION OF STREET ART ON BUILDINGS DAMAGED DURING THE WAR

Abstract

Keywords: Street art; Strengthening of structures; Conservation; Destroyed structures; Dismantling technology

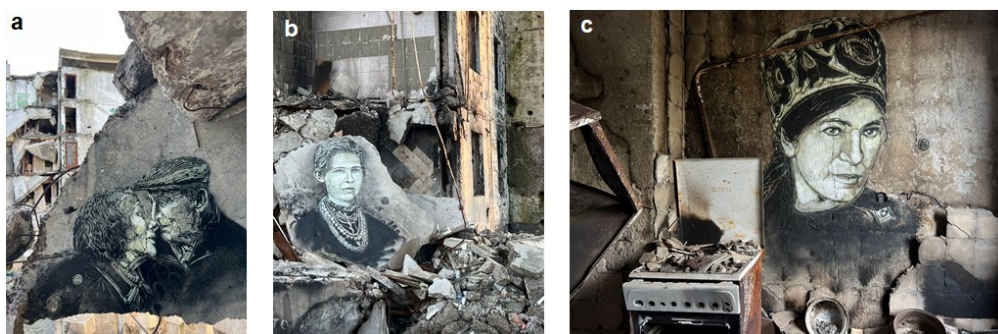
Fig. 1. Mural Christian Guemy in Borodyanka and Bucha. [Photo by Christian Guemy]

For example, the works of the French street artist Christian Guemy, working under the pseudonym C215, appeared in Borodyanka (Fig. 1a and b) and Bucha (Fig. 1c). These works are classified as artistic graffiti with historical and social significance. But the territorial reference – the exhibition – in these works is expanded to the scale of the city and country. The graffiti discussed below, according to the authors, can be exhibited simultaneously as an associative triptych “Faith. Hope. Love”.

An elderly couple kissing on a piece of debris (Fig. 1a) hanging over the collapsed ceiling of a building is a reminder to the author of faith in oneself and those around you. The

portrait of Lesa Ukrainka, an outstanding Ukrainian poetess (Fig. 1b), does not have an individual basis for the city of Borodyanka. Here it is rather a message for the whole country in the context of L. Ukrainka's poem "Hope". These two fragments could technically be removed from the ruins and moved to a safe area for conservation. The portrait on the wall of the apartment (Fig. 1c) is a direct association of place and time. Shown here is fashion designer Lyubov Panchenko, an honorary citizen of the city of Bucha, who died in 2022 during the Russian occupation. The project to preserve this graffiti requires a preliminary survey.

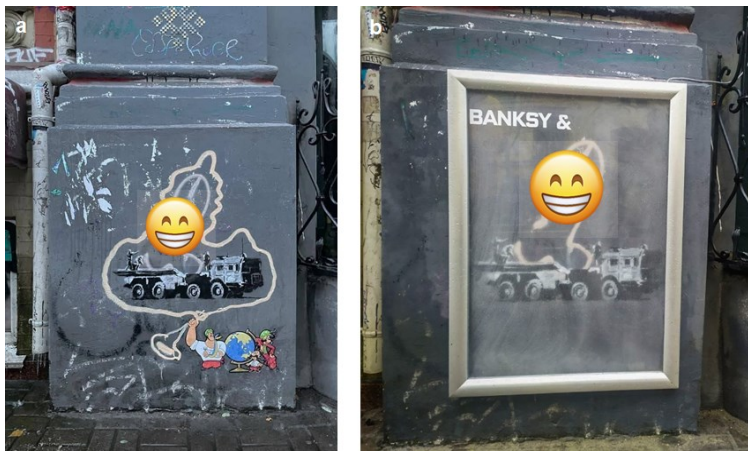
Fig. 2. Mural Banksy at Velyka Zytomirska street in Kyiv.
[Photo by t.me/kyiv_polit, V.Kolyakova, 2022]

The house on the base of which is a drawing was built more than a century ago. The building is brick. The basement pylon of the foundation protrudes from the plane of the facade. In addition, there is a water intake pipe at the corner of the pylon. The geometric shape of the

pylon promotes (Fig. 2a) active moistening of the top plaster layer. All these facts indicate increased humidity of the surface of the base during seasonal precipitation. In this regard, it is proposed to use an improved design of the protective frame (Fig. 3b).

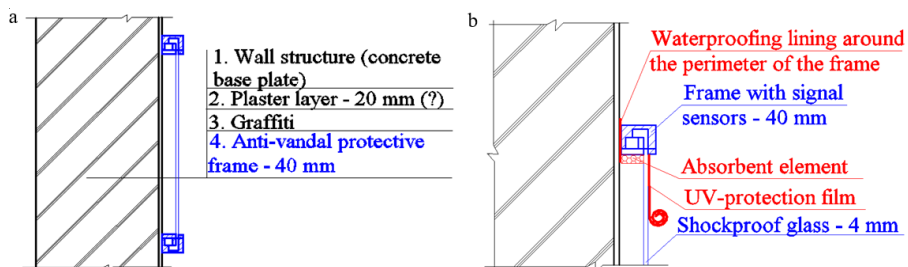
Fig. 3. Protective screen design: a – installed; b – recommended

In the case of Kyiv graffiti, it is proposed to use an absorbent in the protective structure of the frame. The design of the frame holding anti-vandal glass and security sensors is supplemented along the internal perimeter with an absorbent tape made of non-woven material or a plastic box with differentiated holes for loose absorbent (Fig. 3b). In this case, a simple modification of the protective structure allows you to avoid a significant number of problems and increase the durability of the protective screen. Even though the graffiti is located at a height of no more than 90 cm from the sidewalk, the wall is very illuminated in the spring and autumn. Additionally, for a stationary (long-term) display of graffiti, glass with a UV filter should be used or the existing one should be upgraded by gluing an oxide film (Fig. 3b).

In addition to the provided anti-vandal glass in the frame, which must fit tightly to the surface of the building's base, it is necessary to take measures to reduce humidity on the surface of the plaster layer [36]. For this purpose, it is necessary to install deep penetration waterproofing along a closed perimeter around the graffiti. Penetrating waterproofing prevents water under pressure from seeping through layers of concrete, brick or plaster and simultaneously increases the chemical and corrosion resistance of materials to many aggressive compounds, including precipitation. Many modern waterproofing compounds can increase the frost resistance of the base material and this is very important in the climatic zone of Kyiv.

To neutralize the negative phenomenon of condensation, two main methods are used: drying and ventilation. Practice shows that to protect graffiti, the second option in its simplest form is more often used. A transparent polycarbonate, acrylic or glass sheet applied to the graffiti is mechanically attached to the base through special stabilizing pads. This technique allows you to avoid bending the protective screen made of rigid non-plastic materials and additionally creates a gap between the surfaces of the base and protection, where micro-flows of air are formed, the speed of which is sufficient to dry the condensate.

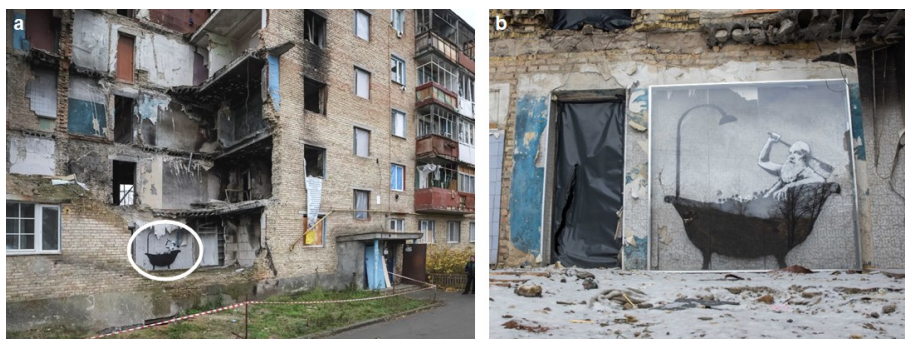
Fig. 4. Mural Banksy in Gorenka. Photo by G. Garanich (Reuters), H. Shpakova: a - November 2022; b - after installing the protective screen, February 2023

The proposed measures to improve protective screens are quite applicable to other graffiti. But... The work discussed above is located on a building that was not damaged by military operations. Works in the Kyiv region was created on the ruins of residential buildings (Figs. 4 and 5). Preserving any of this graffiti requires an individual approach. For example, the graffiti "Man in the Bathroom," is located on the first floor of a destroyed entrance in a five-story residential building (Fig. 4).

The final decision on the restoration of the house has not been made. Options for partial or complete demolition of the building were considered. The difficulty of preserving the work lies in the design features of the base - artistic wallpaper on a paper basis, a plaster layer, brickwork. To ensure the stability of the base of the plaster layer, silicate-impregnating compounds can be used, injected from the side of the brick wall opposite the graffiti [38]. To maintain the solidity of the masonry during dismantling, it is necessary to create and use a special frame bandage made of rolled steel. But a simpler option is also possible - removing the wallpaper and fixing it on a rigid base. This technique requires a more thorough examination.

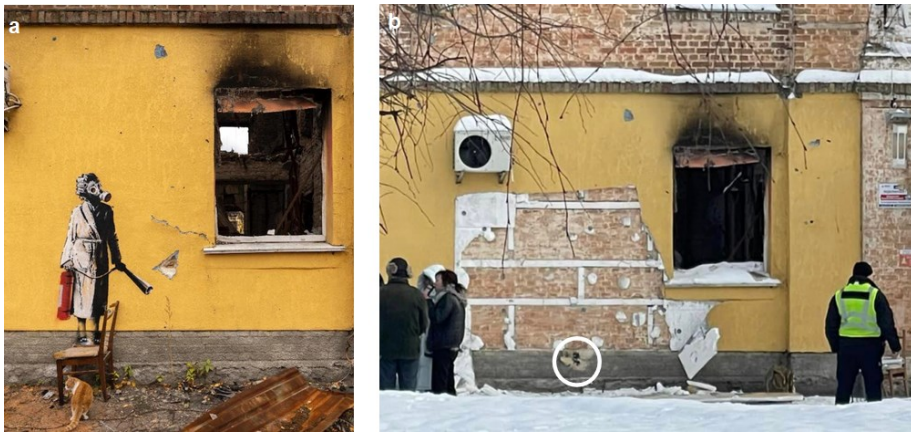
Fig. 5. Mural Banksy in Gostomel [Photo by PA MEDIA, by t.me/Andrii_nebytov, 2022]

An example of dismantling graffiti without a base structure was another notorious work by Banksy in Gostomel - "Woman with a Fire Extinguisher" (Fig. 5). The graffiti was painted on a foam-insulated wall (Fig. 6a). The work was cut from the wall of the house by volunteers who wanted to preserve it. However, their enthusiasm was not shared by law enforcement officers. There is an indictment against the thief. The work itself is located in the Gostomel village council.

The relative ease of dismantling the base can be explained by technological violations during the insulation of the facade. When attaching the insulation layer to the brick wall, the adhesive solution was applied in fragments (Fig. 5b). The structural diagram of the insulated wall is shown in Figure 6a. If the technology for fastening sheet polystyrene foam insulation is followed, it is impossible to dismantle the base with intact sheets. "The Restorers" were lucky in a certain sense.

Unfortunately, we must state the fact that this graffiti was damaged. Compositionally, the work can be called an installation, since its part included not only burnt windows and walls, but also a chair on which the woman “stood” (Fig. 5a). After dismantling the graphic part, a fragment of the image of the lady’s legs remained on the base of the house (Fig. 5b).

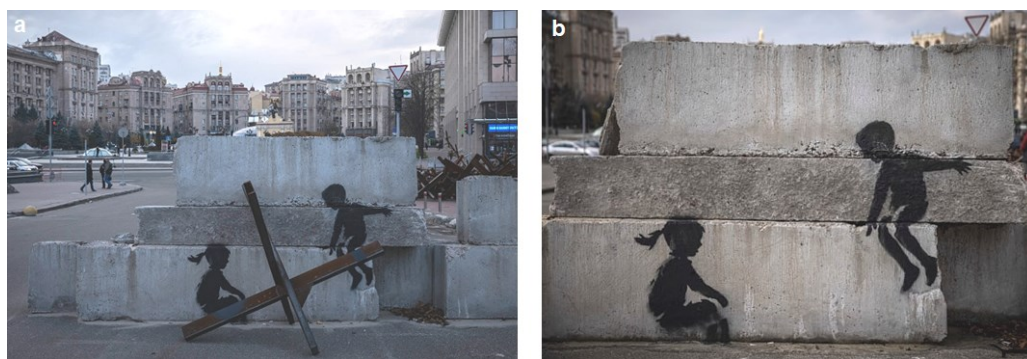
Fig. 7. Installation in Kyiv. Photos by Ed Ram, H. Shpakova, 2022-2023

Another unique installation is located in the very center of Kyiv - “Swing” (Fig. 7a). The graphic part drawn on massive concrete foundation blocks plays up the metal anti-tank hedgehog standing nearby. The author’s stylistic idea is grandiose - “Life goes on against the backdrop of what threatens death.” A change in one of the components in space leads to the loss of any semantic load and, as a consequence, the artistic value of the art object (Fig. 7b).

The complex relocation of this installation can be carried out in several ways: from simple dismantling of individual elements with their subsequent assembly according to risks at the place of exposure to combining the elements. For the second option, a schematic diagram of combining foundation blocks into a single structure has been developed (Fig. 8). It is proposed to combine the functions of a connecting and installation anchor: the through hole is reinforced

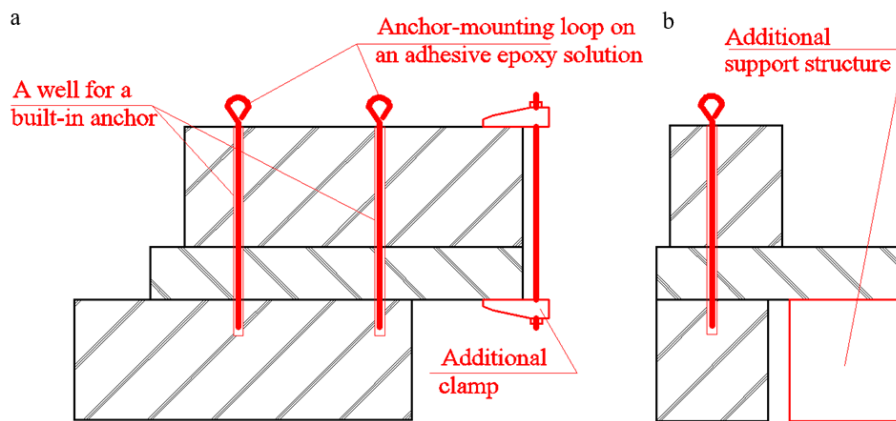
Fig. 8. Schematic diagram of fastening blocks into a single array:
a - front view; b - side view.

with a steel rod and filled with chemical anchors based on epoxy solutions. The resulting connection has sufficient strength. Clamps, friction grips for installation and retaining concrete blocks can be used as additional (safety) means.

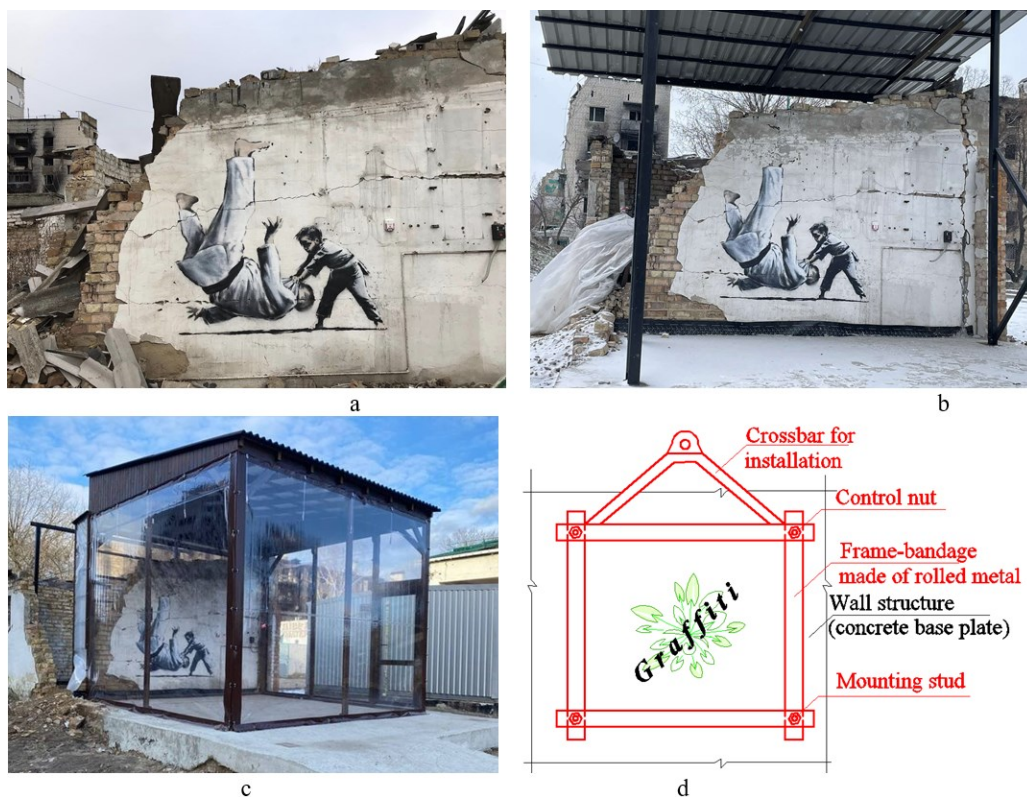
Fig. 9. Protective structure over the graffiti «Judoists» in Borodyanka: a - november 2022; b - february 2023; c - march 2023; d - schematic diagram of a frame-bandage for a fragment of a wall – front view.

The soil base of the work is a paint (lime) mixture for use in interior spaces (internal wall), its physical and chemical properties do not meet the requirements of normal operation in the climatic conditions of Ukraine as for external structures. Therefore, with the beginning of the winter period of 2022-2023, the issue of preserving the work has become very acute. To avoid direct dampening of the graffiti brick wall structures and limestone base, a metal frame for the canopy made of profiled metal was erected (Fig. 9b). Subsequently, to minimize the influence of air humidity and provide anti-vandal protection conditions, a transparent latex fence was installed (Fig. 9), which does not interfere with the view of the exhibition [4, 39].

Therefore, a supporting frame made of rolled steel was proposed, designed and installed. Figure 9d shows a schematic diagram of a frame bandage that can support an element on both sides. To do this, fixing pins are passed through the drilled holes in the element, tightening the frames, and compressing the structure mass. To preserve the integrity of the array and the surface quality of the graffiti, measures are taken to stabilize its chemical state and protect it from minimal mechanical damage (Fig. 6b). For the "Judoists" project, a bandage frame was used and installed on the back side of the graffiti. This decision is due to the condition of the base - a brick wall, which has deviations from the vertical axis [38].

With the onset of the spring-summer period, sharply negative consequences were expected, associated with heavy aggressive precipitation in the form of rain, likely a sharp increase in air temperature and high levels of UV radiation. It should be noted that in this case, they abandoned the technology of preservation with a protective screen, as was done for other art objects, since the entire structure of the wall is subject to destruction, and therefore requires comprehensive conservation [40, 41].
