MODERN RESTORATION METHODS FOR DAMAGED HISTORICAL BUILDINGS AS A RESULT OF MILITARY AGGRESSION. CASE OF EDUCATIONAL INSTITUTIONS

Oleksandr MOLODID^{1,*}, Volodymyr SKOCHKO¹, Ruslana PLOKHUTA¹, Olena MOLODID¹, Ivan MUSIIAKA¹, Sergii BENDERSKYI¹, Sergey BOGDAN²

¹ Kyiv National University of Construction and Architecture, 31 Povitroflotskyi Avenue, Kyiv, 03037, Ukraine

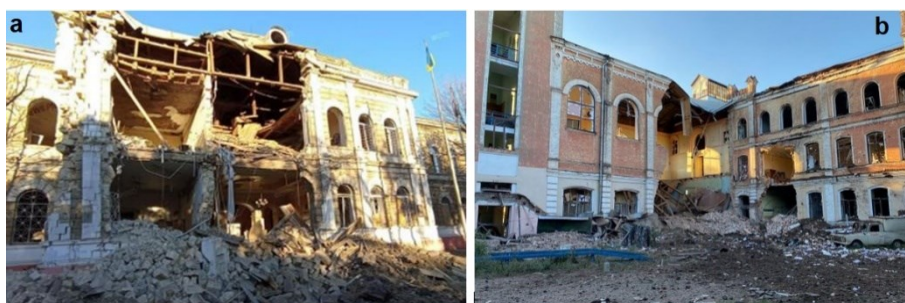
Fig. 1. Examples of historical buildings of educational institutions that were destroyed as a result of the Russian aggression against Ukraine: a – The Mykola Arkas First Ukrainian Gymnasium (Mykolaiv) [<https://nikvesti.com/ru/news/photoreportage/259158>]; b – building of Kharkiv Petro Vasylenko National Technical University of Agriculture (Kharkov) [<https://culturecrimes.mkp.gov.ua/?p=3248>]

A significant part of the damaged and destroyed educational institutions are buildings of historical and cultural significance and architectural monuments (Figs. 1 and 2). Russia has been systematically destroying the historical and cultural monuments of Ukraine, even though it is a party to the "Hague Convention for the Protection of Cultural Property in the Event of Armed Conflict" (The Hague, 1954) [1].

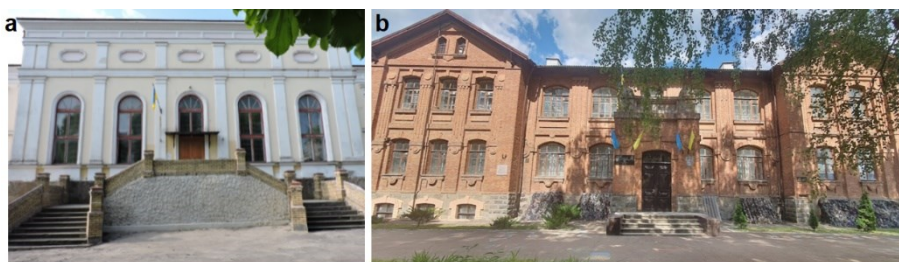
Fig. 2. Examples of historical buildings that were damaged as a result of military actions, in particular from explosive (dynamic) impacts either from rockets or UAVs: a – Zolochiv school No. 1, Lviv Region 1; b – Onufriiv Lyceum (building No. 1), Kirovohrad Region

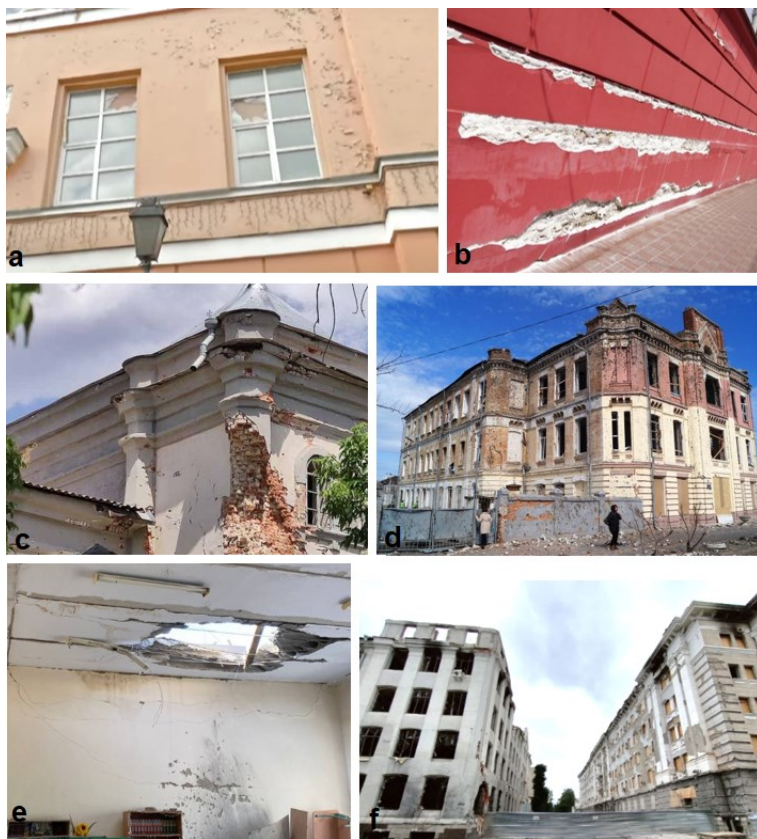
Fig. 3. Damage to structures of historical buildings of educational institutions: a, b, d, f – damage to facades; c, d, f – damage to masonry walls; e, f – damage to floor slabs; f - damage to the roof structures; namely: a-b – The main building of the Taras Shevchenko National University of Kyiv; c - Borivske Church of St. Nikolas, Luhansk region; d - Kharkiv School No. 7; e - Vysokopil Lyceum, Kharkiv Region; f - V. N. Karazin Kharkiv National University [https://www.5.ua/kyiv/raketnyi-udar-po-kyievu-naskilky-sylno-postrazhdav-universytet-imeni-tarasa-shevchenka-290134.html; https://culturecrimes.mkp.gov]

The team of authors conducted an examination of a number of buildings of educational institutions that were damaged as a result of the military aggression. It also included historical and architectural monuments, which were not directly damaged as a result of active military actions at the frontline, but were hit with missiles/UAVs from the distance. According to the results of the mentioned surveys and available information, it can be stated that, usually, damage to buildings and structures is caused by blast waves in this case. The degree of their impact on buildings often depends on the location of the building to the epicenter of the explosion [6]. In the case of close proximity to the epicenter of the explosion, the damage is characterized by visible destruction or significant damage to the structures of walls, partitions, ceilings and roofs, and numerous fragmentary damages to the facade (Fig. 3).

Visible damage to buildings located at a certain distance (approximately 300m or more) from explosion epicenters usually includes destruction and damage to window, door fillings, and frames (Fig. 4b); shrapnel damage to external and internal finishing; shrapnel damage to the roof (Fig. 4a) etc. Such damage should be repaired in initial stages, because the roof and windows are a protective barrier against the external environment impact on the building (precipitation, wind, temperature changes etc.).

In case of restoring the stonework of the structures of historical buildings (for example, as shown in Figure 3c) caused by numerous shrapnel damage, the impact of the blast wave, fires caused by explosions etc., then the following technological operations should be followed - first, perform unloading structures to be restored; if necessary, dismantle the masonry; clean structures from fragile, restructured, contaminated outer layers; to restore the geometric section, it is necessary to use special solutions and substitutes that are similar to the original material of the structures (bricks from destroyed parts, or those that are similar in quality and dimensions to the original); if there are cracks and voids in the masonry, inject them with special repair solutions; if necessary, strengthen the masonry by inserting high-strength rods into it or arranging external reinforcement, taking into account minimal intervention in the structure; carry out further finishing (if necessary).

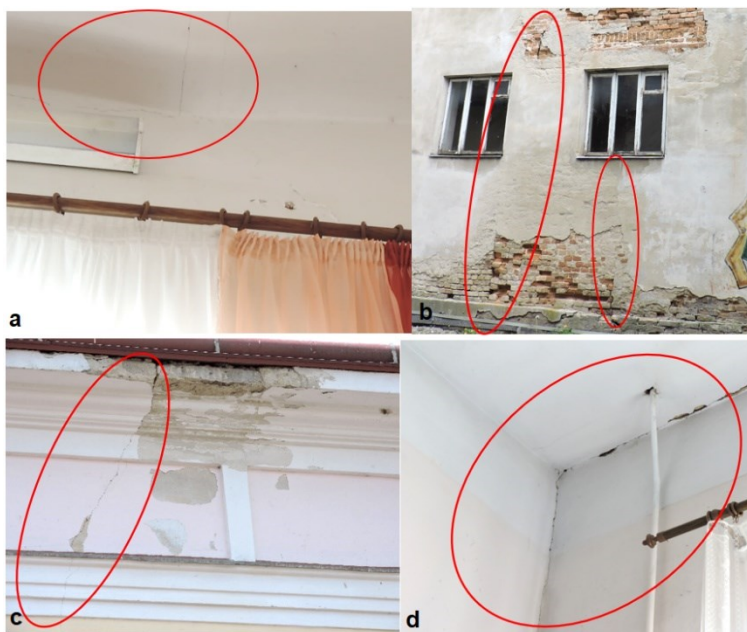
Appearance of cracks in structures could be often observed after blast waves (Fig. 5). Usually, cracks appear at the junctions of vertical elements, walls and ceilings, floor structures, or within window and door openings etc.

Fig. 5. Occurrence of cracks after dynamic explosion impacts: a – in the joints of floor slabs; b, c – in the walls; d - in the joints of the walls and ceiling, where: a - Onufriiv Lyceum (building No. 1), Kirovohrad region 1; b, c, d – Zolochiv school No. 1, Lviv Region

Damage like cracks can be eliminated by injecting and impregnating them with special repair solutions, replacing bricks of the masonry (in the case of significant cracks), or installing additional reinforcement elements [8].

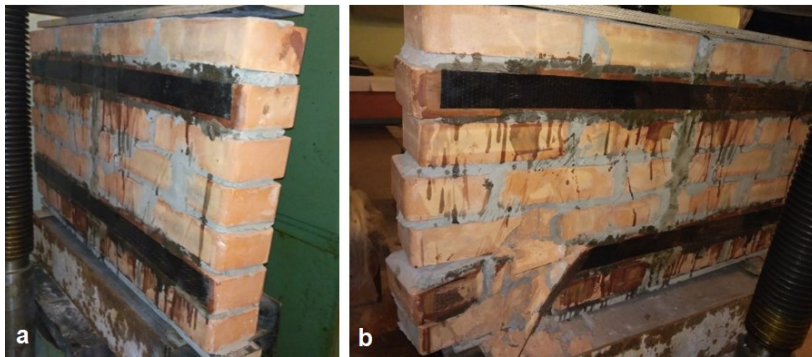
There were a number of experimental studies performed to verify the effectiveness of the given method of strengthening damaged walls [12] (Fig. 9). Their main goal was to strengthen fragments of brick walls by gluing carbon fabrics (FRP) with further determination of their bearing capacity. Reinforced or unreinforced (control) fragments of wall structures were installed on two supports at the edges and a concentrated force was applied to the center of the walls until the moment of their destruction.

Fig. 9. Experimental studies of brickwork reinforcement with carbon fiber:
a – reinforced wall before the start of the experiment; b - the wall after the bending strength test

The obtained research results showed an increase in the bearing capacity of reinforced structures compared to unreinforced ones from 3.8 to 6 times, depending on the method of strengthening (Fig. 10). Hence, according to experimental research, the method of strengthening walls with high-strength fabrics is quite effective and can be used to strengthen historical school buildings.

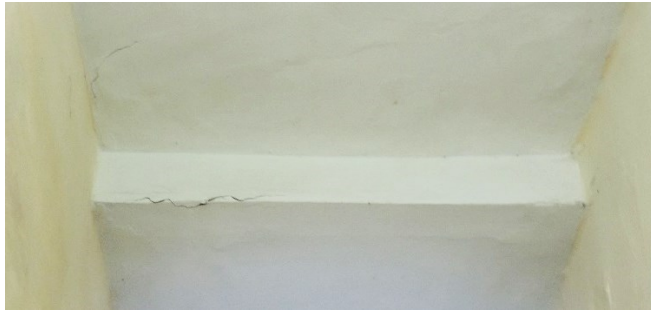
The ceilings is one of the core elements that requires the restoration of serviceability as a result of shrapnel damage, the influence of dynamic or minor thermal loads that occur during military operations (Fig. 12). In historical buildings, wooden or metal beams, reinforced concrete slabs and beams were used as ceilings.

Fig. 12. Damage to the floor beam due to the impact of the blast wave, Zolochiv school No. 1, Lviv Region

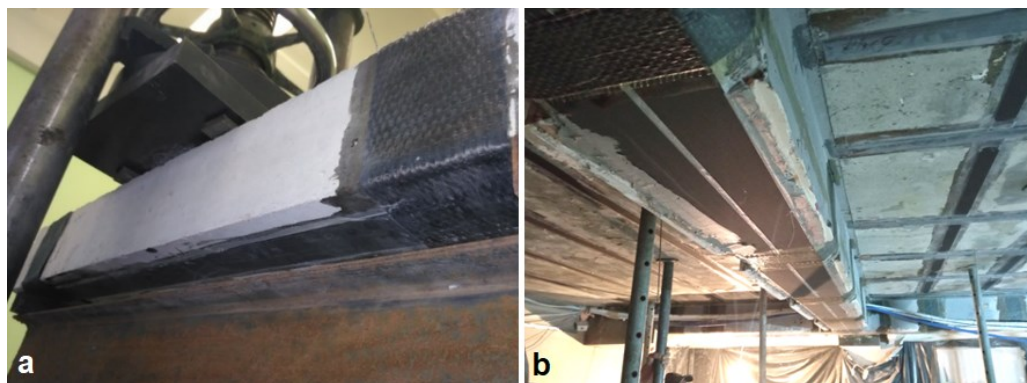
Numerous experimental studies of the specified method performed by the co-author of the publication [12] proved that applying external reinforcement to span structures (beams, webs, slabs) is an effective way of strengthening them, which allows to increase the bearing capacity of the structure by almost 4 times. At the same time, one of the most significant parameters of such strengthening of building structures, especially during the restoration of historical buildings, is that the geometric characteristics of the reinforced structures do not change. It is important that the mentioned experimental studies (Fig. 13a) were repeatedly tested in natural conditions during reinforcement of reinforced concrete structures and such solutions proved themselves from the positive side for a long time (Fig. 13b). That is why this method of strengthening can be recommended for use in repair and restoration works on historical buildings, in particular, and at educational institutions.

Fig. 13. Span structures reinforced with high-strength carbon materials (FRP) : a - reinforced concrete beam in the process of experimental research (mounted on a press before testing); b – reinforcement of the beam slab of the floor at the construction site

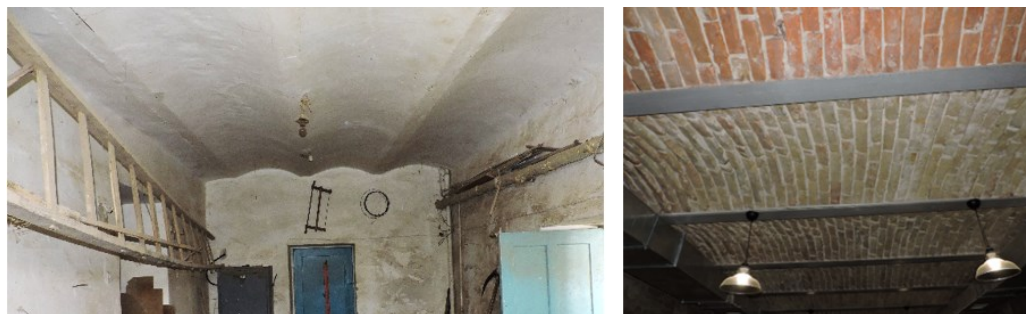
When strengthening metal structures (for example, beams of the ceiling) of historical buildings (Fig. 14), which could be damaged by dynamic influences, you can use a method of strengthening similar to the one mentioned above - gluing high-strength fabrics or lamellas.

The technological process of strengthening metal beams includes the following work operations: surface cleaning; surface dedusting; stabilization of (if necessary); strengthening of the structure; and protective and decorative finishing (if necessary), which in most respects (except reinforcement) meets the requirements of DSTU-NB B V.3.2-4 [7]. Experimental studies aimed at checking the effectiveness of reinforcement allow us to state that reinforced elements (metal beams) have significantly lower deformability, namely deflection, compared to non-reinforced elements by 39.5%. At the same time, the permissible load on the reinforced beam was 11.8% more than the load for the unreinforced structure [12].

Fig. 14. Metal beams in the ceiling in basements (Zolochiv school No. 1, Lviv Region)
