THE HERITAGE OF POLISH ZOOLOGICAL GARDENS - ARCHITECTURAL AND ARTISTIC MONUMENTS AND THEIR CONTEMPORARY PRESENTATION

Mateusz GYURKOVICH¹, Agata BONENBERG², Łukasz NETCZUK³,
Karolina DUDZIC-GYURKOVICH^{1,*}, Piotr GRYSZKA⁴, Przemysław REDMERSKI⁴

Keywords: Zoological gardens; Architecture; Cultural heritage; Artwork; Conservation strategies

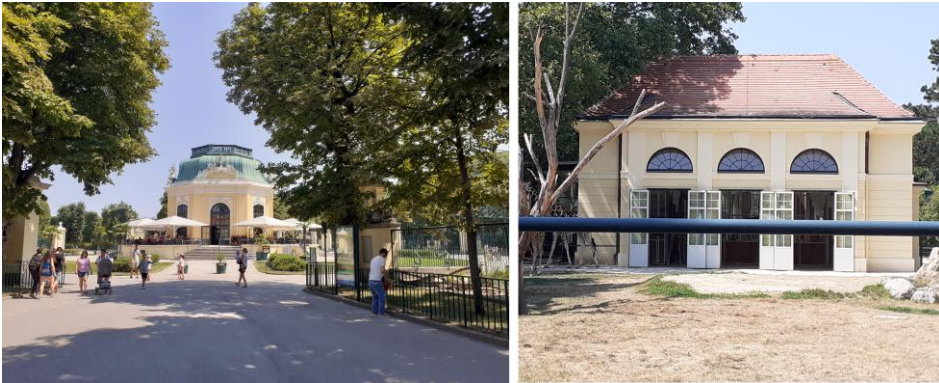
Fig. 1. Tiergarten Schönbrunn - Imperial Pavilion, today serving as a restaurant (left) and giraffe house, historical part (right)

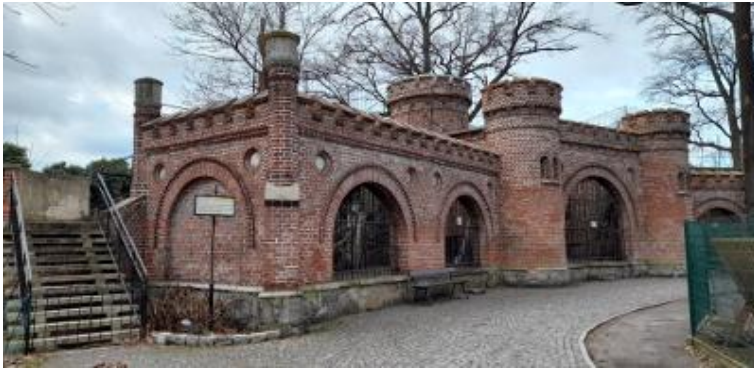
Fig. 2. Wrocław Zoo—Bear Fortress (designed by K. Lüdecke 1864-65, F. Jung 1900, present view)

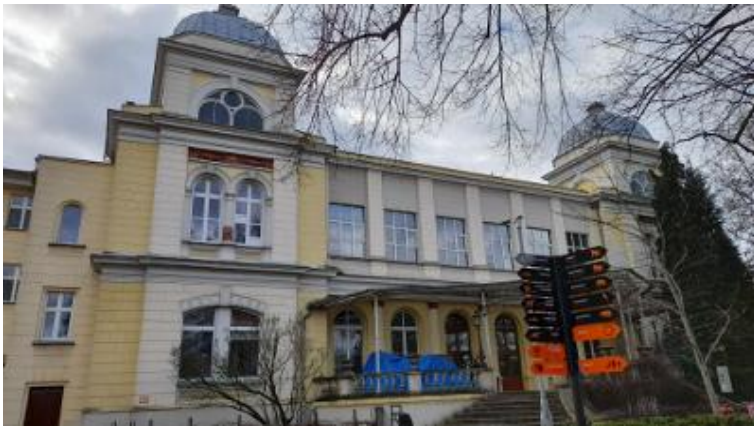
Fig. 3. Wrocław Zoo—Restaurant and Concert Hall—now terrarium (designed by K. Lüdecke 1864-65 and C. Schmidt 1887)

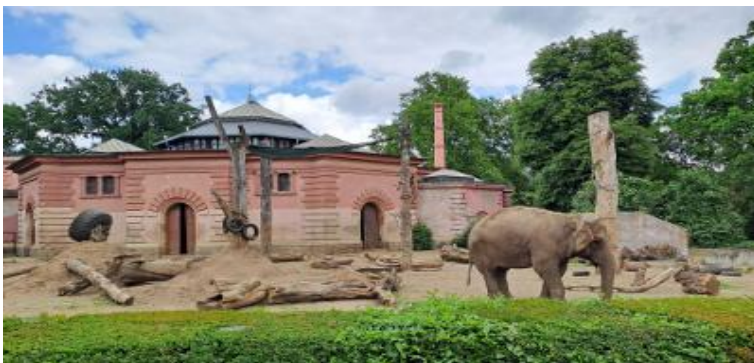
Fig. 4. Wrocław Zoo Elephant House (designed by A. Grau 1873 and C. Schmidt 1887), present view

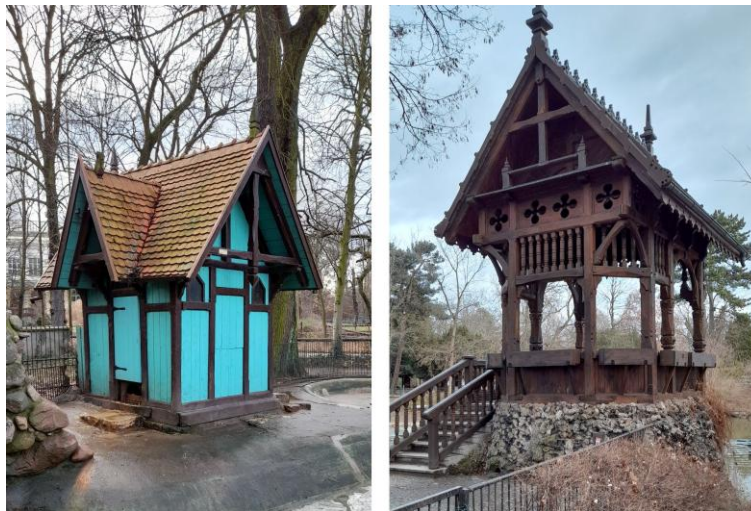
Fig. 5. Wrocław Zoo—wooden monuments: Nutria House (left) and restored arbor by the pond (right), present view

The area of the zoo is equipped with several small wooden structures that have distinctive stylistic features: a bridge and a pavilion over a pond and the so-called nutria house—one of the oldest structures in the zoo that still performs the same function thanks to the conservation efforts (Fig. 5). In addition to that, the numerous examples of masonry work are of considerable value and still under formal protection. For example, the former entrance pavilion (now changed to adapt to the restaurant) with a gate from 1891-95; the zoo walls from 1863-64; the bear, seal and baboon enclosures from the 1930^s, which have undergone several alterations that changed their original form.

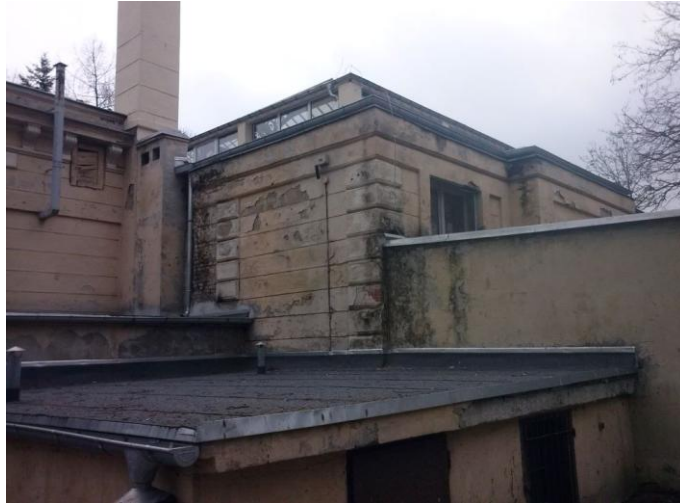
Fig. 6. Wrocław Zoo—Bird House—external view, state before renovation (photo by Beata Pawelec, Creoprojekt)

By 2018, the pavilion had undergone several major renovations, mainly consisting of reconstruction and extensions, during which most of the original decorative elements, both inside and on the façades, were removed: architectural details of the interior design, woodwork,

façade details, mainly cornices and the shape of the window band, skylight and skylight covering. The functional layout of the interiors was changed, additional breeding areas were separated, technical corridors were added, a heating substation was added and the form of the external aviaries was changed. The building has lost much of its original fabric and form (Fig. 6). After decades of intensive use, it was in urgent need of renovation. The immediate surroundings of the building have also been redesigned.

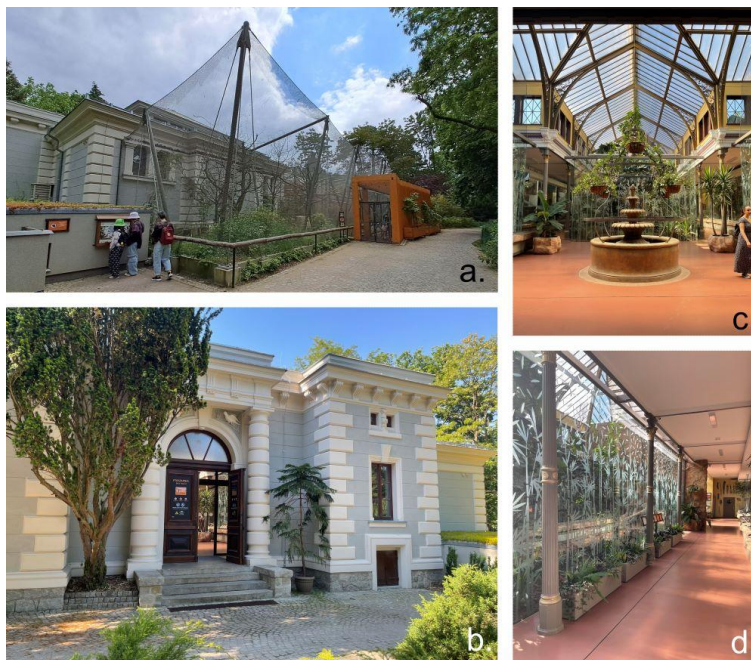
Fig. 9. Wrocław Zoo Bird House after renovation:
 a - new external aviaries against a background of the reconstructed historical form of the building;
 b - entrance (photo by B. Żmuda); c, d - interiors (photo by B. Żmuda)

Finally, the restoration of all the surviving original decorative elements, such as the rusticated, plastered façade, surviving cornices, stone plinth, staircase and entrance portal, internal columns and surviving but decayed fountain in the interior, was made. Based on the

historical-iconographic and stratigraphic research and the work program, a conservation restoration of the entire façade, portal and door carpentry was designed (Fig. 9).

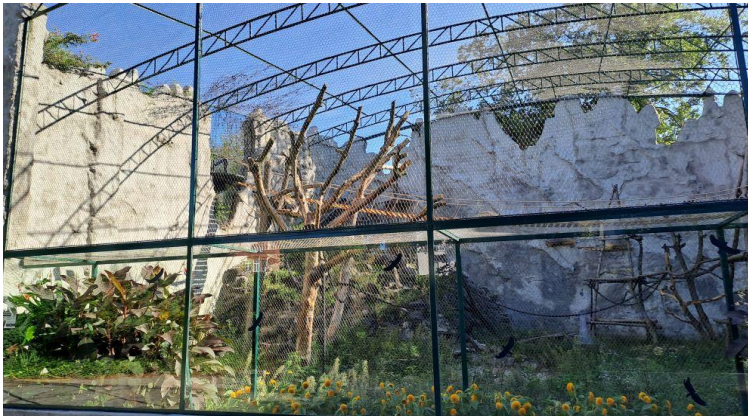
Fig. 10. Old Zoo Poznan - Aviary in Alpinarium with grotto (designed by Böhmer and Preul 1905-06),

Today, Poznań's Old Zoo is an area of architectural, artistic and natural interest. It is one of the few green enclaves in this part of the city. According to Bielawa-Pałczyńska the complex of the Old Zoo contains valuable architectural objects [32] and ten of them have been included in the Register of Historical Monuments of the City of Poznań since 25th April 1978 under the entry A/201 [33]. According to the register, the protected architectural heritage includes the Alpine Garden with a grotto (1905-06), designed by Böhmer and Preul and built on the site of a previous half-timbered monkey house, which holds great value. Next to the area are the former bear cages, which now house ornamental plants and a small pond with carp. Adjacent to the cages is the former aviary (Fig. 10), which features an artificial rock in the interior. Currently, the aviary is home to small capuchin monkeys (*Sapajus apella*), which enter from the nearby monkey house through a netted corridor over the visitors' walkway. The building is designed in neo-Gothic style and the vaulted reinforced concrete interior is inspired by the famous Azure Grotto in Capri.

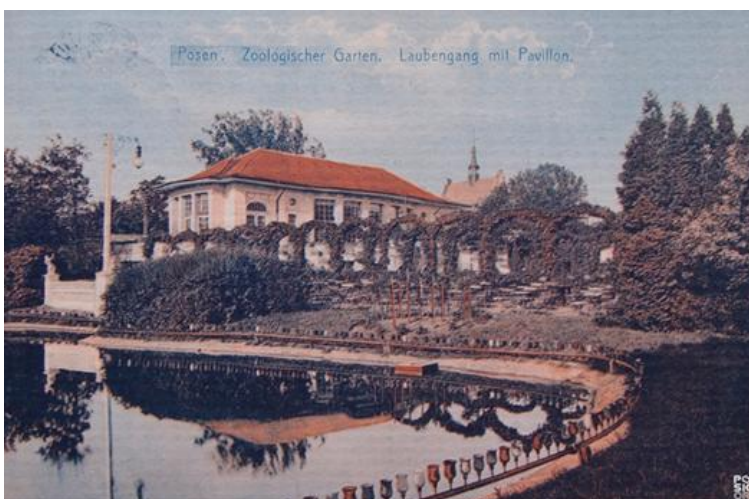
Fig. 11. Old Zoo Poznań - Museum of Environmental Knowledge and Institute of Agricultural and Forest Environment of the Polish Academy of Sciences (ca. 1910).

An important architectural element in the establishment of the zoo and the basis for fundraising in its initial stages, was the entertainment section of the garden, with an elegant restaurant housed in a brick building on Bukowska Street. The building was built in 1908 to a design by Paul Pitt, the author of many of the city's Art Nouveau townhouses. For the restoration he used a proto-modernist aesthetic inspired by Berlin architecture. The building has a rectangular plan and is covered by a hipped roof with pronounced eaves (Fig. 11). The building was once flanked by a platform, a terrace connected to the animal house by garden steps [34]; however, it did not last to this day. After 1918 the building became the property of the City of Poznań and at present it houses the Museum of Environmental Knowledge and the Institute of Agricultural and Forest Environment of the Polish Academy of Sciences.

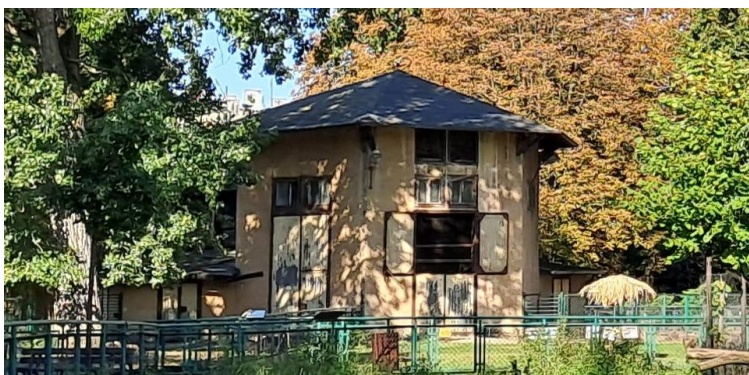
Fig. 12. Old Zoo Poznań, former elephant and giraffe house

In the center of the garden there is a small pavilion for elephants and giraffes (Fig. 12). It is a remnant of the steam engine depot of the former Stargard Railway Station, the very center of the Old Zoo. The steam engine shed was built as a frame structure, due to its location in the fortification zone of the Poznań fortress, which allowed no permanent brick buildings due to military requirements [28]. The building was rebuilt in the 1880s and 1890s, gradually losing its original architectural features. Today, the skeletal structure of the façade is no longer visible.

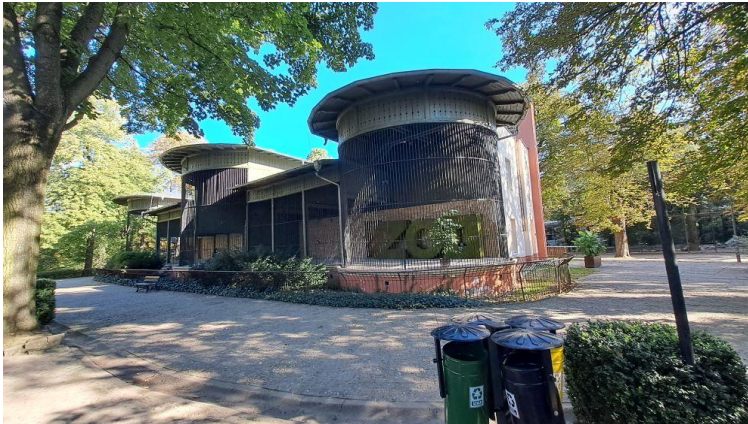
Fig. 13. Old Zoo Poznan, Old Lion House pavilion—former cages of the big cats, now a didactic part of the museum

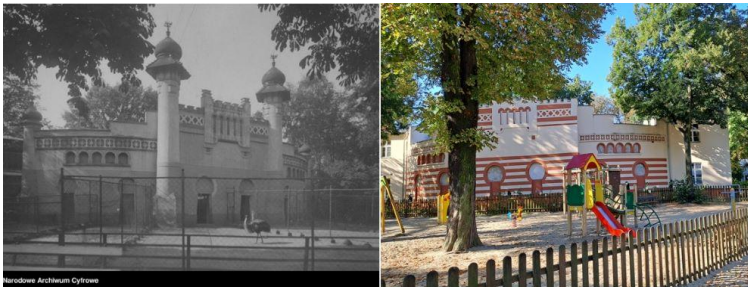
Fig. 14. Old Zoo Poznan - Large carnivore pavilion with ostrich pavilion (ca. 1924) (left).

Illustration source: <https://gloswielkopolski.pl/zoo-w-poznaniu-przed-wojna-wygladalo-pieknie-przenies-sie-w-czasie-zdjecia/ar/ci-14537397>. Present view of the old ostrich pavilion (right)

have recently been painstakingly repainted (Fig. 14). The zoo was extended in 1928-29 with the construction of a brick pavilion for rodents and small carnivores, a pavilion with an aquarium and a brick entrance with ticket offices.

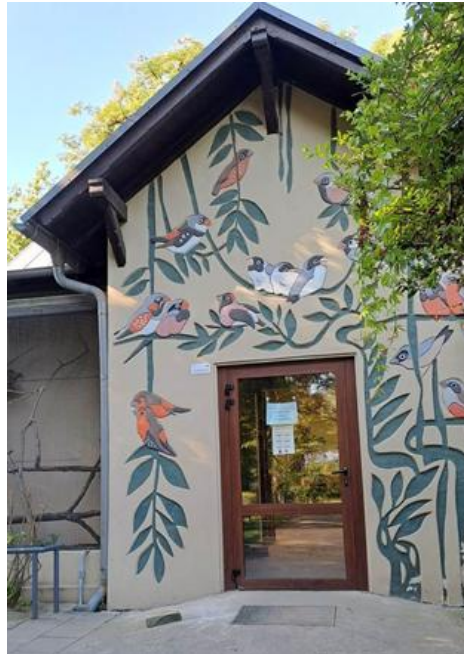
Fig. 15. Old Zoo Poznan- sgraffito by S. Mrowiński on the pavilions of the birdhouse

In the 1970^s, the artist and engraver Stanisław Mrowiński created unique sgraffiti depicting animals on the facades of the Bird House, Monkey House, Small Carnivores and Aquarium buildings. At present they are still in place and serve as the unifying element of the various architectural forms of the pavilions (Fig. 15). It should be added that greenery has been an important and integral part of zoos since their beginning. High greenery and flower beds adorned the entertainment area of the garden. Despite the damage caused by the war in 1945, which affected not only the buildings but also some of the old trees and even though almost 150 years have passed since the garden was created, the Old Zoo still has chestnut trees that are protected by law and have had the status of a natural monument since 1992.

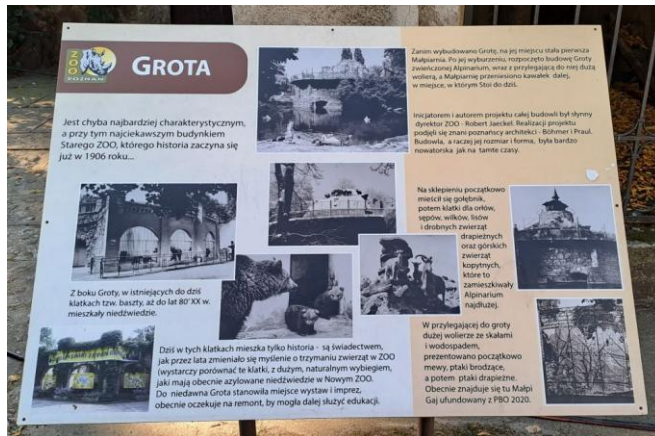
Fig. 16. Old Zoo Poznan, Didactic and informative board showing the former appearance of the alpine garden with grotto

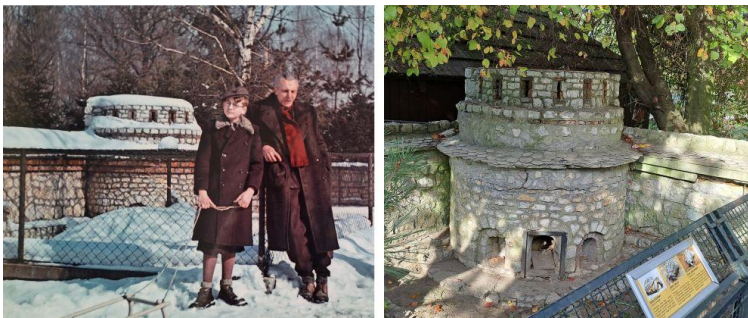
Fig. 17. Cracow Zoo—former small mammal enclosure, now summer tortoise enclosure, view in 1940 (left) (photo by M. Szumiec) and actual state (right)

Most of the zoo's original buildings were wooden structures that have not survived or have been rebuilt using different materials but following the formal decisions. Of the zoo's pre-war monuments, three elements have survived in their original form: a small mammal enclosure, now used in the summer to exhibit land tortoises (Fig. 17); a former marten house (now serving as a sculpture in one of the flower beds at the entrance to the zoo) and a glassed-in "Bison Pergola" from the 1930s (Fig. 18), located on the main axis of the garden next to the current giraffe enclosure.

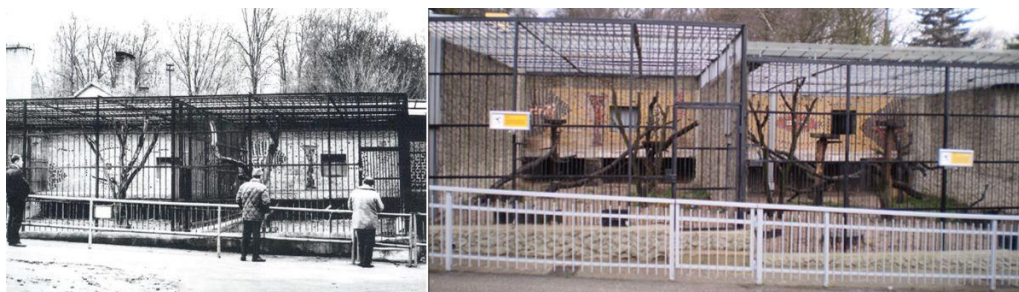
Fig. 19. Cracow Zoo - Mosaics in the big cat enclosures before (1967-1968) and after rebuilding of the walls between the enclosures (2009). Illustration source: Cracow Zoo's archive (left); photo by K. Wawer/P. Redmerski (right)

In the 1960^s and 1970^s, the garden authorities collaborated with the highly talented artists Roman and Helena Husarski. Roman Husarski (1923-2004) was a writer, architect and sculptor who taught at the Drawing, Painting and Sculpture Department of the Faculty of Architecture at the Cracow University of Technology. Together with his wife Helena, in the 1950^s he patented a technique of ceramic decoration called piropicture, which involved spraying a liquid-colored glaze onto a substrate (masonry, plaster) heated by gas or electric burners so that the two layers were permanently bonded [44]. Using this technique, they created many avant-garde decorations for important public buildings in Kraków and Malopolska, such as the northern wall of the KS Korona hall in the Podgórze district of Kraków [45]. They also designed and executed numerous mosaics, mostly abstract, which decorated both private and public buildings, such as the complex of the Cracovia Hotel and the Kijów Cinema, designed by W. Cęckiewicz and built in the 1960^s and 1970^s [46]. For the Cracow Zoo, they made a mosaic wall decoration for the Exotarium, connected to the Monkey House, with the characteristic 'crocodile' at the entrance and mosaics for the complex of cages and indoor enclosures for big cats, located opposite the Monkey House, completed in 1967 in the front part of the zoo (Fig. 19).

The complex of enclosures for big cats functioned until the animals were gradually moved to new, larger pavilions in the distant and more wooded part of the garden in 2012-18, which met modern breeding and display requirements. Parallely, it was decided to demolish it and build a modern pavilion for chimpanzees and macaques in its place. For this task, detailed documentation was prepared. Although the cats' enclosures were not under the legal Conservators protection, the mosaics on the internal walls were of great artistic value; therefore, it was decided to preserve and relocate them.

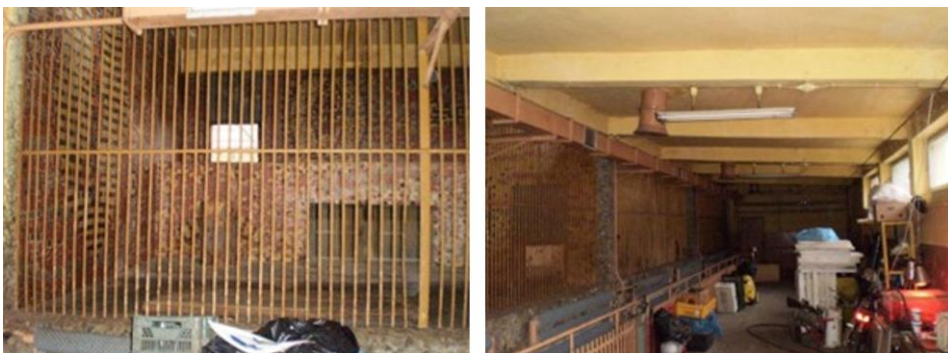
Fig. 21. Cracow Zoo - Existing condition of the interiors of the big cat pavilion before its demolition in 2009 (photo by K. Wawer/P. Redmerski)

The inner walls of the animal enclosures were also decorated with mosaics (Figs. 21 and 22). The pavilion was originally designed to allow visitors to view the animals from inside. However, these rooms have not been open to the public since at least 1980.

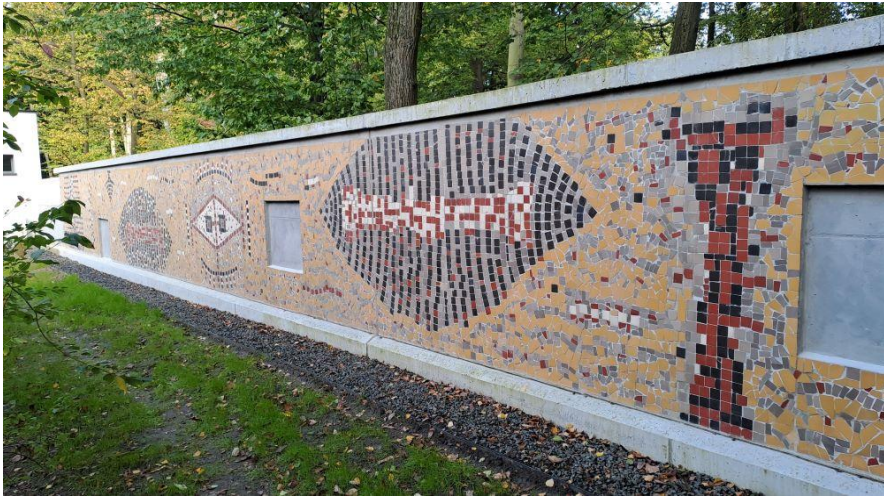
Fig. 24. Cracow Zoo—view of completed wall with mosaics exhibition

The fence was designed to protect the revalued ceramic decoration from rain. The cornice with a drip prevents dripping from above, while the lower shape of the parapet/sill protects the mosaic from splashes and rising damp from the ground (Fig. 24).

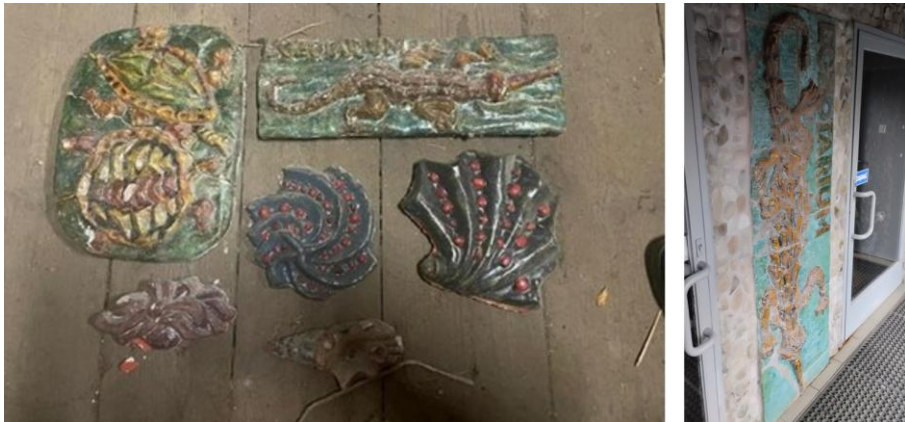
Fig. 25. Cracow Zoo—mosaics found in the staff changing rooms from the Exotarium pavilion (left), mosaic of crocodile at the entrance to the Exotarium (right) (photo by M. Rażny, P. Redmerski 2020, 2024)

In 2022, during the modernization of the changing room and workshop building at the rear of the Zoological Garden, some other, previously unknown ceramic decorations designed and produced by Mr. and Mrs. Husarski were discovered. It is supposed that they have been moved there during one of the renovations of the Exotarium building (Fig. 25). In connection with the planned construction of the 'New Exotarium' on the zoo site, it is planned to display them and incorporate them into the planned building.
