## PROBLEMS OF REPURPOSING THE MONUMENTS OF RESIDENTIAL ARCHITECTURE FOR CULTURAL AND ARTISTIC FUNCTION

### Abstract

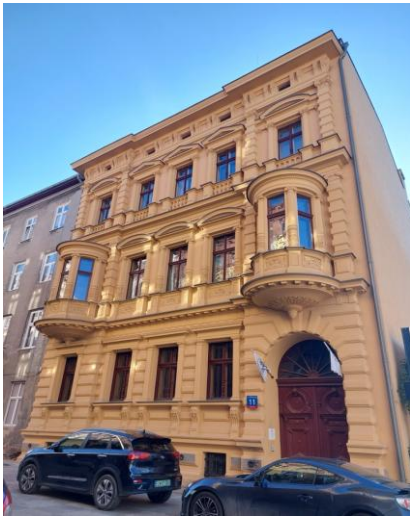
**Fig. 5.** General view of the house of architect Hilary Majewski at 11 Włókiennicza Street in Lodz.

The Neo-Renaissance house was built in 1883–1886 and belonged to the then city architect. At first it was a private mansion, but later it became a tenement building. After the architect's death, the house changed owners but always remained residential. In 1947–1950, a number of buildings in the courtyard were dismantled and apartments were arranged in the attic, which somewhat changed the original layout. In 2022–2023, simultaneously with the arrangement of the entire building on Vlokenniča Street, it was restored and an art space was arranged.

As already mentioned, this is not an ordinary museum, because what is exhibited here primarily are the methods of decorative decoration with intricately patterned wallpaper, marble, imitation marble on staircases, floor tiles, room colors and decoration with the so-called "mazerunki" (a wood texture pattern obtained from boards with a tangential cross-section of wood or veneer (plywood) with a rich, complex pattern) (Fig. 6). Most often, the texture of expensive wood species was imitated on the basis of softwood (spruce and pine) or fiberless wood (poplar, linden and alder). The rooms were originally furnished, but the furniture has not survived.

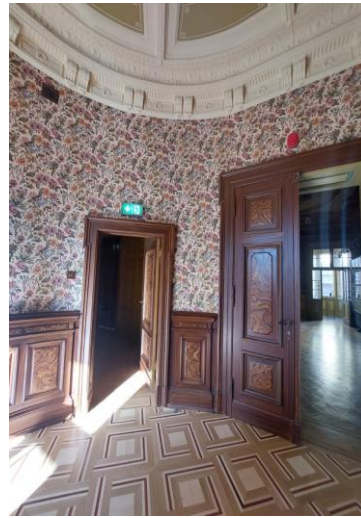
**Fig. 6.** Interiors of the house of architect Hilary Majewski.

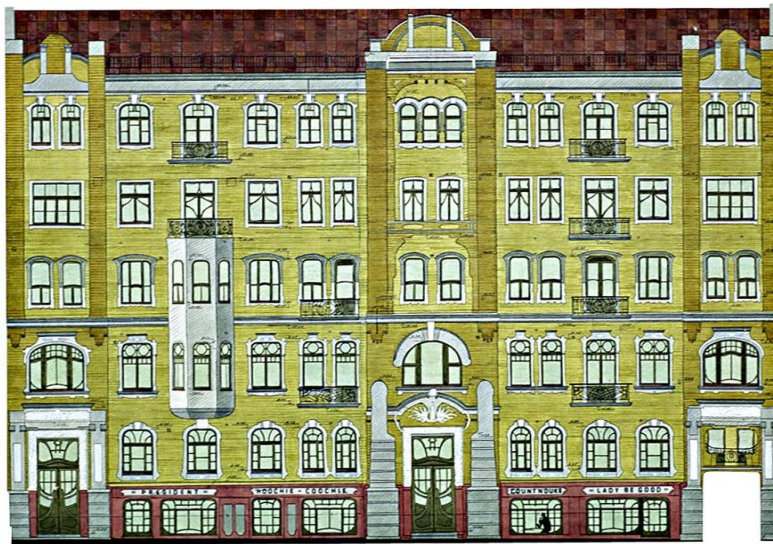
Fig. 9. Facade restoration project (Personal collection)

The facade of the apartment building is designed in the style of decorative Art Nouveau; the interiors feature Art Nouveau and pseudo-Renaissance styles. The large number of complex decor complicated the nature of the restoration measures, since the object is on the monument protection register and authentic details had to be preserved unchanged. As a result of numerous repairs, the general appearance of the interiors of Rodzianko's apartment has changed repeatedly, so one of the initial tasks was to determine the type of interior decoration that it had during the time of the owner of the apartment building, L. Rodzianko. The interior featured a large number of different decorative finishing techniques, so a separate restoration technology was developed for each type.

The building was surveyed in 2001 and a redevelopment project was developed on their basis. The project consisted of eight volumes of documentation, where a separate volume dealt with the results of field surveys, including measurements, photo fixation, soundings, chemical and technological studies, the state of engineering networks and decor on the facades and interiors. Stratigraphic studies were also conducted.

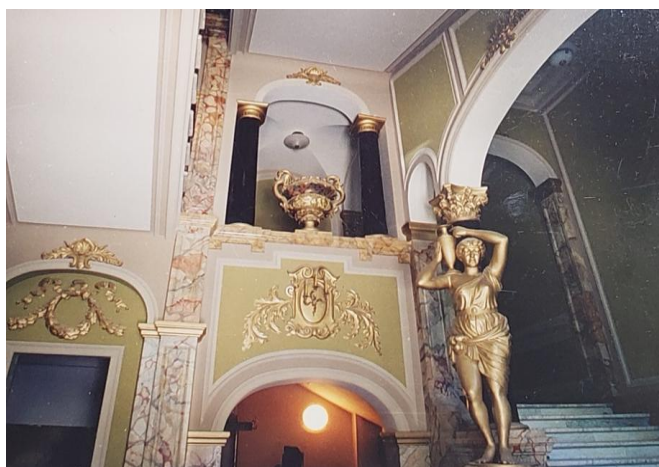
Fig. 10. The theater lobby after restoration. Photo from the collections of Y. Ivashko

The accents of the lobby were columns, vases and sculptures of women with amphorae (Fig. 10).

The condition of the columns and vases was found to be satisfactory; there was loss and damage to parts of the column capitals and paint layer swelling on the capitals. As already noted, the vases were made by semi-dry filling into molds of cement-sand mortar with a plasticizing admixture and subsequent painting with bronze paint. The sculptures of women with amphorae were covered with gilding. The column was made of gypsum, the foot was covered with a layer of putty, on top of which a layer of dark brown oil paint was applied, two layers of putty and another layer of dark brown oil paint. The capital of the column was also made of gypsum, covered with a layer of drying oil, dark brown oil paint, a layer of brown paint with a green tint and two finishing layers of bronze paint.

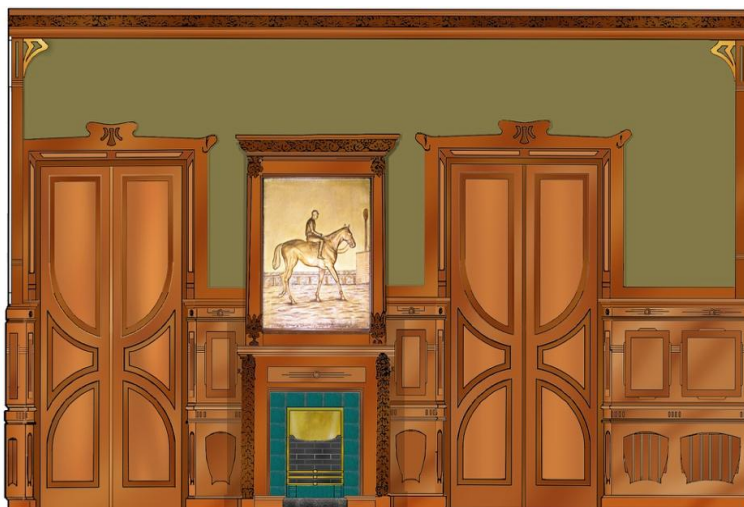
**Fig. 12.** Wall elevation of the “English Cabinet.” Restoration project (personal collection)

On the walls and ceiling are paintings depicting various types of horse riding (Fig. 13) and above the fireplace is a bas-relief of the cavalryman Leonid Rodzianko himself riding his favorite mare, "Raketa," which won the Grand Prix at the London Races (Fig. 12).

It is worth mentioning the decoration of each room separately. From the main staircase, the visitor entered the so-called “English Cabinet” of the owner, decorated in the Art Nouveau style and with a horse theme (Figs. 11 and 12).

The layers of lime-gypsum-sand mortar, lime-gypsum-sand cover, textured lincrusta, putty and several layers of paint were applied on top of the brickwork of the walls in the "English Cabinet." As a result of the conducted field surveys, remains of authentic English silk wallpaper (green striped) were found under the lincrusta, which were pasted over old theater posters. The ceiling was decorated with plaster stucco decoration; layers of drying oil, emulsion putty, several layers of bronze paint and a layer of varnish were applied to the plaster. The wall frieze was made of wood with a gray two-layer putty and a layer of varnish and the stucco frieze curl was made of plaster with layers of drying oil, emulsion putty, two layers of bronze paint, a layer of varnish and a layer of painting on the plaster. The ceiling moldings and fireplace decor were also made of plaster with a covering. The decorative finish of the "English Cabinet" used imitation wood in the moldings and ceiling moldings.

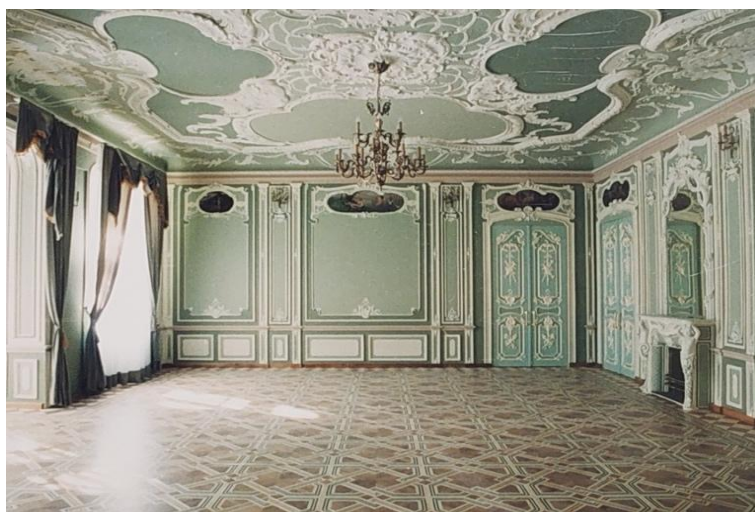
**Fig. 14.** The theater hall after restoration.

The main room is a large banquet hall, which was converted into a theater hall (large stage—80 seats, microstage—21 seats). This is the most decorated room in Rodzianko's apartment (Fig. 14). The general color scheme of the hall is a light green background with white details.

Some of the stucco details were gilded, as were the elements of the fireplace decor. The patterned cornice, moldings near the paintings, overlays near the paintings, a pattern near the lamp, pilasters, ceiling moldings and fireplace decor were plaster and some of the moldings and panels were made of lime-gypsum-sand mortar.

The ceiling of the hall was covered with a layer of gypsum mortar with a small admixture of lime on the shingle, with stucco decoration. At the time of the inspection, the condition of the plastering of the ceiling of the banquet hall was considered unsatisfactory due to the presence of through cracks throughout the entire ceiling plane and due to the presence of areas of deflection.

The stucco decoration in the banquet hall was in satisfactory condition with the fixation of small losses and chips and surface corrosion of the gypsum stone. The problem was that during the operation of the premises, as a result of repairs, the parts were covered with layers of emulsion and oil paints, which changed the relief of the decor. In addition, thick paint layers began to peel off from the base along the line of through cracks over time.
