DEGRADATION OF POLISH MANOR HOUSES – ANALYSIS OF TECHNICAL, LEGAL AND ADMINISTRATIVE FACTORS AFFECTING THE STATE OF PRESERVATION OF HISTORICAL SUBSTANCE

Aleksandra KUŚMIERSKA¹, Mariusz KOSIŃ^{1,*}, Joanna GONDRO²

¹ Czestochowa University of Technology, Faculty of Civil Engineering, Department of Civil Engineering, Akademicka Street 3, Czestochowa 42-201, Poland.

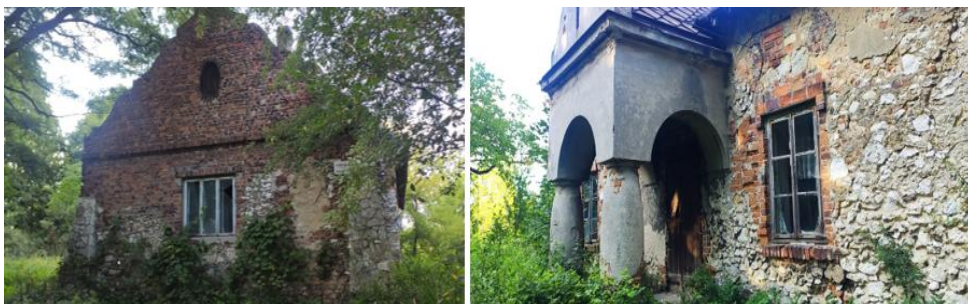
The manor house has been in poor technical condition for years despite the preparation of design documentation and obtaining the necessary permits. The current state of the manor is shown in figure 1. The key problem turned out to be the high investment costs, which were additionally increased due to strict conservation guidelines [12]. An example is the position of the conservator of monuments, who requires the restoration of the existing walls and roof truss - even though these elements are in a state of extreme degradation. The cost of renovation is then many times more expensive than reconstruction using traditional technologies. The designer proposed a compromise solution - full restoration of the most valuable element, the historic basement and reconstruction of the damaged walls and roof while maintaining their historic appearance. The conservator's lack of consent to the proposed compromise led to a significant increase in costs, which made it impossible to obtain financing. As a result, the facility continues to deteriorate.

Fig. 1. Current condition of the manor house - 2022, from the left: northern elevation, front elevation (western)

The Czepurek Manor, dating back to the turn of the 18th and 19th centuries, is characterized by a modest classicist architectural form, typical of rural areas of that period [11]. It was entered into the register of immovable monuments in 1989. The building is characterized by a rectangular plan, a symmetrical façade and a gable roof. The structure of the building is based on limestone and brick walls, using local building materials. The oldest part of the building is the basement, topped with brick barrel vaults – an example of the high-class construction craftsmanship of the era. Above the cradle, several dozen years later, a ground floor development was built along with an unused attic and the newest part is the kitchen annex.

In the case of Czepurka Manor, the rigid requirements for the restoration of the severely degraded walls and roof truss, instead of allowing their reconstruction while maintaining the historic appearance, significantly increased the investment costs. This approach, coupled with the lack of flexibility on the part of the conservation services, made it impossible to obtain financing and halted the revitalization process.

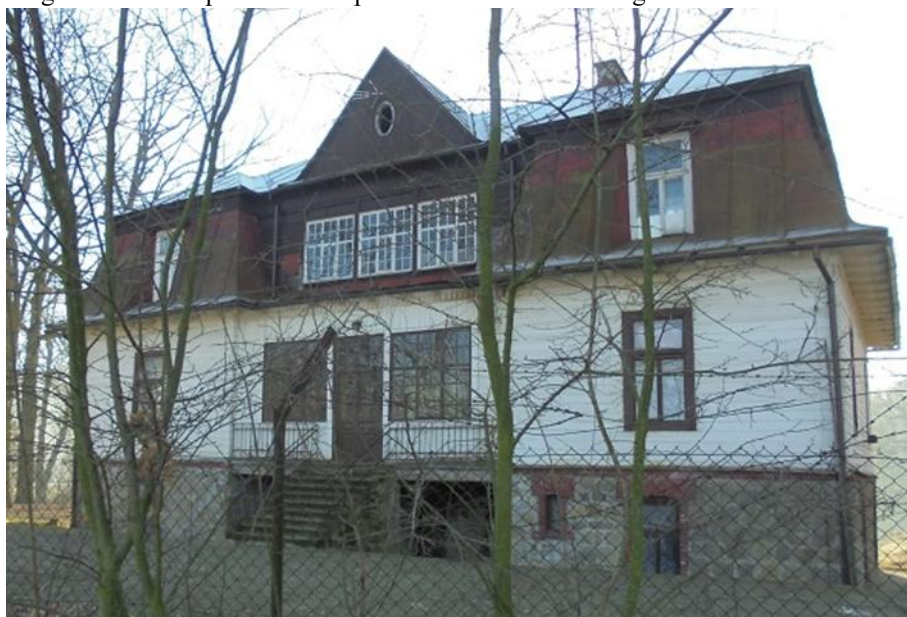
The manor house in Konary (Fig. 2), also known as the Grabowski manor house complex, was built in 1920 [13]. In 1988, the building was entered into the register of immovable monuments of the Małopolska Voivodeship. It is believed that the current building was built on the site of an earlier manor house. After the war, it housed an agricultural school and then a production cooperative. The building has a wooden and brick structure and the character of a villa. It was built on a rectangular plan, has a basement and is covered with a mansard roof decorated with dormers. The lower floor, including the basement, was made of stone. The sections above the basement were made in a wooden structure, which gives the building lightness and visual elegance. The building is distinguished by a projection on the

south side and concrete fan-shaped stairs leading to the main entrance. After the war, the interiors were rebuilt to suit the needs of the production cooperative.

Fig. 2. Current condition of the manor - 2017, north elevation. (photo by Ewa Brandys, source: polskiezybytki.pl)

The manor house in Konary is another example of a facility with great potential that was not used due to the restrictive approach of the conservation services. Within the park area, a concept was created to build a wedding hall and a hotel for guests. This was to enable the generation of revenue to support the maintenance of the facility. The main problem was the refusal to consent to changes in the layout of the rooms in the existing historic structure. The change was necessary due to modern requirements related to evacuation and fire regulations. The conservator did not allow the construction of a new glass-covered hall in the park area, which – although designed with respect for the historical layout – could have ensured the functional and financial self-sufficiency of the entire complex. The lack of compromise between the parties led to the investor withdrawing from the project and the further sale of the manor house. The manor house, unadapted and unused, is falling into further disrepair, remaining another example of wasted potential of cultural heritage.

The example of the Manor House in Konary shows that the lack of consent to any changes to the layout of the rooms, despite the need to adapt the facility to fire safety and evacuation regulations, led to the blocking of investment opportunities. As a result, the owner was forced to abandon the idea of adapting the building for a hotel function and sell the facility, which remained unused and was subject to further deterioration.

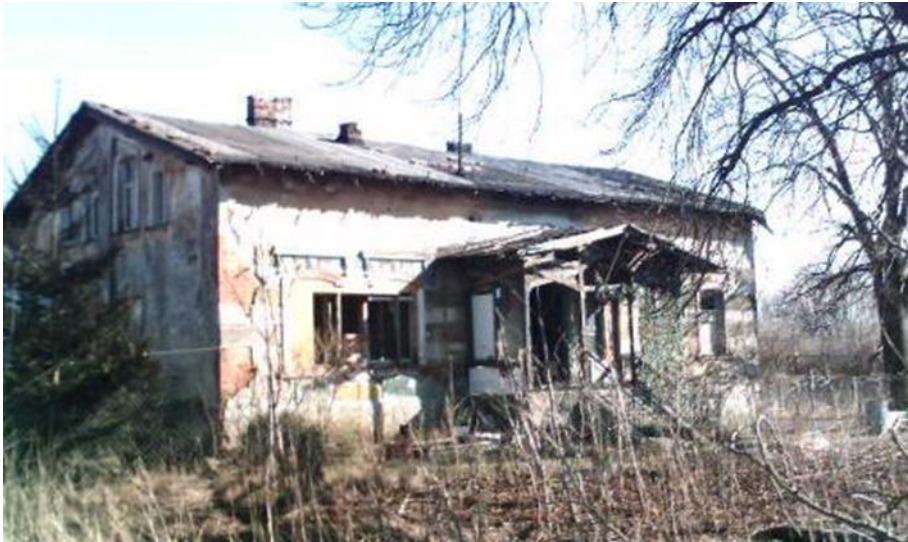
The manor house in Rębowo (Fig. 3), located on the outskirts of Gdańsk, was built in the early 18th century [14]. It was designed as a landed gentry residence, in accordance with the manor and farm layout typical of the Gdańsk region.

The building represents a simplified classicist style – it has a rectangular plan, a symmetrical facade and a low, gable roof. The manor house was built on the foundations of an older residence. Ceramic bricks were used for its construction. The building is divided into two parts: the western part – higher and with a basement and a wooden porch, which contains architectural elements that may date back to the 18th century. The eastern part of the building was built in the interwar period and has a simplified functional character. In 2022, the building was partially destroyed by fire. In 2024, the procedure for entering the manor house into the register of immovable monuments of the Pomeranian Voivodeship was initiated. The initiation of the

Fig. 3. Devastated manor house in Rębowo (2007) – front view.
(Photo by Tomasz Steifer, source: [wikipedia.org/wiki/Rębowo_\(Gdańsk\)](https://wikipedia.org/wiki/Rębowo_(Gdańsk)))

The manor house in Rębowo is an example of a building of significant historical value that for years remained outside formal conservation protection. The lack of entry in the register of monuments made it impossible to use legal tools to protect the historic substance and to enforce basic security measures from the owner [15].

The case of the manor house in Rębowo illustrates the risk associated with the lack of entry in the register of monuments. In such situations, there is no mechanism that would oblige the owner to take the necessary actions to protect the historic substance from progressive destruction.

In turn, the example of the Manor House in Rębowo shows the opposite situation, in which the lack of any formal protection results in the complete degradation of the object. In such cases, there is no legal mechanism that would oblige the owner to take basic security measures.
