PRESERVING URBAN INFRASTRUCTURE: ASSESSMENT OF NATURAL DISASTERS USING MODERN TECHNOLOGIES

Following an information from the Trifești City Hall regarding the occurrence of a landslide at the home of a citizen from the village of Trifești, which caused the destruction of the resistance structure of the building and the evacuation of the owner, it was ordered by order no. 14 of 28.10.2016 the formation of a Technical Support Group for the management of emergency situations generated by earthquakes, landslides and landslides to assess the situation on the spot and draw up a statement of findings.

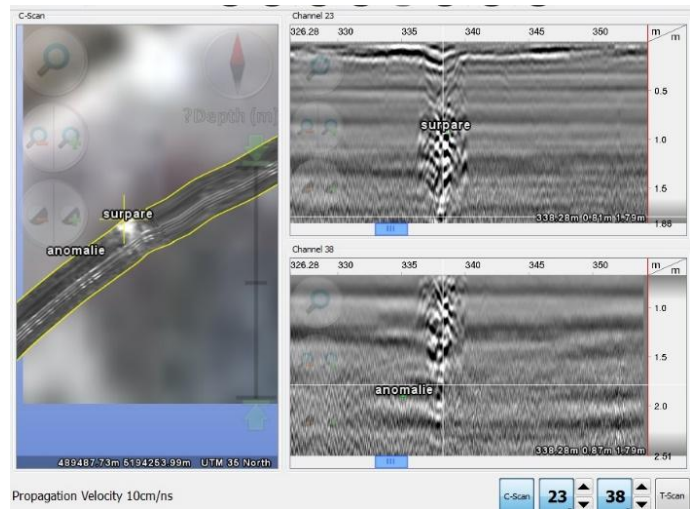
Fig. 3. First anomaly identified

The first anomaly identified in the scan shows the breaking of the land as well as the possible existence of a structure (Fig. 3).

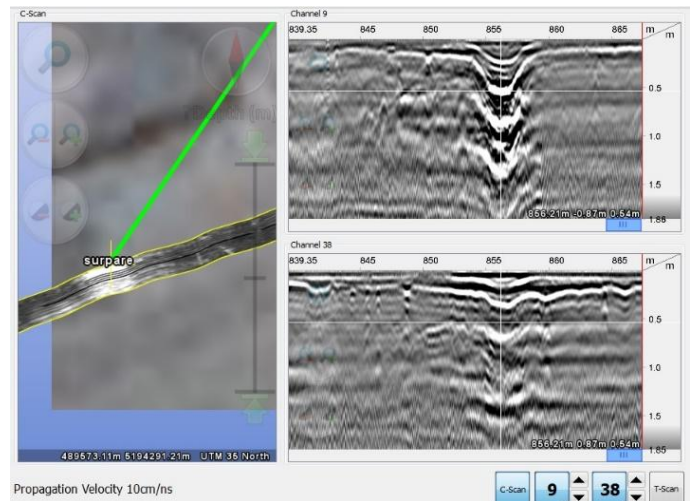
Fig. 4. Second anomaly detected

The second major anomaly identified by the GPR is shown in the image below, where you can see the fact that the earth broke and that area was covered with another layer of earth and compacted. It should be mentioned that the soil layer will continue to collapse (Fig. 4).

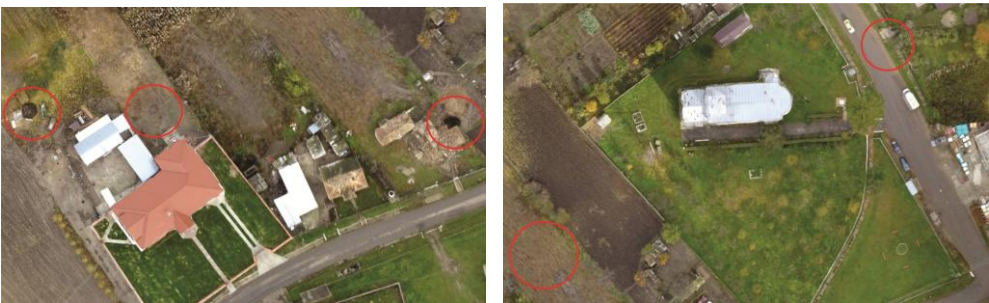
Fig. 8. Identified areas with height differences (image from the drone at a height of 120 m)

As a result of the aerial mapping, the software marked several areas with soil differences and of all the anomalies, only a few remained that should be checked by the people in the area in order to be eliminated or investigated further (Fig.8).

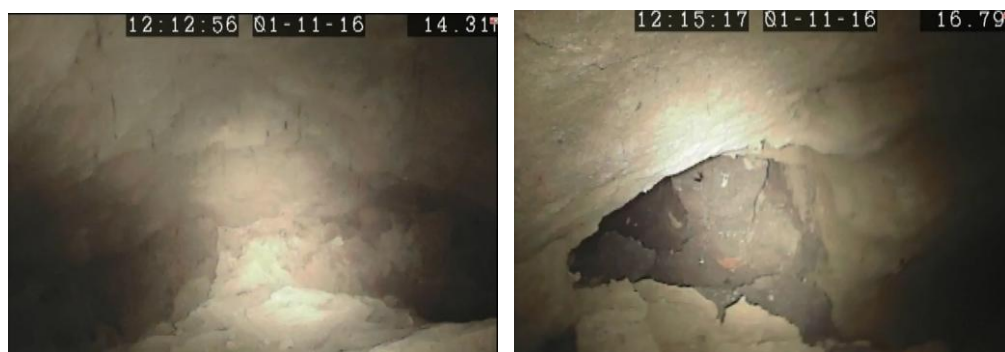
Fig. 9. Findings using video inspection (video inspection done on the property affected by the land sliding)

The next step was the video inspection carried out on the property, where cracks in the soil layer and the existence of some formations (possibly objects) could be observed. Fig.9.
