## CULTURAL HERITAGE IN MARATHON: THREATS AND DISASTERS

Ioannis STERGIOPOULOS<sup>1</sup>, Nicholas ANASTASOPOULOS<sup>1,\*</sup>

<sup>1</sup> School of Architecture, National Technical University of Athens, Patision 42, 10682, Athens – Greece

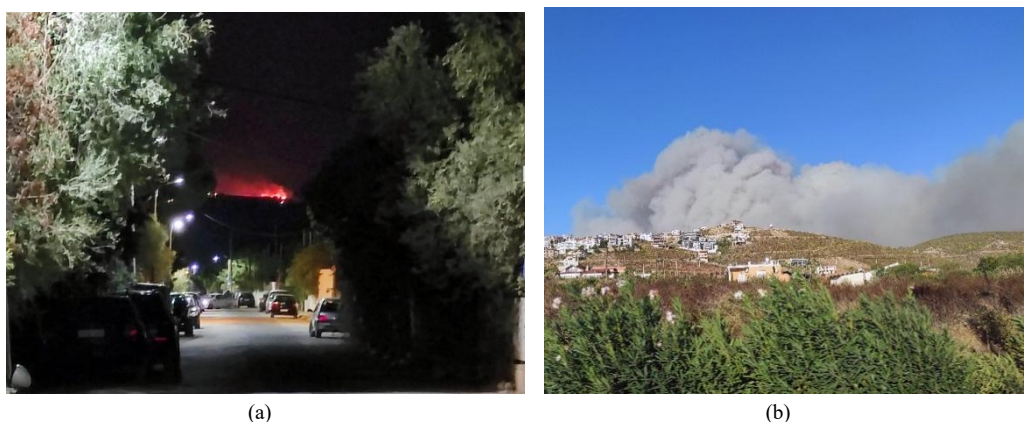
**Fig. 2.** (a) View of the August 11<sup>th</sup>, 2024, fire approaching the outskirts of the city of Nea Makri the same night [6]  
(b) View of the August 11<sup>th</sup>, 2024, fire threatening a residential area in the city of Nea Makri the next morning [6]

The most recent and one of the most disastrous fire outbreaks in all of Eastern Attica and the Municipality of Marathon started on 11 August 2024 in Varnavas, Attica, during the final writing stages of this paper. The fire spread rapidly, affecting much of eastern Attica, including the areas of Marathon, Marathon Lake, Grammatiko, Varnavas, Oinoi, and Nea Makri (Fig. 2). It continued southwest, reaching suburban areas of Athens, such as Dionysos, Penteli, and Halandri. The fire caused irreparable damage to buildings, residences, and agricultural establishments but also severe ecological destruction to the precious suburban natural environment of Attica. The fire spread widely as strong winds (6-8 Beaufort) and very high temperatures prevailed in the area. It is worth noting that Greece has just experienced its hottest June and July on record, with long heat waves and temperatures reaching 42 degrees Celsius. These hot and dry conditions combined with the high August winds were favorable for the outbreak of fires. Furthermore, the lack of any serious precautionary measures and of a clear fire management plan from the city council of Marathonas, combined with chronic administration issues, has contributed to the lack of effective prevention policies for environmental disasters. Climate change on cultural and natural heritage can have a serious impact on large areas. However, the results depend to an extent on local characteristics such as the microclimate, local topography, vegetation species, and the hydrology, combined with the anthropogenic threats that apply on-site and the physical and structural characteristics of cultural heritage.

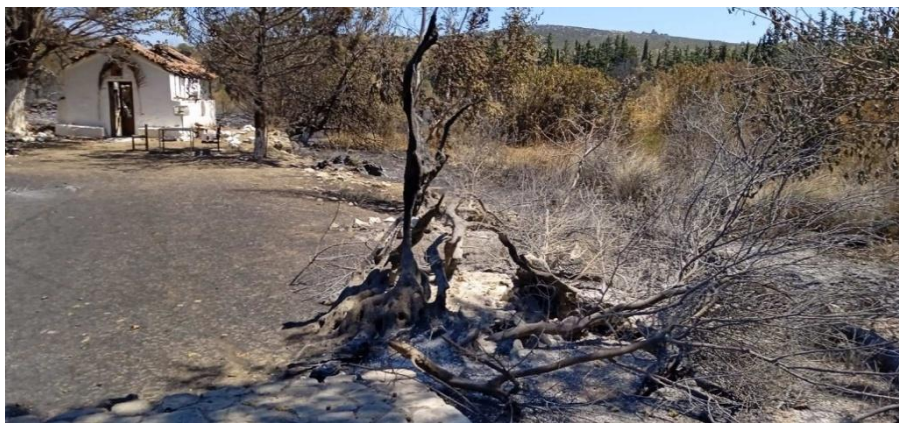
**Fig. 3.** The results of the August 11<sup>th</sup>, 2024, fire in Oinoi. The fire entered the archaeological site of Oinoi, burned the post-Byzantine temple of Agioi Apostoloi, and destroyed a large area of vegetation cover, including old olive trees that were part of the historic agricultural landscape of the area [18]

Evidence of the fire of August 2024 also indicates severe damage within the study areas. The fire burned a large part of the archaeological site of Oinoi (Fig. 3) and posed a serious threat without damaging the archaeological site of Ramnountas in the fire-affected area of Grammatiko. The data relating to the fire could not be included in the preceding statistical analysis of this study, as the damage recording process is still in progress at the time of the writing. However, it is certain that much of the natural resources of the municipality of Marathon have been seriously affected, with the tangible cultural heritage being at risk from the fire effects for several years. Nevertheless, it is essential to make an initial reference to an event that highlights the issues raised in this study.

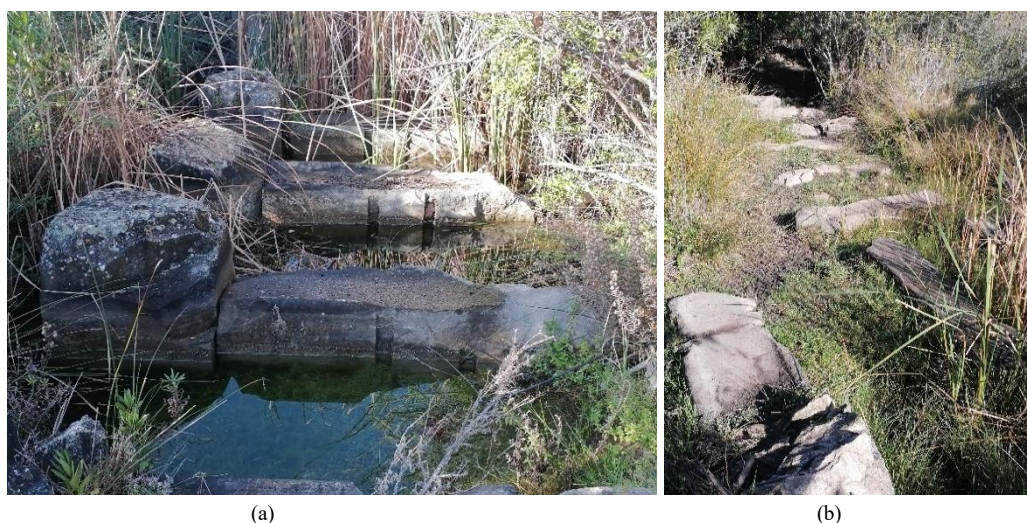
**Fig. 4.** (a), (b) Views of the flooded archaeological site of Oinoi in November 2023. The plain topography of the site acts as a water collector for local streams. A large portion of water may come from an ancient unidentified underground water source. Maintenance issues are also obvious, threatening the monument [7]
