RENOVATION OF A POST-INDUSTRIAL BUILDING AND CHANGE OF ITS UTILITY FUNCTION

This paper analyzes the methodology of the renovation process of a post-industrial building located in Częstochowa, whose original warehouse and production function was changed to a workshop and office function.

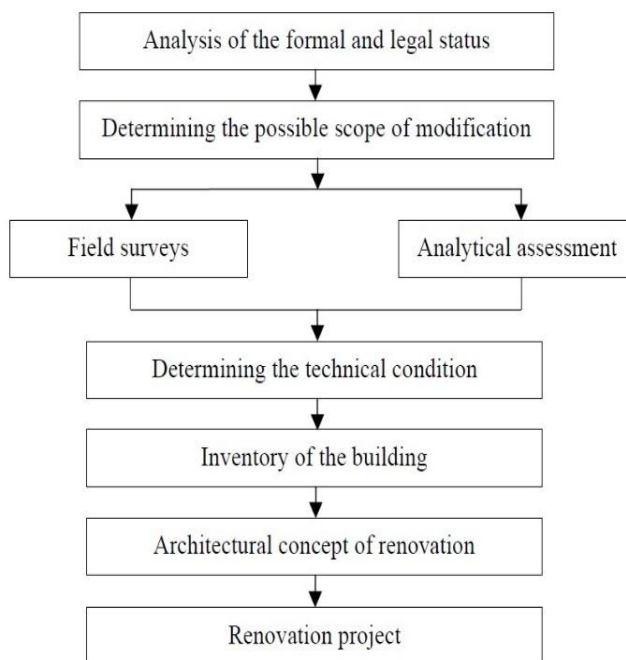
Fig. 1. Methodology of the decision-making and implementation process in the field of renovation of facilities with their adaptation to a new utility program

Detailed design documentation was prepared, covering the full scope of renovation and reconstruction works, with the assumption that as much of the original character of the building would be preserved as possible while meeting all the requirements related to its new function. The developed methodology is presented in Figure 1.

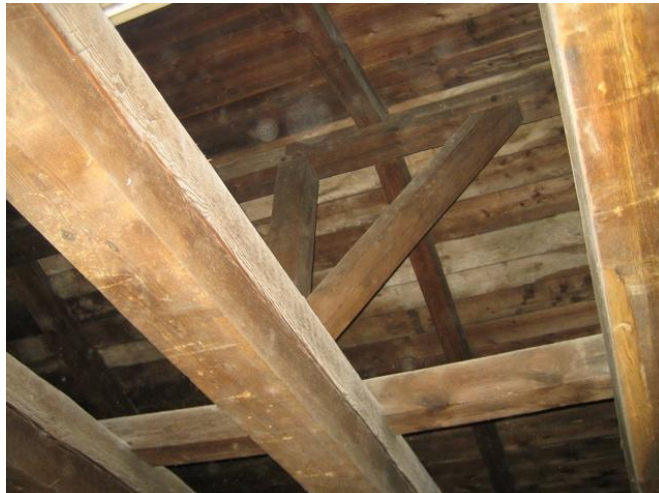
The roof truss was made in a truss-purlin structure. The purlins were supported at one end on the wall plate and the other on a lattice truss positioned parallel to the longitudinal axis of the building. The truss was supported by wooden beams embedded in the longitudinal walls, bracing the walls (Fig. 2).

Fig. 2. Existing roof truss structure during renovation

The technical condition of the roof truss was assessed as good; no defects or traces of biological corrosion were observed. Considering the unique nature of the roof structure solution used, the surfaces of individual elements were cleaned, preserved, and covered with a varnish, preserving the structure of the wood. After completing these works, the entire structure was left visible (the suspended ceiling was abandoned), which, combined with the visible structure of the brick wall in places, creates a unique character of the interior, referring to the austere style of industrial buildings from the beginning of the 20th century.

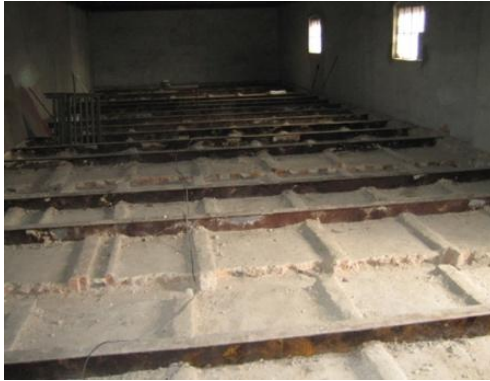
The building ceiling between the first and second stories was made as a semi-heavy Klein ceiling (Fig. 3). Its technical condition was very poor - the corrosion of the ceiling beams was so advanced that it was necessary to dismantle them. Therefore, a decision was made to replace the ceiling also with a beam-slab ceiling (Fig. 4), which would integrate the structure of the existing walls and would have an appropriate load-bearing capacity adapted to the size of the loads expected for future use. A solution in the form of a composite steel-concrete ceiling made on

Fig. 3. Existing building ceiling

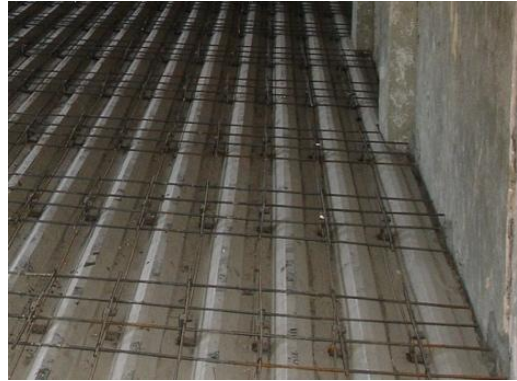
Fig. 4. New composite floor before pouring the slab

corrugated sheet metal was chosen. A solution of the same type was adopted during the renovation of the historic building of the Wrocław Główny railway station [16].

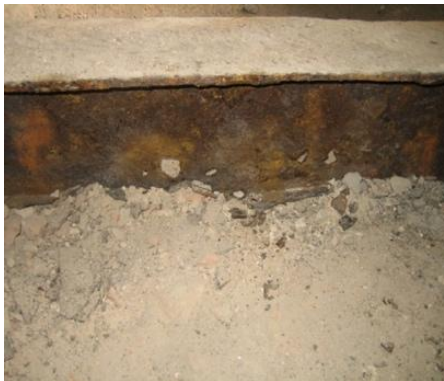
The corroded steel I-beams (Fig. 5) were replaced with new ones (Fig. 6), and the brick slab was replaced with a reinforced concrete slab made of corrugated sheet metal. Due to the required usable height of the story for the new function, the key issue was to use a solution in which the height of the steel I-beams would be as small as possible, which translates into a reduction in the structural thickness of the ceiling. Therefore, it was decided to use a solution in the form of a composite steel-concrete ceiling, in which the height of the steel beams was the smallest among all the considered variants.

Fig. 5. Corrosion of existing ceiling beams

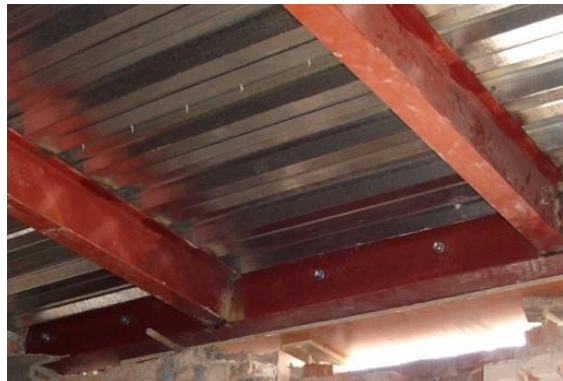
Fig. 6. New ceiling beams

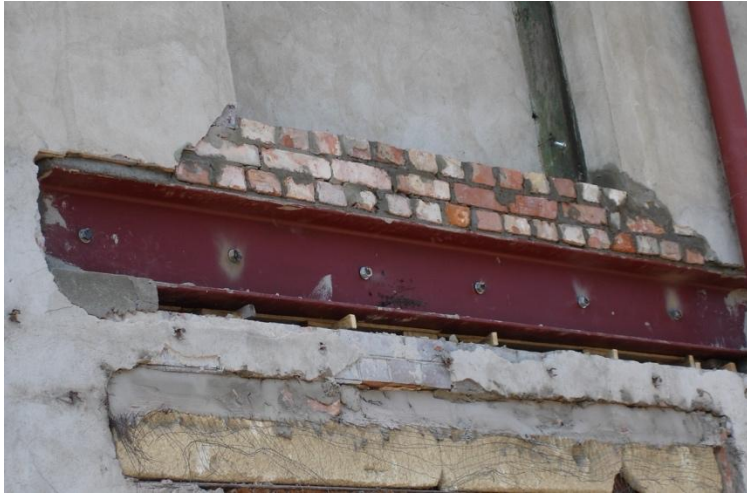
The upper-story arch-shaped lintels were made of bricks and were in good technical condition. A decision was made to renovate them and expose them from the inside of the wall. For this purpose, the internal plaster was removed, and the wall surface at the lintel was cleaned and preserved, revealing the brick structure. The lower-story lintels were made of steel sections embedded in the wall at both ends and insulated from the outside (Fig. 7).

Fig. 7. New lintel (strengthening the structure in light of new utility requirements) at the location of the widened existing opening

In places where the existing dimensions of window and door openings were preserved, the old lintels were left. In places where it was decided to widen the openings, lintels in the form of two hot-rolled C-sections placed in grooves carved in the wall and screwed together were used (Fig. 7).

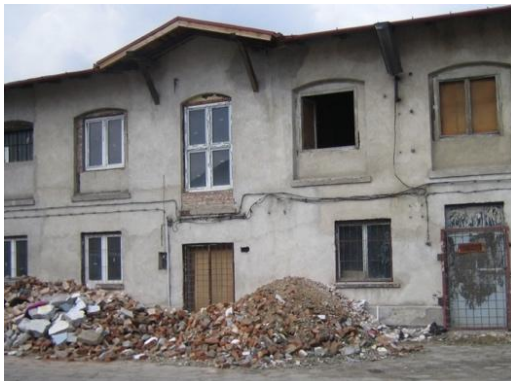
The building elevations were uniform surfaces of external walls. The external cement-lime plasters were cracked, with gaps in some places (Fig. 9). Loose plaster fragments were removed and leveled, and the surface was primed. In order to meet the utility requirements, thermal insulation of the external walls was made together with a new plaster in orange and yellow colors. The shape of the window openings on the second floor was emphasized by making pilasters in a different color than the wall, referring to the original appearance of the building. A bay window with rustications was made in the central part of the front elevation with extensive glazing providing lighting for the staircase (Fig. 10). The plane of the walls of the above-ground part was extended in relation to the plane of the ground floor walls, creating a plinth (setback) protecting the wall from water leaks.

Fig. 9. The front elevation of the building before renovation

The window and door joinery was devastated or missing in places. A change in the shape of the windows on the second floor (compared to the original state) was visible – the window openings were reduced, changing their shape from arched to rectangular (Fig. 9). A decision was made to restore their original shape with the division of the window sashes by mullions, referring to the solutions from the era in which the building was built (Fig. 10). The windows on the upper and lower floors were made of wood; the front door and the staircase skylight were made of aluminum. Due to the workshop function of the rooms on the first floor, the height of the window openings was reduced, thus enabling the location of workstations directly at the wall of the building.

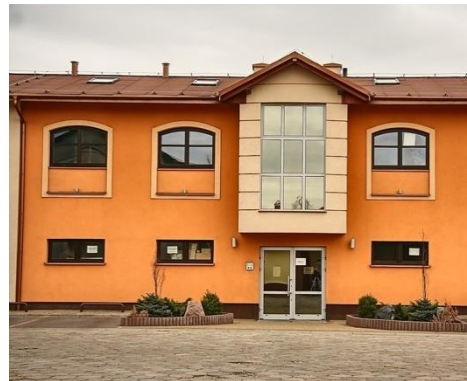
Fig. 10. The front elevation of the building after renovation

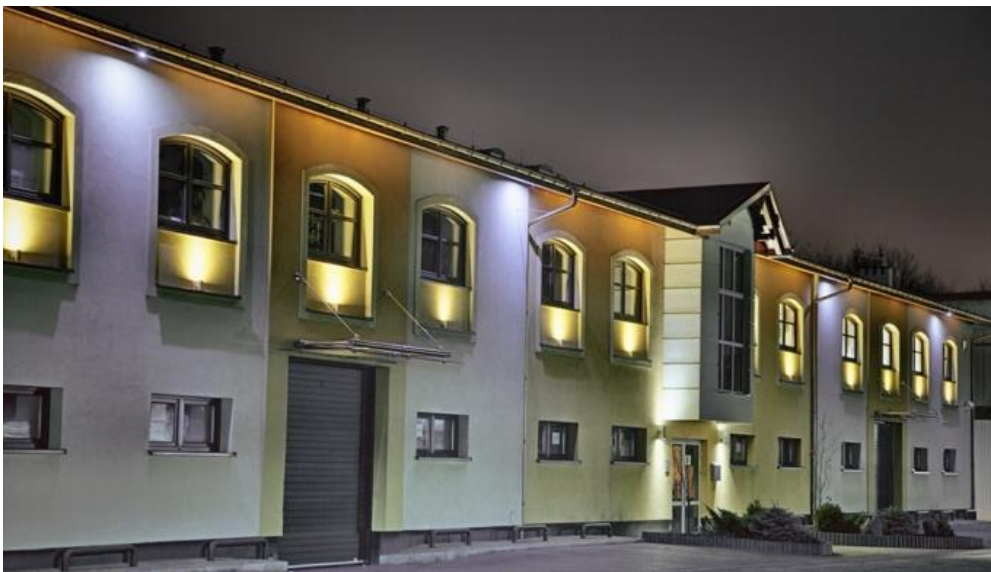
Fig. 11. The final effect of the renovation works carried out

The final effect of the renovation and restoration works is shown in Figure 11.
