## INVESTIGATION ON TRADITIONAL RESTORATION TECHNIQUES OF TILING DECORATIONS IN THREE SAFAVID DOMES OF ISFAHAN

### Abstract

**Keywords:** Dome; Tiling; Traditional technology; Restoration; Isfahan

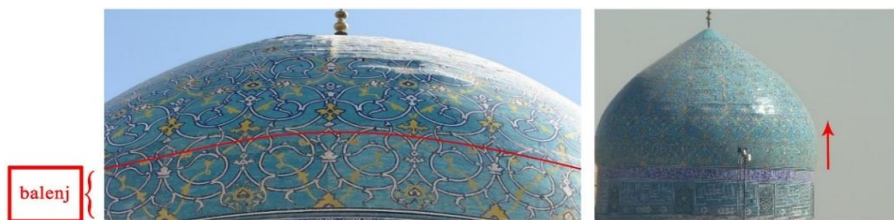
Fig. 2. Jame-Abbasi mosque dome, *Balenj*, or the impost of the dome: height determined by the arrow and the assumed horizontal line

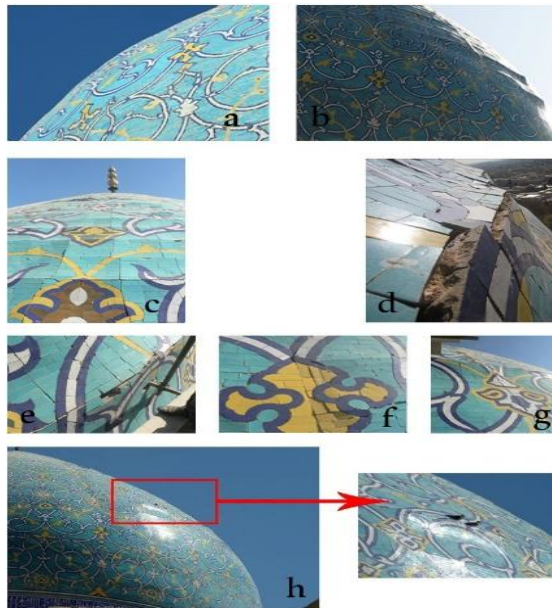
Fig. 3. Jame-Abbasi mosque dome: a. Inflamed tiles; b, h. Wrinkled tiles; c, d, e, g. Breaking and separation of tiles from the dome; f. Lack of adhesive mortar on the back of tiles after the 1980s and 1990s restorations

- Inappropriate coupling (the separation line at the background Narreh tiles is also in the same direction) (Fig. 3e, f).
- Elimination or destruction of the old tiles of the dome and their replacement or substitution with new ones.

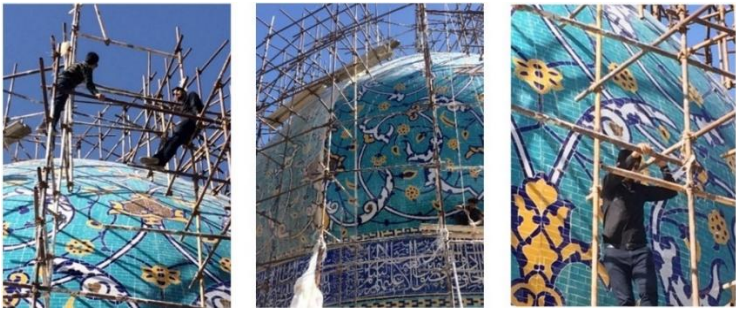
Fig. 6. Dome of *Chahar-bagh* school, recent restoration of tiling

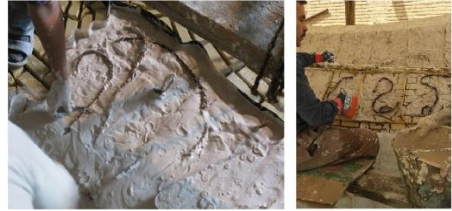
**Fig. 14.** *Chaharbagh* school dome, Gypsum mortar being poured on the back of *Narreh* tiles. (source: Panjehpoor)

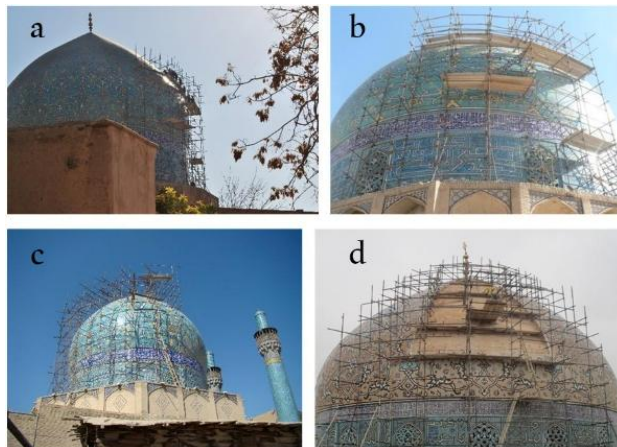
**Fig. 16.** Buttresses over historical domes of Isfahan: a, b: *Jame-Abbasi Mosque*, 2010; c: *Chaharbagh school*, 2010; d: *Lotfollah Mosque*, 2022 (sources: a, b, c: Motalebi; d: CHO)

- Use of very heavy buttresses over the dome for a very long time (Fig. 16).
- Damages exerted by the buttress to the dome and destruction or breaking of the tiles (Fig. 32a).

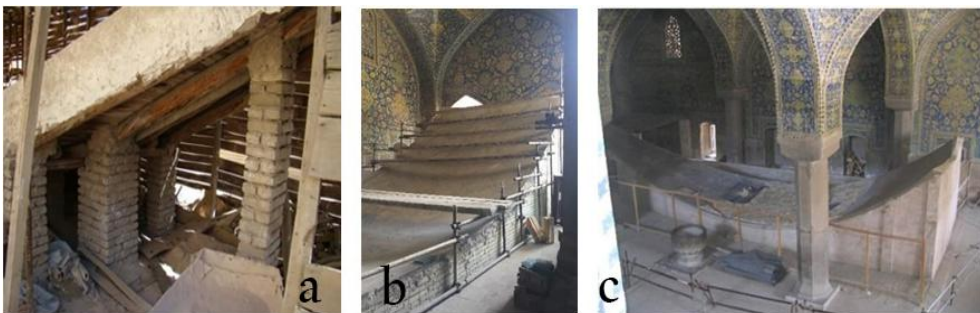
**Fig. 19. a.** the lower part of the old curved restoration mold of the *Chahar-bagh* school dome; **b, c.** curved mold of the recent restoration of the *Jame-Abbasi Mosque* tiling dome (sources: a. Motalebi 2010; b, c. CHO)

c. To make the curved mold of 1/1 scale on the ground. Now we turn to the executive phase and making of the mold on the ground, usually to be done by traditional carpenters and tile workers. One of the templates of meridians (dovetailed slabs of longitudinal arc) is put on the ground with at least a 1m separation from its surface at the closest point. Now the template of the similar “meridian” is put precisely at the same height as the previous one with the aid of “level-stride” and fixed there. Then orbits become installed at their place after fixing of the templates. In this way, both the distance of the meridians and the curvature of the mortar supposed to fill this part are determined. The skeleton of a *Tark* is fixed on the ground using a mortar of gypsum and brick, and the floor of the mold is formed by some slabs. Then the whole of its surface becomes flat using gypsum mortar to evoke for us precisely the curvature of *Tark*. Now the negative/concave mold is prepared, which is referred to as an arced mold or “curve *Takhmiri*” (Fig. 19).

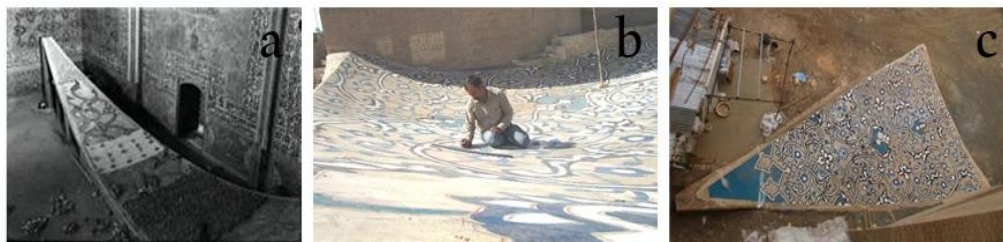
**Fig. 21.** a: Implementation of the design over the mold, using oils, of previous restorations of *Jame-Abbasi Mosque*; b: *Lotfollah Mosque*, drawing of design over the mold of the dome; c: *Lotfollah Mosque*, completion of design over the curved mold. (source: a, b, c. CHO)

- Tracing method (*Garteh-bardari*): In this method the lines become needed, design paper is put on the surface of the mold, and finally the design is traced using a colored powder (e.g., coal powder). Then it is firmed over the mold surface by pencil.
- The “copy-paper” method: In this method the design of the dome is implemented over the mold surface using a “copy-paper” embedded below the design paper. Then the resulting design is colored with oils (except for the background color of the dome). Now its surface becomes fixed by linseed oil to prevent fading of the color (Fig. 21).

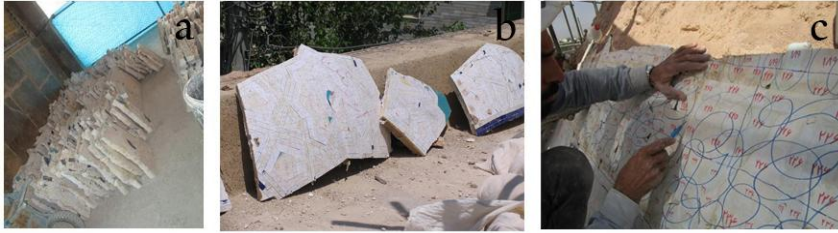
**Fig. 22.** Papers glued to the surface of the tile's *Parcheh*. a: *Parchehs* laid together in a recent restoration of the *Jame-Abbasi* dome to be installed on it; b: *Parchehs* of tile of another dome; c: *Parchehs* of tile in a recent restoration of *Lotfollah* mosque. (source: b. Enayati; a, c. CHO)

**e. Preparation of the design, its numbering, and its cutting.** In this step the tile workers provide several copies from the original dome's design. Then parts of the dome, which is to be restored, are divided into pieces of 60×60cm or 60×30cm rectangles with their marginal areas being flat and free of any complicity of the design. Each of these pieces puzzled together is named as *Parcheh* (Fig. 22a and b). Then each part will be marked, e.g., by a pencil of the same color; the jointing location of each tile with the adjacent one is determined by drawing a line at their intersection, and finally each *Parcheh* is coded with a number (Fig. 22c).

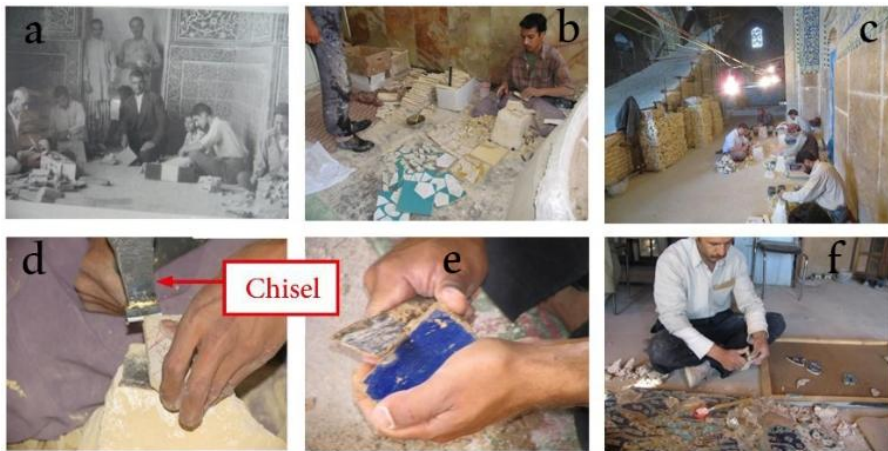
**Fig. 23.** a: Carving and chiseling of the tile in the past; b: Gluing of cut papers of the tile's design over the glazed surface of the tile by *Sirish*; c: Chiseling and carving in a recent restoration workshop of *Jame-Abbasi* Mosque; d: Chiseling and carving; e, f: Removal of clay. (sources: top, CHO; bottom, Enayati)

f. Making and carving of tiles. After finishing marking of the pieces of the design, the paper is cut in such a way that its dimensions don't exceed those of the *Narreh* tile. Then the pieces are glued with *Sirish* over the glazed surface of the tiles. When the *Sirish* gets dried, the carving of the tiles begins with light and heavy chisels<sup>11</sup> (Fig. 23a, b, c, and d). The next step is *Gel-Bordegi*<sup>12</sup> and thinning the width of the tile's back (Figs. 23e and f).

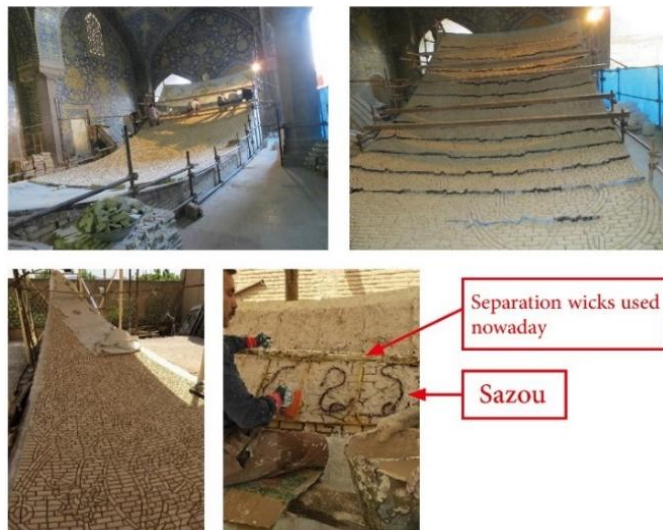
**Fig. 24.** Embedding of *Narreh* mosaic tiles inversely on the surface of the curved mold. (top): mold of *Jame-Abbasi* Mosque (source: CHO); (bottom): mold of dome, *Chaharbagh* school (source: Panjehpoor)

g. Pouring mortars at the back of the *Parchehs* over the mold (*Parche-rizi*). After finishing the tile carvings, pieces corresponding to each *Parcheh* are laid out together in their numbered turn from their glazed face over the curved mold surface at their appropriate location (Fig. 24). Thereafter, by putting clay wicks<sup>13</sup> between the *Parchehs* of the tiles to a height of 3cm, the intervening borders of two adjacent tiles are separated to prevent sticking to each other during mortar pouring. Now a mortar of water and gypsum is poured to the back of *Parchehs* embedded in the curved mold (Fig. 25).

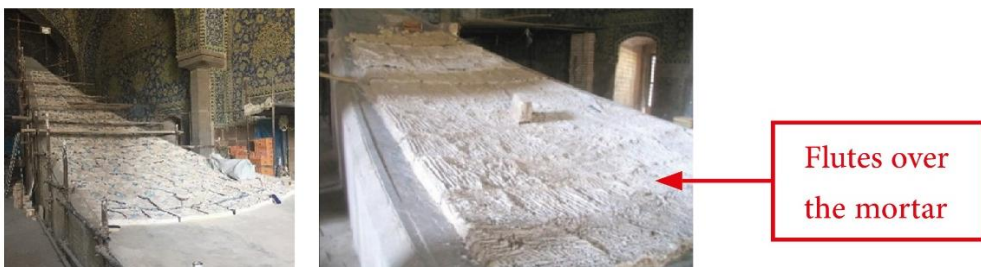
**Fig. 25.** Mortar pouring to the back of the *Narreh* mosaic over the curved mold and flutings of this somewhat denser mortar. Recent restoration of the *Jame-Abbasi* dome (source: CHO)

considerably reduced compared with that of Isfahan, and the mixture is added with an amount of clay. The result of the operation is yet to be announced. Generally, the mortar used in the back of the tiles in the curved mold is denser and more viscous than the one used in the space between the tiles and the tough surface of the dome itself (*Zebreh*); i.e., the consumed water of the former is less than that of the latter (Fig. 25). It is for the more dilute nature of the latter that it is referred to as *Dough-ab* of gypsum (Fig. 25).

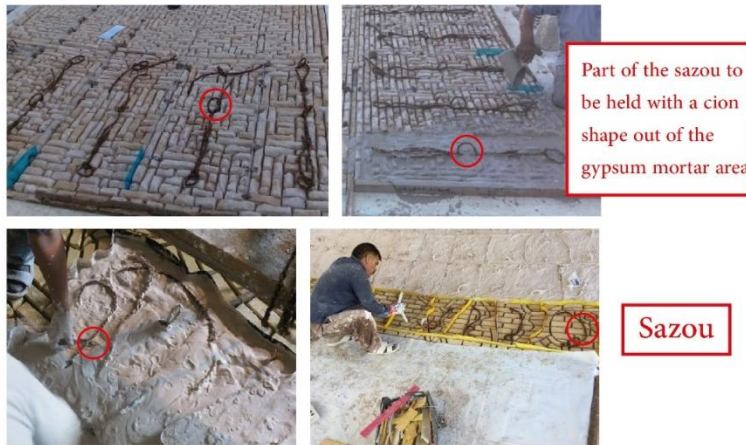
**Fig. 26.** Gypsum mortar with the *Sazou* rope at the back of the tile and the separating “walls” of each *Parcheh*; (top): *Lotfollah Mosque’s* dome restoration (source: CHO); (bottom): *Chahar-bagh* school’s dome restoration (source: Panjehpoor)

Due to the heavier weight of the *Parcheh* and for the sake of its firmness and also a better attachment of *Narreh* to the mortar on its back, ropes known as *Sazouii* (*Scrophularia*) made from fibers of palm are used, which are spirally embedded in the back of the *Parcheh* of the tile (Fig. 26). Mortar of gypsum is poured up to the level of clay-wicking between the *Parchehs*. The surface of the mortar becomes fluted before becoming dried (Fig. 25) so that at the onset of installing the *Parchehs* over the dome, it becomes better engaged with the *Dough-ab* to be poured later to its back once more. As soon as the mortar becomes dried, *Parchehs* are separated from the curved mold's surface and (after numbering) become ready to be transferred to the dome for installation (Fig. 22). Part of the rope remains out of the mortar's level in a coil shape to play, firstly, the role of a handle in their transferring, and secondly, after installing the *Parcheh* over the dome and *dough-ab* was poured to their back, the same handle provides a better engagement and contributes to the firmness of the *Parchehs* over the dome's body (Fig. 26).

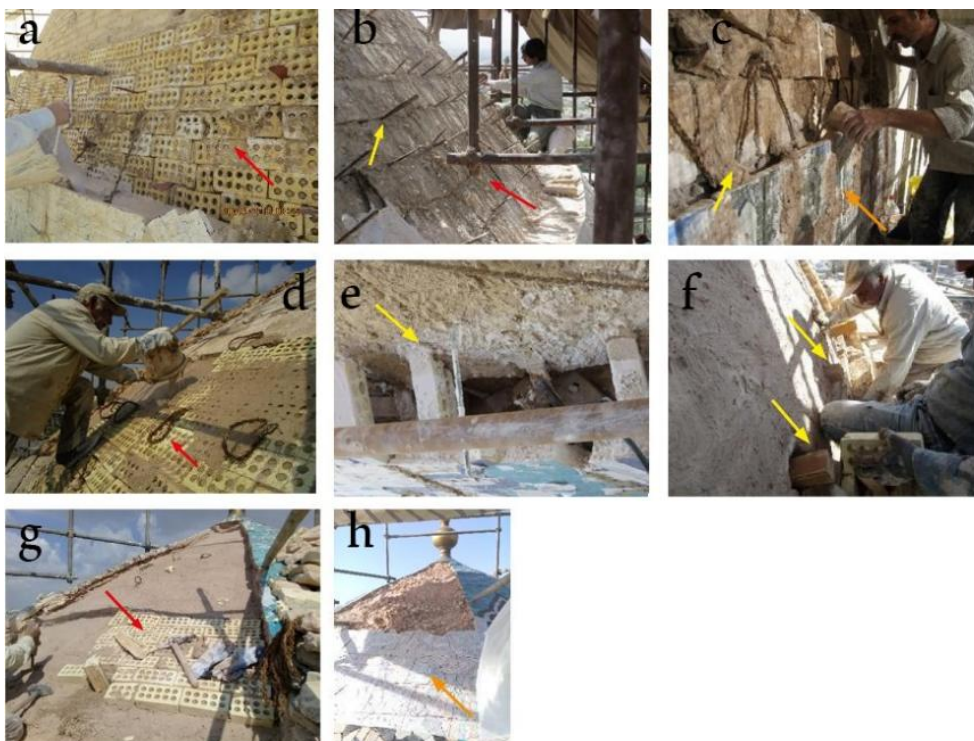
**Fig. 28.** Installation of hollow bricks (a, b, d, g; red arrow); installation of anthrax (b, f; yellow); installation of *Parchehs* of tile (c, h; orange); installation of *Darab* (c, e; yellow); gypsum mortar poured in back of the *Parchehs* (a, c, d; blue) (source: CHO)

- Installation of *Parches* of tile, after embedding of hollow bricks and anthraxes (Fig. 22a and b), it is the turn of *parchehs* of tile themselves. The jointing of the first installed *Parcheh* is important, as the next *Parchehs* are to be regulated with this. This is termed as the *Ostad-kar* or *Usta*, namely the “master” *Parcheh*. After embedding a *parcheh* at its place, a brick is inserted between the dome's “wall” and the uppermost part of the *Parcheh* to fix the former. This brick attaches the dome's wall to the backward surface of the *Parcheh* of the tile. This brick is termed as *Darab* (Fig. 28c and e). After laying one row of *Parcheh*, it is the time of their final fixing over the dome using a sort of *Dough-ab* to fill the caves behind the *Parchehs*. Sometimes brick-and-tile debris is added to this gypsum mortar for the saving of the latter and as a filler as well (Fig. 28a, c, d, and i).

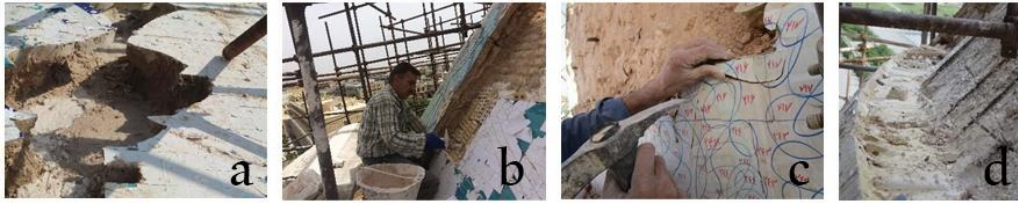
**Fig. 29.** a: *Parchehs* of tile involving a distension; b, c: modification and addition of some of the tiles after installation of *Parchehs*; d: and after *Dough-ab* pouring (source: CHO)

Sometimes processes are made at the outer margin of the *Parchehs* due to the complicity of the design (Fig. 29a), but they perturb coupling of the *Parchehs* with the adjacent ones. For this reason, these prominent bricks (processes) are usually numbered and removed, to be embedded later and after fixing one row of *Parcheh* over the dome (Fig. 29b and c). *Dough-ab* takes time to be dried (Fig. 29d), after which the next row is worked out following the installation of anthrax.

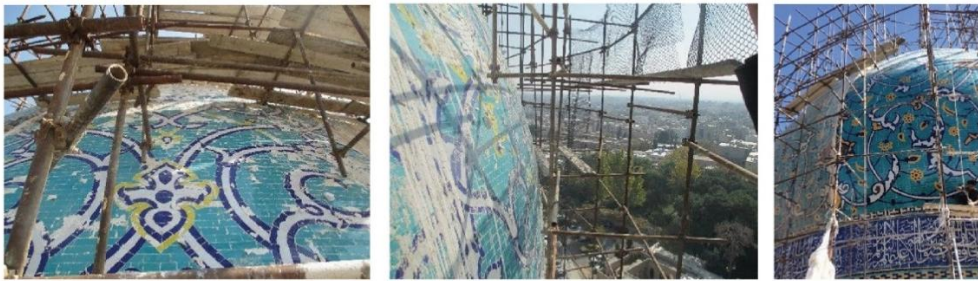
**Fig. 30.** Dome of *Jame-Abbasi*, after *Dough-ab* pouring and jointing, but before cleaning (source: CHO)

After *Dough-ab* pouring, it is the time for jointing (*Band-keshi*) and filling the cracks between the tiles and *Parchehs* through moisturizing the cracks and then filling them with a mortar of sifted gypsum, known as *Narmeh* (fig. 30). The surplus mortar will be later cleaned by cloth. All these steps are carried out separately and identically at each *Tark*.

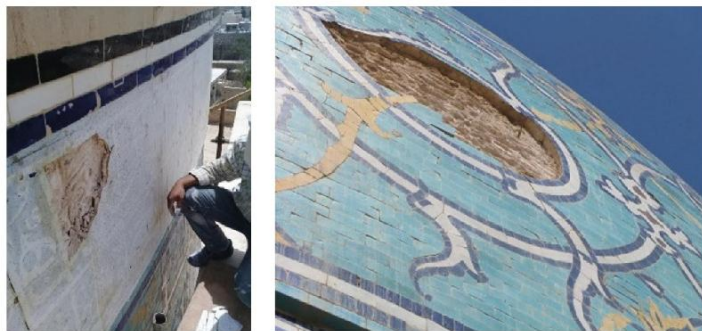
**Fig. 31.** Local restoration of dome's tiling (source: CHO)

This method is applied when parts of the dome's tiling have undergone local or scattered damages without needing to be totally restored (Fig. 31), such as cases when only several tiles needed to be repaired within each *Tark*. In some other cases only the mortar to the back of the tiles should be renewed; otherwise, new tiles with the same color and dimensions should replace the damaged ones. After removal of the powder gypsum or worn mortar and soil, first the supposed surface should be water-sprinkled so that the surface does not absorb the water of the mortar, and then the roughness of the surface becomes flat using a layer of gypsum mortar. Then these parts are filled with the mortar, and tiles are laid out one by one and finally leveled. Sometimes local restorations end up with the re-jointing and filling of cracks.

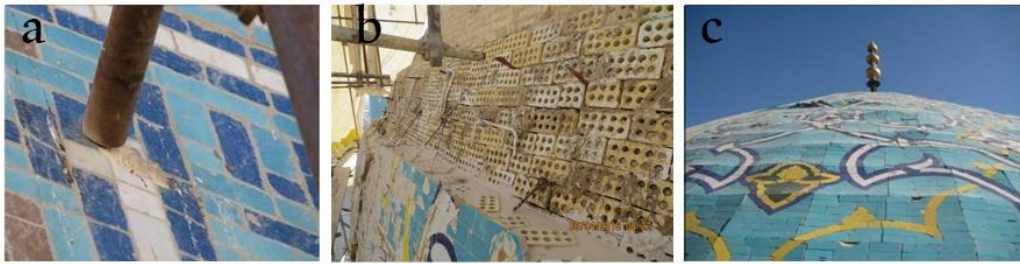
**Fig. 32.** a: Dome of *Jame-Abbasi Mosque*, damaged and broken tiles due to pressure exerted by buttress (Motalebi 2010); b: Dome of *Chahar-bagh school*, use of jackhammer to remove old mortar and its separation from tiling [39]; c: Dome of *Jame-Abbasi Mosque*, installation of anthraxs after that of tiles' *Parchehs* (Motalebi 2012)
