INTERNATIONAL JOURNAL CONSERVATION SCIENCE

DOI: 10. 36868/IJCS.2025.03.06

RESTORATION OF ARCHITECTURAL OBJECTS' STUCCO DECOR: UKRAINIAN EXPERIENCE

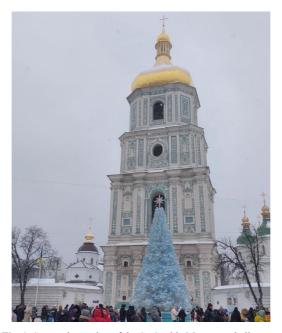
Fig. 1. Stucco decoration of the St. Sophia Monastery bell tower.

which were combined with ornaments in the form of flowers, leaves, and sometimes angels' figures. The moldings of window and entrance openings were also complexly profiled and decorated. A lot of stucco decor instead of traditional sculptures in Catholic Baroque distinguishes the Cossack Baroque of the Hetmanate (Fig. 1).

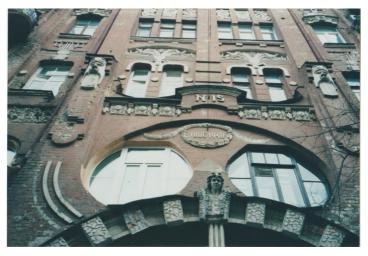
Fig. 2. Fragment of the facade of a building at 15 Arkhitektora Horodetskoho Street in Kyiv.

It is worth noting that the preservation of stucco decor has always been a problem, as it was primarily lost because of numerous repairs, reconstructions, unsuccessful restorations, and changes in the function of the object. At the same time, even if the facade decor is more or less preserved, the decor in the interiors of historical buildings is in a much worse condition (Figs. 2-4).

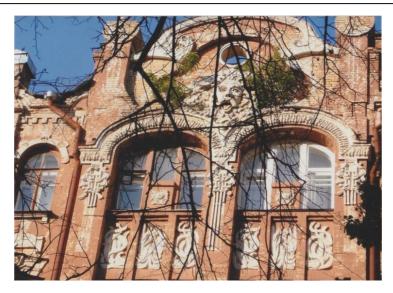
Fig. 3. Crowning stucco decor of the house at 15 Arkhitektora Horodetskoho Street in Kyiv.

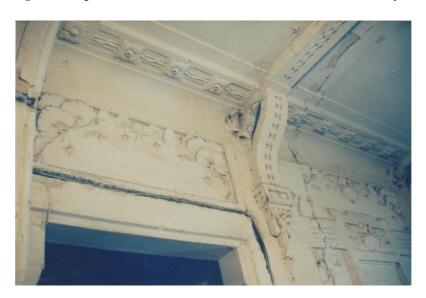
Fig. 4. Smoothing the original decor of the stairwell in the house at 21 Yevhena Chykalenka Street.

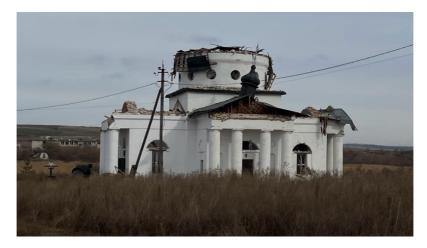
Fig. 5. The St. George's Church in the village of Oleksandro-Shultyne, in the Donetsk region, destroyed on August 4, 2023

The war, which has been ongoing in Ukraine with varying intensity since 2014, has increased the amount of destruction, especially in the east and south of Ukraine. It is already possible to predict a large number of historical sites that need to be rebuilt and restored. The problem is that the information needed for restoration mainly concerns known sites, while in the regions, there is often no information about how the site looked before the war, and there are no

relevant drawings, measurements, or photo recordings (Figs. 5, 6). The most difficult task will be to recreate sites in a state of ruin.

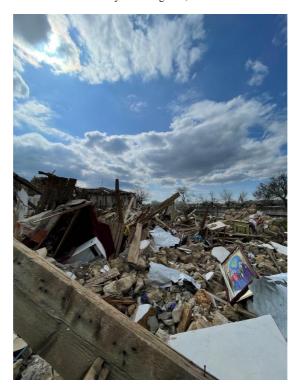
Fig. 6. Ruins of a village church in the Mykolaiv region.

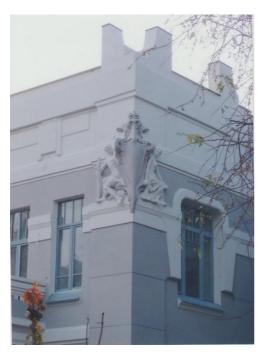
Fig. 7. Fragment of the facade at 14 Zahorivska Street.

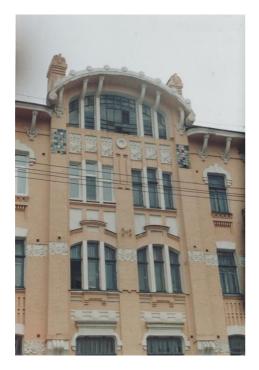
Fig. 10. The central part of the facade of the tenement house at 19 Bulvarno-Kudriavska Street.

phenomenon (Fig. 10). In the most expensive residential buildings, stucco decoration was used to decorate both apartments and the main staircase and lobby (Fig. 11).
