## PRESERVATION, RECONSTRUCTION, AND EXPANSION OF THE FORMER SILK FACTORY COMPLEX IN LODZ, POLAND. CASE STUDY

### Abstract

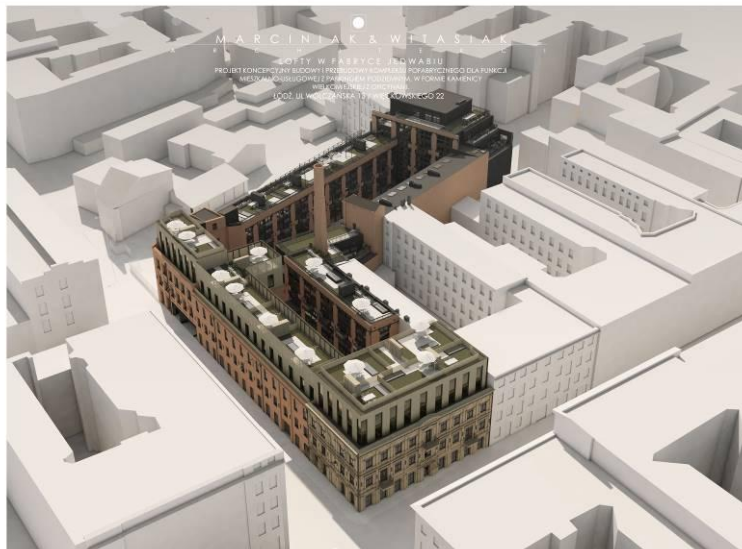
**Fig. 1.** The visualization of the factory complex.  
Author of the project: Marciniak & Witasiak Architects

extremely diverse in terms of layout, area, and number of levels, which allows them to respond to the needs of a diverse group of new residents (Fig. 1).

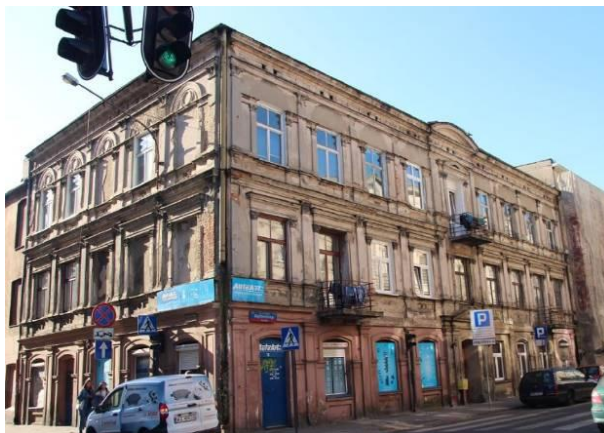
**Fig. 3.** View of the original tenement house from the intersection of Wólczńska Street and Więckowskiego Street in Łódź  
Author of the picture: Anna Połomka

The main goal of conservation works for the "Lofts in the Silk Factory" investment is to stop the deterioration and restore functional and historical properties. The tenement house at the intersection of Wólczajska and Więckowskiego streets in Łódź is a two-story tenement house preserved in the Neo-Renaissance style (Fig. 3,4). The tenement house is a two-story building and built in a nine-axis rhythm. On the eastern side, it has a five-axis façade with an entrance gate in the fourth axis. The entrance gate is crowned with a flattened arch. The vault in the gate opening is segmental, with straight side walls. Window and door finials are characterized by a flattened arch. The main windows on the named stories have a simple lintel. The Neo-Renaissance style, part of the broad historicism movement, showcased the fascination with Renaissance culture and art and the desire to recreate harmony and elegance. The building has classic symmetry and well-balanced proportions, modeled on Renaissance architecture.

The story divisions are distinguished by profiled cornices. Window and door disturbances evoke longing for the event and Renaissance inspirations by creating window bands, pilasters with simplified capitals, and composite pilasters. The central axis accessible at the front is accentuated by a doorway topped with a tympanum. The remains of the balcony slab balustrades and window joinery have not been preserved in the building. The door joinery is also secondary, made of steel, and characterized by a different form. The façade facing the yard is no longer as representative as the façade facing the street. It is simple, without an avant-corps located in the stairwell. The balcony slabs on the horizontal, eastern equipment are heavily damaged due to the lack of waterproofing, which is provided by the installed steel elements and subsequent local loosening of the plaster. They enable conservation research to uncover open

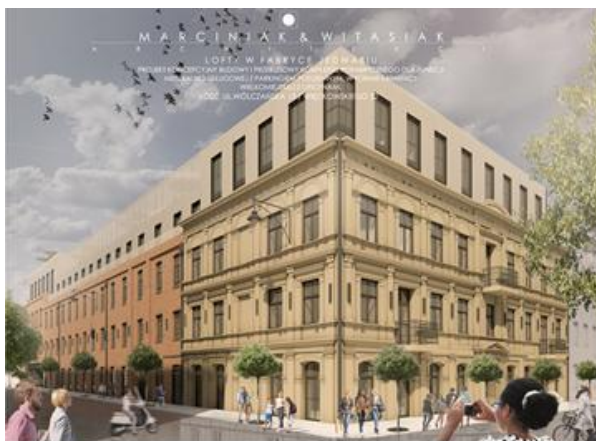
**Fig. 4.** Visualization of a revitalized tenement house with a planned superstructure and adaptation of a silk factory  
Author of the project: Marciniak & Witasiaak Architects

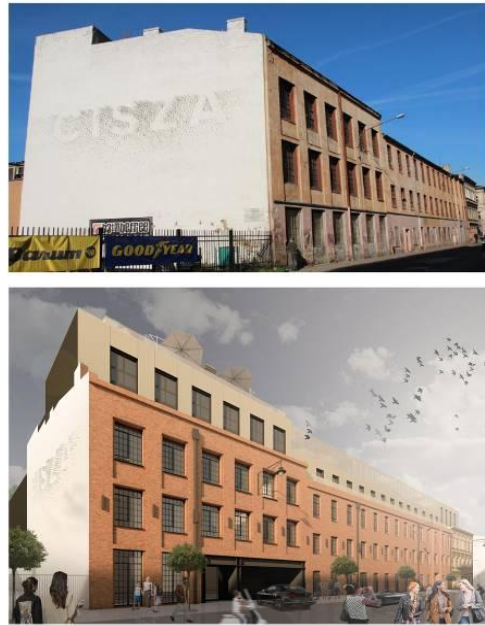
**Fig. 5.** Upper picture: Original façade of the silk factory building  
Author: Anna Połomka Lower picture: visualization of the project by Marciniak & Witasiak Architects

The factory building currently has a smoothly plastered and painted eastern façade. A spatial mural by Łukasz Berger was painted on the southern façade in 2015. The window openings are rebuilt in places, while on the ground floor they have nets. According to conservation studies, the plinth zone is heavily damp, which resulted in the plasters loosening in the ground floor zone (Fig.5,6). The building's window joinery is made of wooden profiles; its condition is poor, and the original layers of paint have not been preserved. The factory building is preserved in its original form. The plasters have shrinkage cracks, moisture and loosening, especially on the eastern side and in the ground floor area. The building's façade is characterized by secondary roofs.

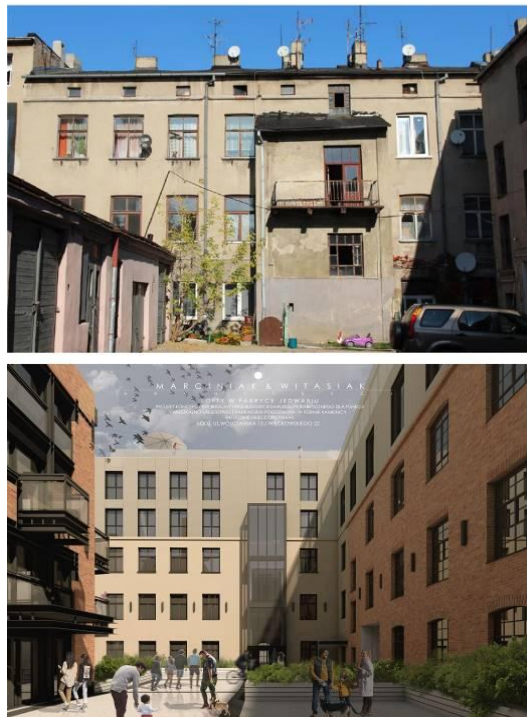
**Fig. 6.** Upper picture – original view of the tenement house from the courtyard.  
Lower picture – visualization of the project by Marciniak & Witasiak Architects  
Author of the picture: MSc Anna Połomka

The original locksmith windows made of cast iron profiles are preserved in their original form, are partially devoid of glazing, and are heavily covered with corrosion products. The gate opening located in the third axis from the north has been preserved in its original form. However, the original gates have not survived and were replaced with a modern steel gate. The interior of the gate opening has re-plastered walls and a preserved sectional vault. The wall surfaces in the lower zones are damp and have loose plaster and peeling layers of secondary paints. From the side of the yard, two cast iron bumpers have been preserved; one of them has a missing upper element in the form of a ball. The outcrop on the surface of the clearance wall revealed the presence of limestone. The interior of the factory building is devastated; the ceilings and walls are damp, divided, and modernized, and the interior has no historical value.

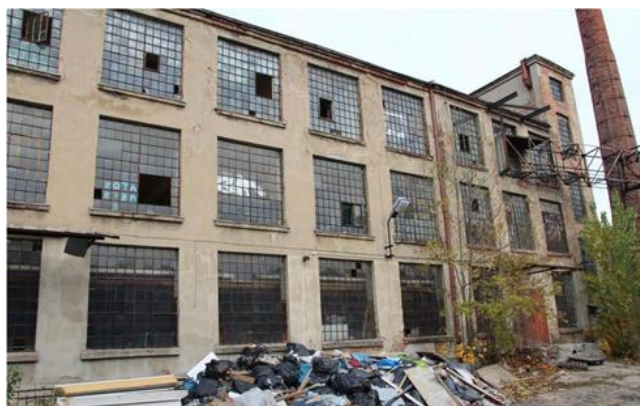
**Fig. 8.** The condition of the building's façade with the secondary roofing  
Author of the picture: MSc Anna Połomka

The building is a single-bay structure with reinforced concrete ceilings and brick walls, covered with a wooden roof. The original locksmith windows made of cast iron profiles are preserved in their original form, but the lack of glazing and corrosion can be seen. The steel gates have also been preserved but are now covered with secondary paint coatings. The interior of the building is neglected and re-adapted. Reinforced concrete ceilings and wall surfaces have peeling coatings of secondary paints. The author focuses on the analysis of the front elevation of the building B5 (Fig.7). Characteristic damages to the front façade include plaster defects on large wall surfaces, moisture and surface damage, oil stains on the façade, scratches on lintels, destruction of the ramp, dampness of the lower surface of the wall, and damage to the external stairs in the basement located near the southern wall (Fig. 8-10).

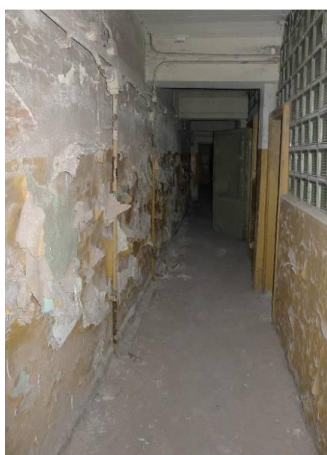
**Fig. 10** Building B5 – dampness in the northern wall in the basement. Author of the picture: Dr. Eng. Jan Kozicki

The technical condition of the building varies in different places. The condition of the wood in the roof truss is poor. There is a visible leaking problem as a result of wet ceiling lining and falling plaster, as well as wet ceilings and walls on all floors. Moreover, there can be noticed scratches in the ceilings above the ground floor. The condition of the wall should be assessed as poor because of the moisture visible on all floors and the accompanying plaster on the outer surface of the wall. The outer surface of bricks from both sides presents losses and destruction. Separation of cracks in concrete window lintels is known from the exact edge of the jambs.

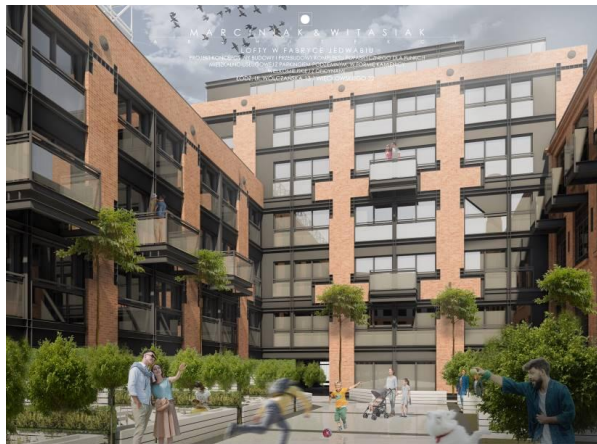
**Fig. 11.** Visualization of the inner courtyard. Author of the picture: Marciniak & Witasia Architects

After the technical and conservation expertise of the building, there were several recommendations that should be followed. The building should be protected against moisture. The method of foundation of the building should be verified, especially the northern walls. The results of ground tests in detail ought to be specified. There should be performed vertical and horizontal moisture insulation. The pillars between the windows have to be reinforced, as well as the scratched wall fragments, which should be secured. New stairs and ceiling protection must be considered, taking into account fire safety conditions. Designers had to create projects of the external partitions, taking into account the use of thermal protection (Fig.11) [8].
