## RESTORATION OF CEILINGS IN BUILDINGS DAMAGED AS A RESULT OF OVER-DESIGN IMPACTS, WHILE PRESERVING THE ESTABLISHED URBAN ENVIRONMENT

**Keywords:** Off-design impact; Restoration technology; Operational suitability; Hollow-core slabs; Historic heritage

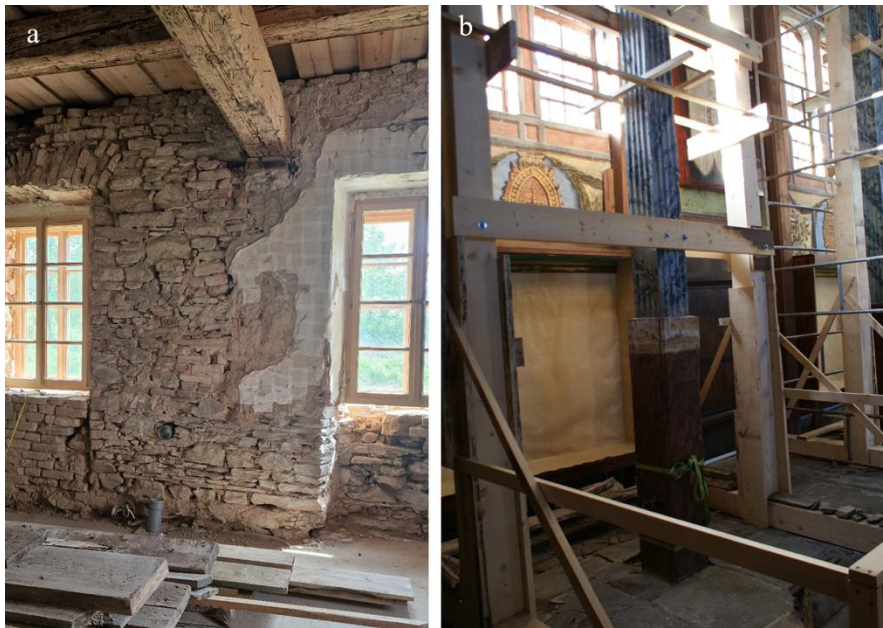
**Fig. 1.** Polish experience in the repair and structural reinforcement of historical buildings. Renovation of the manor complex in Wrocanka and the wooden church of St. Mary Magdalene in Rabka-Zdroj

their cultural value. In this regard, Ukrainian researchers often benefit from international experience and consultations, including with researchers from Poland (Fig. 1), with whom they work together for the reconstruction of Ukraine [1-4].

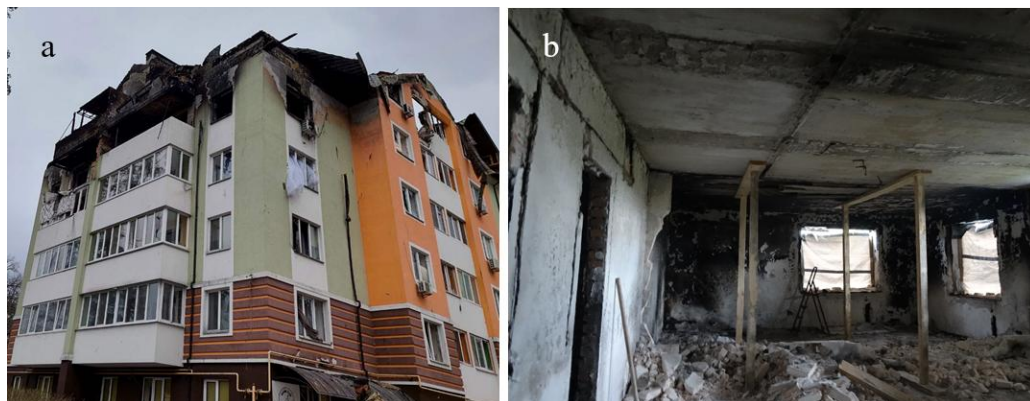
**Fig. 3.** A multi-story residential building in Irpin damaged by the shelling: left—exterior; right—interior

Hundreds of high-rise and low-rise residential buildings in Irpin, Bucha, Borodianka, Kharkiv, Mykolaiv, and other cities are examples of the above damage (Fig. 3).

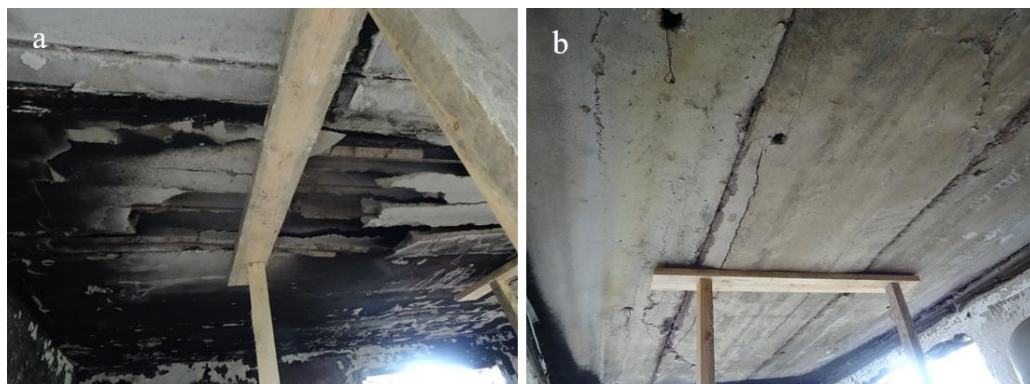
**Fig. 4.** General view of ceiling damaged by thermal impact: left – slab body falling out; right – lower zone cracking

Damage to reinforced concrete floor slabs caused by hostilities includes deterioration of the physical and mechanical characteristics of the materials from which the slabs are made due to high temperature or fire; formation of holes; breakage of reinforcing elements; and falling out/destruction of the body of the elements. The general view of damaged hollow-core slab floor structures is shown in Figure 4.

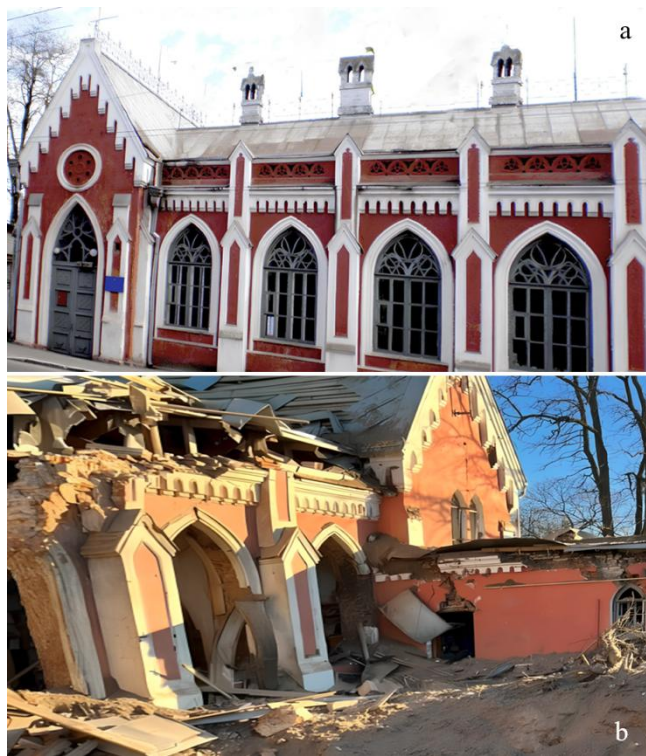
**Fig. 5.** Exterior of the regional youth library in Chernihiv: above – view as of the 2010s; below – view after damage

An example of a historic building that has suffered damage to its structures, including ceilings, is the regional youth library in Chernihiv. The library building is an architectural monument of the late nineteenth century. It was damaged as a result of full-scale military aggression on March 11, 2022. Due to the blast wave, the supporting and enclosing structures were damaged (walls, roof, windows, ceilings), as well as interior and exterior finishes (Fig. 5).

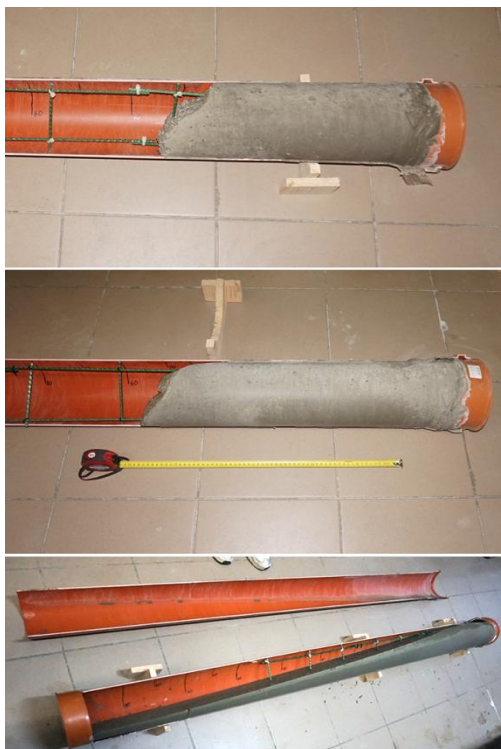
**Fig. 8.** Results of filling the pipes with concrete mixtures: from top to bottom – mixture No. 1; mixture No. 2, and mixture No. 3

The concrete mixture was placed through a hole in the upper part of the pipe. After the concrete mixture was placed, a technological break was maintained for its hardening, after which the pipe was disassembled and the results were evaluated. The appearance of the concrete obtained from each of the experiments is shown in Figure 8.

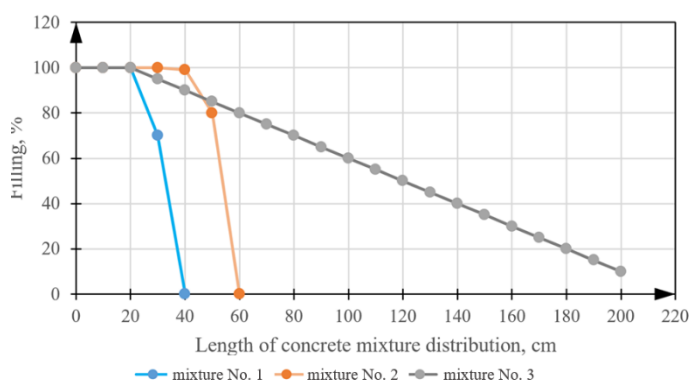
**Fig. 8.** Graph of the percentage of void filling along the pipe length

For a more visual representation of the research results, a graph of the percentage of cavity filling along the length of the pipe was constructed (Fig. 9), as well as the dependence of the concrete mixture distribution length in the pipe on the cone spread (Fig. 10).

Following the experiment results, it was found that for the void filling to the furthest possible distance, it is necessary to use a concrete grout with the largest cone spread. However, the concrete grout alone does not allow for achieving a sufficient percentage of the void cross-section filling; in the most distant zone, the filling is only about 10%.

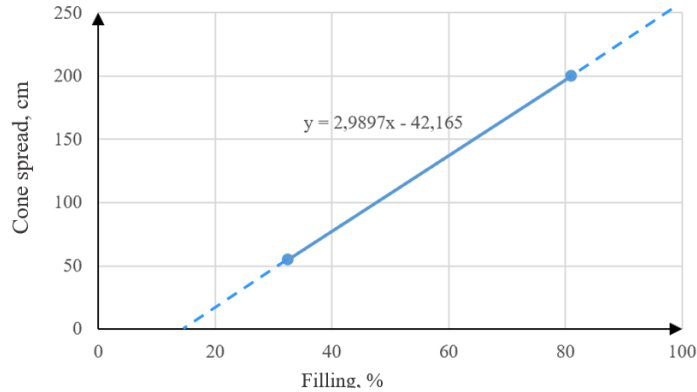
**Fig. 10.** Dependence of the concrete mixture distribution length in the pipe on the cone spread

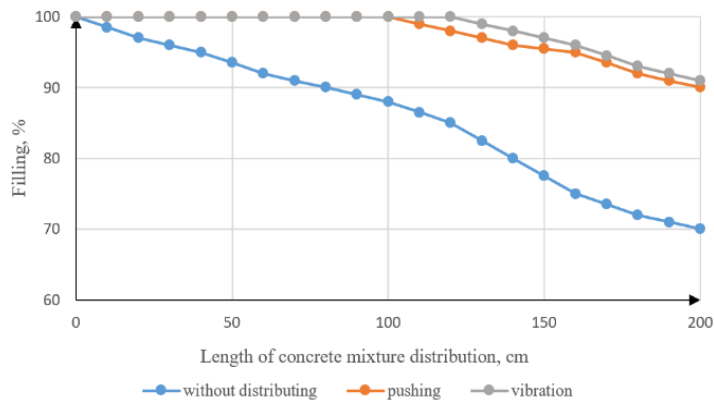
**Fig. 12.** Dependence of pipe section filling on the method of mixture distribution

The experiment results are listed in Table 2. Based on these data, the dependence of the filling of the pipe cross-section with concrete mixture on the method of its distribution was constructed (Fig. 12).

According to the experiment results, the use of additional technological methods made it possible to significantly increase the filling of the pipe section along its length. The greatest filling of the pipe cross-section was achieved by vibrating the concrete mixture, although the difference, compared to pushing, is insignificant (less than 5%).

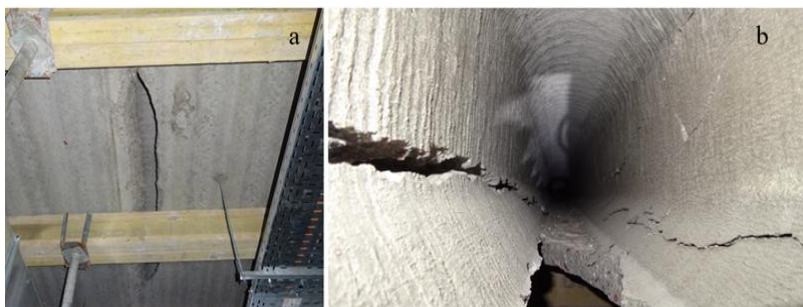
**Fig. 14.** Appearance of the damaged floor slab: left – bottom surface; right – interior space

The experimental studies' results were tested at one of the construction sites damaged by off-design impacts. The damaged floor slabs were restored to serviceability. The slabs to be restored had damage to the lower surface, in particular, destruction of the lower zone body, cracking of the slab body, loss of structural integrity, loss of individual reinforcement (individual ropes), pretension, etc. (Fig. 14). It was decided to use this method for the restoration of the damaged slabs' serviceability. This involves installing reinforcing cages in the voids and then filling them with concrete. Before the work, the slabs were calculated to determine the need for additional reinforcement.

The initial data for the calculation were slab width  $b = 1200\text{mm}$ ; slab thickness  $h = 400\text{mm}$ ; slab span (between supports)  $L = 11,800\text{mm}$ ; protective concrete layer  $a = 40\text{mm}$ .
