RESEARCH WORK IN DEVELOPING DESIGN SOLUTIONS ON THE EXAMPLE OF SOIL REINFORCEMENT UNDER THE FOUNDATIONS OF SUPPORTS OF STAIRS TO THE MAGDEBURG LAW MONUMENT IN KYIV

Keywords: Stairs; Magdeburg Law Monument; Restoration work; Experimental research; Chemical soil consolidation; Polyurethane materials; Structural and technological solutions; Injection

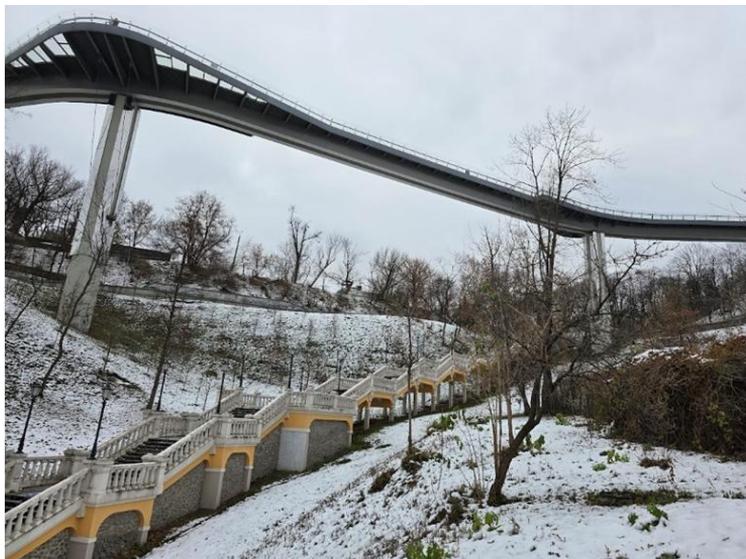
Fig. 1. General view of the territory with the already constructed pedestrian and bicycle crossing and stairs to the Magdeburg Law monument.

(Khreshchatyi Park), planned in the form of several terraces, opening onto the Dnipro River valley. According to [2], the territory belongs to the III (complex) category of complexity of engineering and geological conditions. Currently, a staircase runs through the territory of Khreshchatyi Yar. These stairs start from the upper entrance on Volodymyrskyi Descent, repeat the bend of the ravine, and extend to the Magdeburg Law Column and below – to Naberezhne Highway [3]. A general view of the territory with the already-built pedestrian and bicycle crossing and stairs to the Magdeburg Law Monument is presented in figure 1.

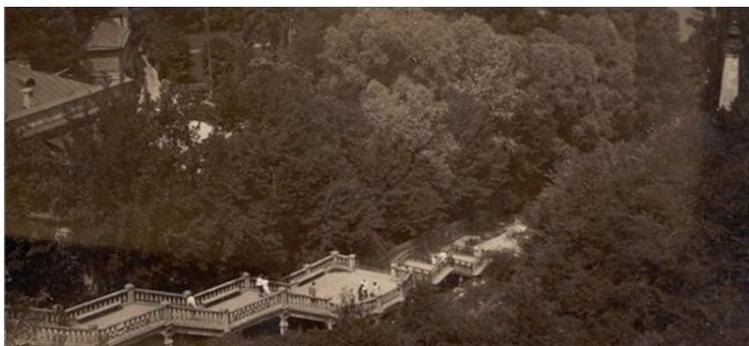
Fig. 3. 1920s. Stairs to the Magdeburg Law Column [4]

The construction of the concrete stairs began in March 1914. Thus, the passage to the Embankment was closed and the wooden stairs, which were in a dilapidated state, were dismantled. At the first stage of construction, an entrance was built from the side of the Oleksandrivskyi (now Volodymyrskyi) descent in the form of a brick arcade and concrete-granite stairs to the column, raised above the ravine on concrete risers [3]. However, further work on the construction of the second stage (the main stairs below the column and the entrance from the Dnipro embankment) was not carried out (Fig. 2). Figure. 3 shows the view of the stairs after their repair [3].

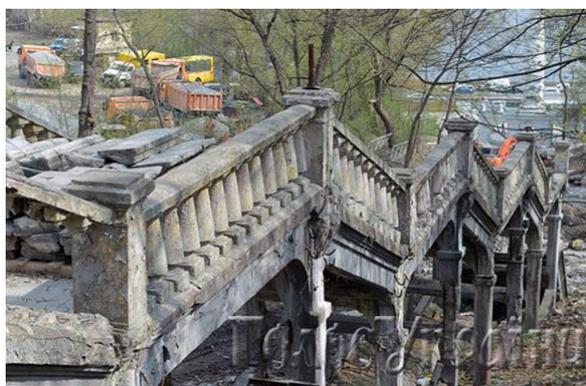
Fig. 4. Condition of the stairs before their reconstruction in 2013 [5]

repair of the stairs was carried out in 1974. The last reconstruction of the stairs (Fig. 4) and the colonnade devoted to the 1025th anniversary of the Baptism of Rus was carried out in 2013.

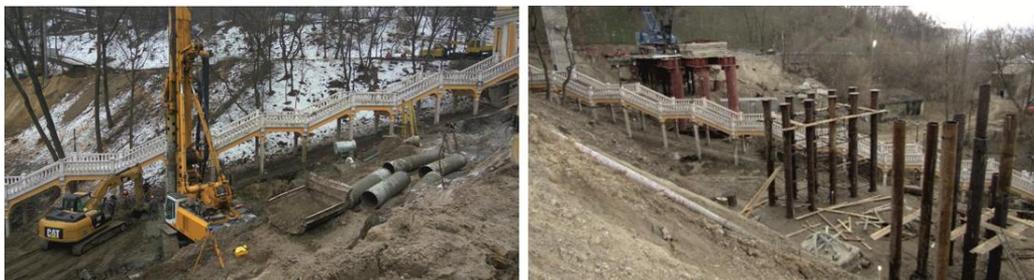
Fig. 7. View of temporary supports during their construction (2019).

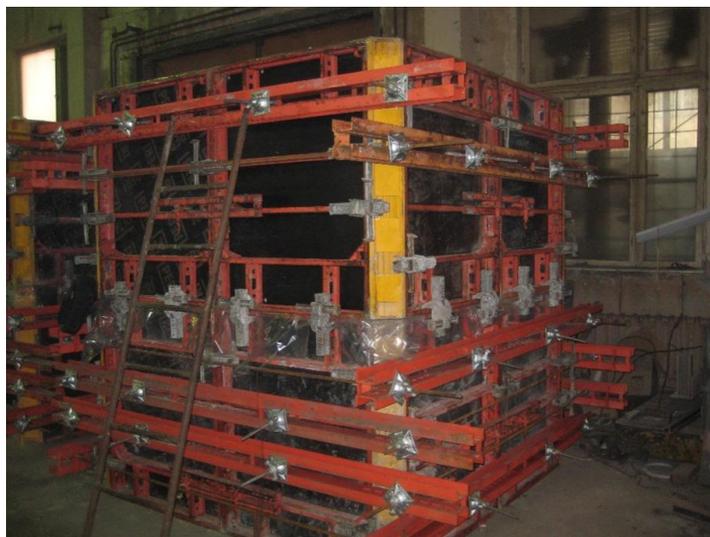
The limiting structures of the stands were composed of formwork structures (Fig. 10). The main task of the formwork was to hold the specified, initial soil stamp without moving to the sides when acting on it.

Fig. 10. The limiting structures of the stands are made of formwork.

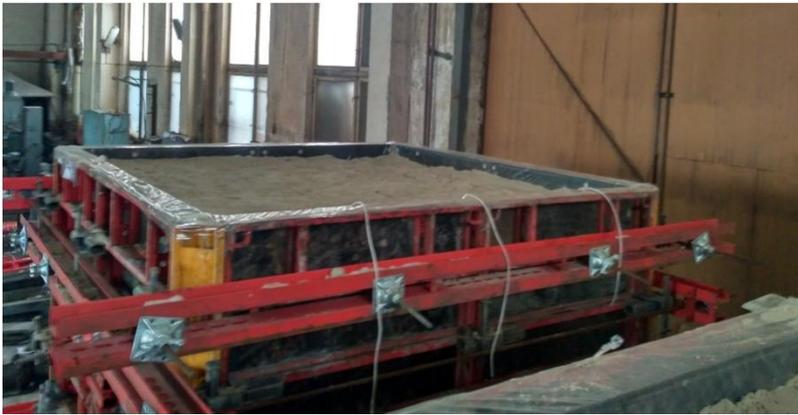
The sandy soil was poured into the formwork structures in layers (10–15cm) and compacted with a light rammer (Fig. 11).

Fig. 11. Sandy soil poured into experimental stands.

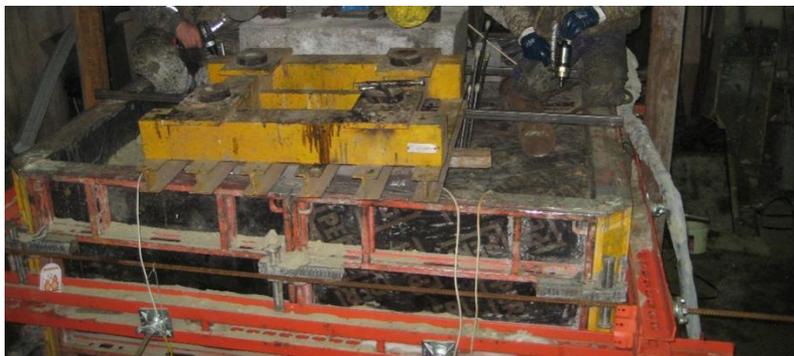
A day before the experimental studies, polyurethane materials were injected into the soil of the stands to strengthen the sandy soil (Fig. 12).

Injection of polyurethane material was performed as follows. Three injection steel tubes $\text{Ø} 12\text{mm}$ were sunk into the places indicated in Fig. 9 so that the lower ends of each of the three tubes were placed at a distance of 500 mm from each other, the upper ends were 200 – 350mm above the ground level. Plastic injectors with a check valve were screwed into the upper ends of the injection tubes.

Fig. 12. Injection of polyurethane materials.

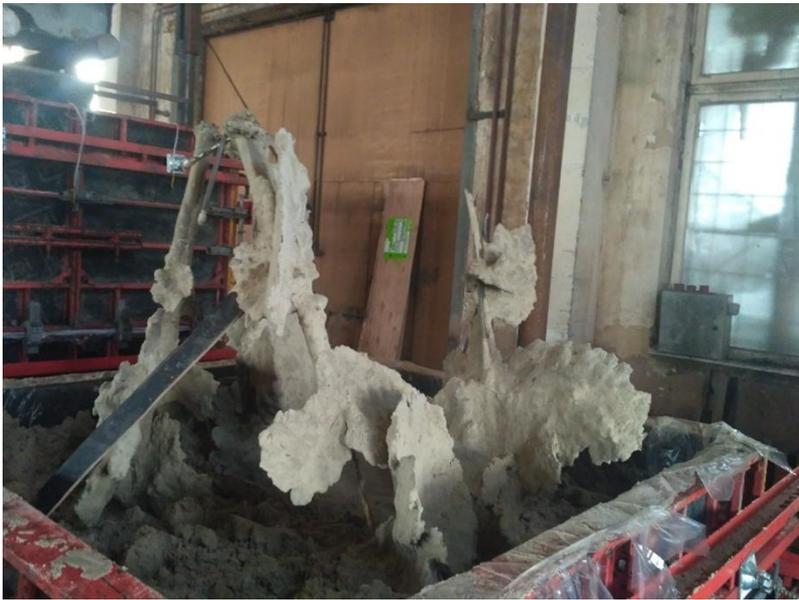
At the next stage, the soil was removed from the stands, without violating the structural integrity of the chemical consolidation itself. As a result, it was found that at the points where the injection material exited the tubes into the soil, soil-polyurethane plate-like branches were formed, which broke the soil masses, compacting them and fastening them by binding (Fig. 13). At the lowest points where the largest volume of material was injected, it spread to a distance of up to 80 cm from the point of exit from the tube.

Fig. 13. Stand with removed soil and formed chemical fixation.

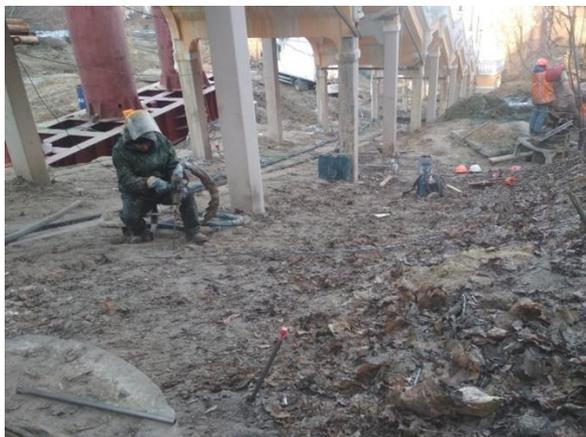
The injection process begins by connecting the injection gun, with the transport hoses connected to it, to the injector (Fig. 16). Injection begins immediately after pressing the lever on the gun and stops after releasing it.

Fig. 16. The process of injecting polyurethane material into the soil under the foundations of the staircase supports at the construction site.
