## PRELIMINARY DESIGN STUDIES OF THE SCULPTURAL DECOR OF A RENAISSANCE HOUSE AT 23 RYNOK SQUARE IN LVIV

*The Scholtz-Wolfowitz' house at 23 Rynok Square in Lviv is a characteristic monument of Renaissance architecture. The history of its construction is complex and has not yet been fully elucidated. Pre-project studies conducted in 2008, as well as a detailed literary and archival search, allowed us to clarify the periodization of the development of the building's sculptural decoration. Laboratory studies confirmed the stages of formation of the elements of the architectural decoration and polychromy of the tenement house, and their conclusions became the basis for forming the concept of restoration work. This article is devoted to the methodological aspects of pre-project analysis and the development of practical recommendations for the restoration of valuable Renaissance objects in Lviv.*

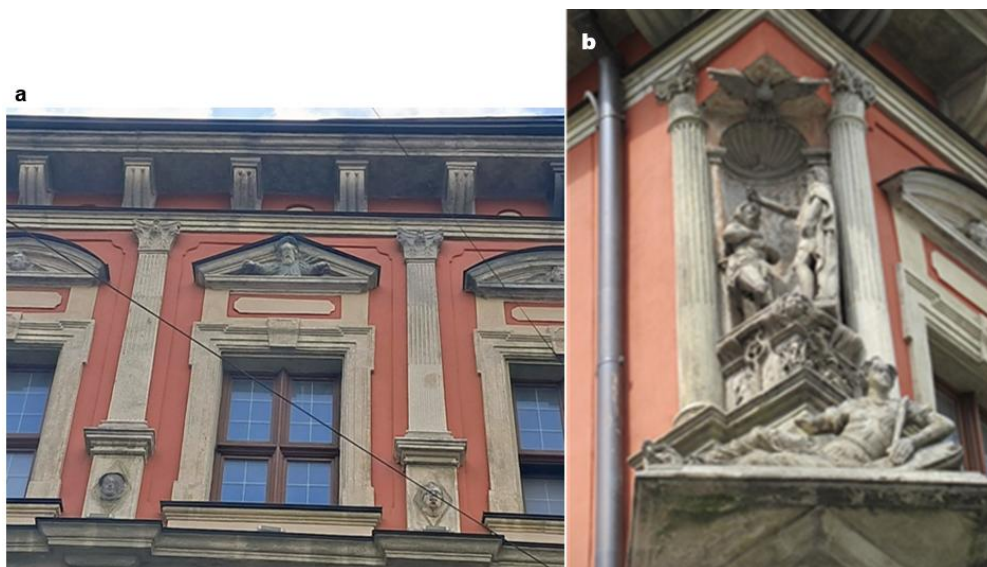
Fig. 2. Image of God the Father in the pediment of the middle window of the second floor (a) and the “Baptism” of the corner aedicula (b)

- first and second floor cornices. In the tympanums of the second-floor cornices, there are high reliefs: God the Father above the middle window and two cherubs above the windows on both sides (Fig. 2a);

- the composition “Baptism” of the corner aedicule (Fig. 2b). The flanking pilasters, which are compositionally and proportionally tied to the general arrangement of the facade, speak in favour of the simultaneous execution of the aedicule with the rest of the architectural decor of the facade. This is also evidenced by the nature of the execution of the sculptures of the aedicule, which are similar to the sculptures in the cornices above the windows. The slab on which the allegory of Faith is placed is supported by an aedicule pedestal, which indicates that it was built during the house’s construction;

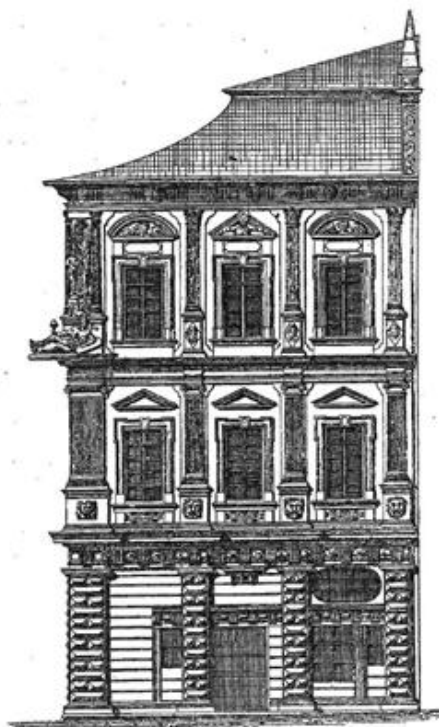
**Fig. 4.** The facade of the Scholtz-Wolfowitz house at 23 Rynok Square in Lviv. Corresponds to the second stage of development of the façade's sculptural decoration [4]

The following elements can be attributed to the second period of the first stage of the formation of the facade, which are only elegant sculptural decorations and carry only a semantic and aesthetic load (Fig. 4):

- coats of arms of the Haz and Scholtz-Wolfowitz families on the pedestal of the aedicule;
- portrait mascarons on the pedestals of the pilasters at the same level;
- cartouches with sayings under the windows of the first floor.

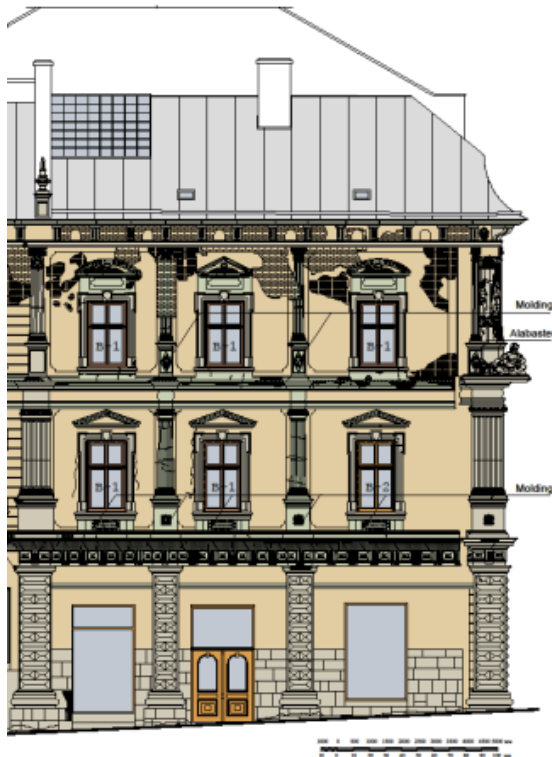
**Fig. 6.** Cartogram of losses and materials of the Scholtz-Wolfowitz' house at 23 Rynok Square. Facade from the side of Katedralna Square

Based on the results of field surveys, a cartogram of losses and materials was formed, which is presented in figures 5 and 6.
