## RENOVATION OF A SACRED OBJECT MADE OF LIMESTONE, ADAPTING IT TO THE CONDITIONS OF CONTEMPORARY USE

*The paper presents a selected sacral object built of limestone located in the Kraków-Częstochowa Upland in the town of Kalej. It is an interesting object of local religious culture worth recording in the literature due to its unique character and scarce publicly available information about it. The Kraków-Częstochowa Upland is located in southern Poland, in the upper Vistula and upper Warta river basins, also called the Kraków-Częstochowa Upland, and covers an area of 2615km<sup>2</sup>. This area was formed in the Mesozoic era in the Jurassic period and is characterized by the occurrence of sedimentary rocks in the form of limestone. In the Jurassic area, limestone was once the basic building material characterized by high durability and exceptional colors. It was commonly used to build monumental castles, churches, and residential and farm buildings. The paper presents a historical outline of the construction of the sacral object and the maintenance and modernization works performed over the years to adapt it to the current conditions of use and religious worship.*

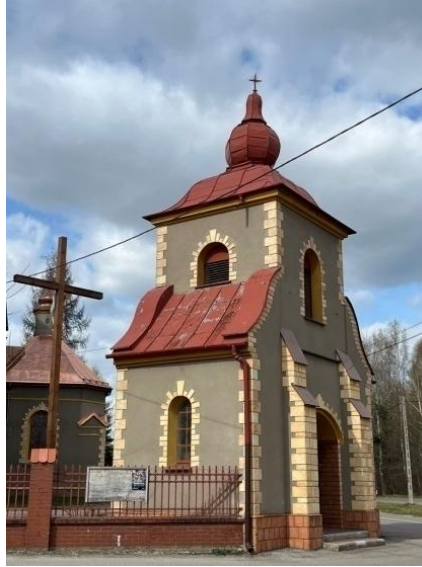
**Fig. 4.** A contemporary view of the belfry in front of the church in Kaleja

In the years 1930-1936, the parish priest, Father Edward Dyja, built a belfry in the corner of the church plot, which was also the entrance gate to the church (Fig. 4). The technology of the belfry construction was identical to that of the main church building, using limestone on lime mortar [11, 19].

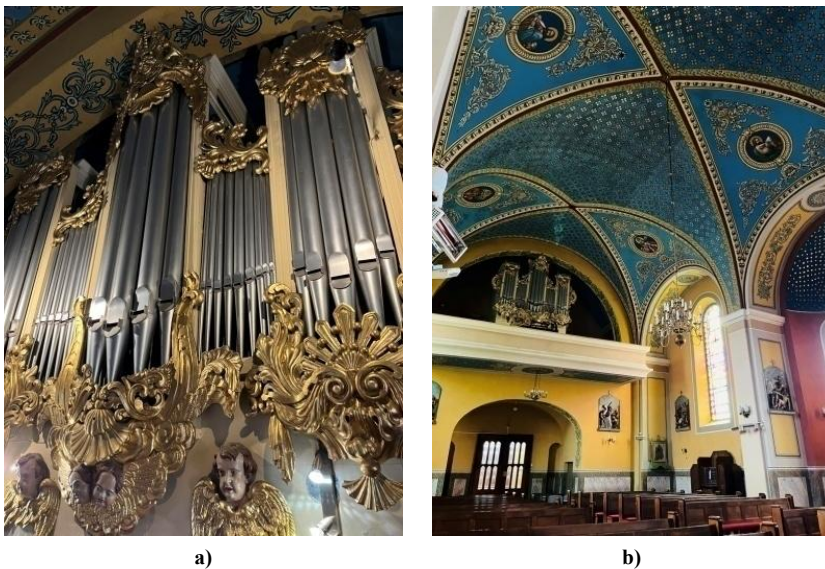
**Fig. 5.** Contemporary view of the pipe organ in the church in Kaleja: a) close-up, b) view from the main nave

At the same time, a seventy-year-old, long-awaited pipe organ was purchased, made in 1852 from larch wood by the Krakow master Ignacy Wojciechowski, whose internal mechanism was modified by Józef Szymański in 1862. The organ came from the Church of Saint Barbara in Częstochowa and had previously been in Jasna Góra (Fig. 5) [11, 14].

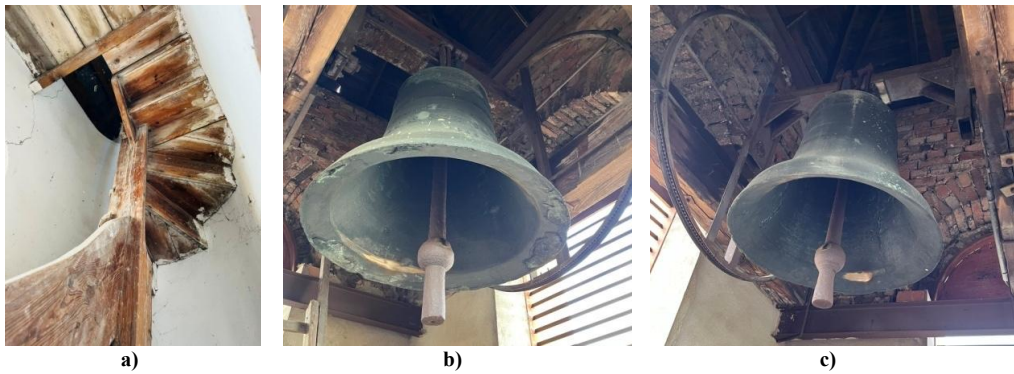
**Fig. 7.** Contemporary view of the bells in the church tower in Kaleja: a) wooden stairs from 1927 leading to the belfry, b) the Mary bell, c) the Saint Stanislaus Kostka bell

In 1949, the next parish priest, Father Maciej Namysło, thanks to the generosity of the parishioners, introduced changes to the church building. An iron gate was purchased and installed in place of the entrance door to the church building. Wooden, richly carved entrance doors to the church were installed. Additionally, two bronze bells were made: a smaller one weighing 257kg and a larger one weighing 400kg. These corrosion- and abrasion-resistant bells made of an alloy of copper with tin, zinc, and lead were cast in the company of Jan Uciechowski from Wągrów near Warsaw. The smaller bell was baptized with the name Saint Stanislaus Kostka and was inscribed with the following inscription: "I call and ask that the Youth of the Way follow in your footsteps and be a comfort to your parents," while the larger one, named Mary, has the following inscription engraved: "Most Holy Mother, take care of our parish." On Christmas Day in 1950, the parishioners could hear their first sound (Fig. 7) [11, 14].

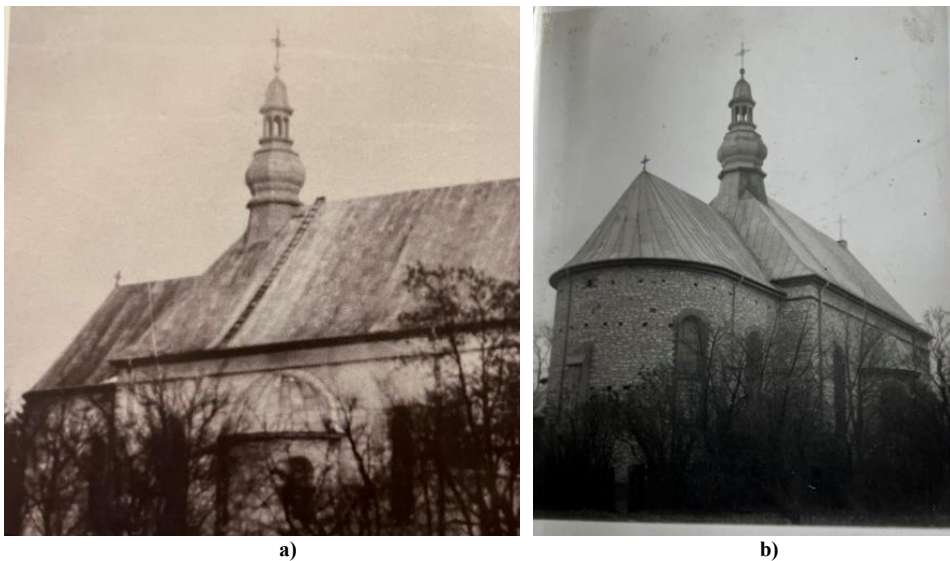
**Fig. 8.** View of the church from 1952-1960: a) western elevation [4], b) northern elevation [14]

In 1952, work began on modernizing the roof of the church. The old roof tiles, with their numerous cracks or gaps, caused rainwater to enter the building through the cracks, causing the church to deteriorate. Therefore, the entire roof covering was replaced with galvanized sheet metal (Fig. 8).

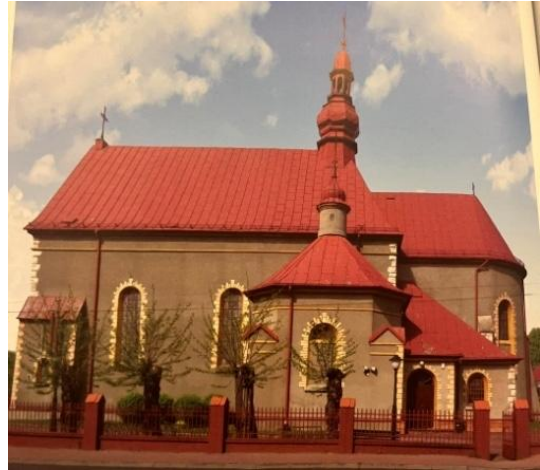
**Fig. 10.** View of the church today: a) main entrance, b) right elevation [14]

Another parish priest, Wojciech Galon, installs an iron gate in the belfry, which is the entrance to the church plot from the outside. In 1961, a general renovation of the pipe organ was carried out, including the installation of an electric drive and the replacement of wooden pipes. The window directly above the organ was also bricked up to protect it from sunlight. The next stage was plastering the church from the outside and securing the roof covering with galvanized sheet metal with anti-corrosion paint [11]. The building received a new look from the outside (Fig. 10).

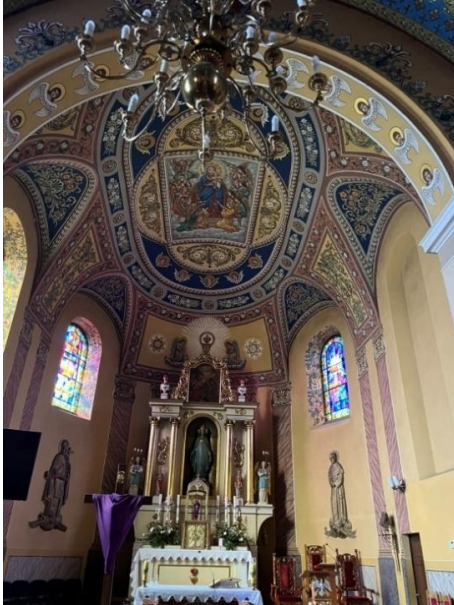
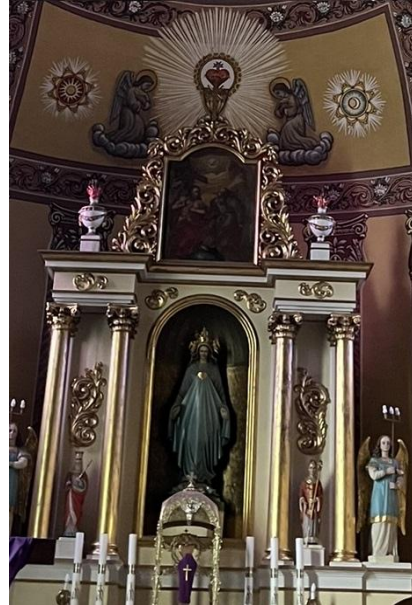
**Fig. 11.** Contemporary view of the main altar in the church in Kaleja:  
a) view from the main nave, b) figure of Our Lady Queen of Angels with angels

At the same time, an important event for the faithful was the construction of a new main altar inside the church. It was built entirely on a stone base of sandstone, a fine-grained sedimentary rock created by combining quartz and mica with the addition of a silica or clay binder. The stone part was custom-made in Krakow, and a mensa and an ornate extension were made entirely of wood on it. A figure of Our Lady Queen of Angels with angels was placed on the richly decorated extension (Fig. 11). The entire altar of Saint Barbara was moved to the left side aisle, where it stands to this day.

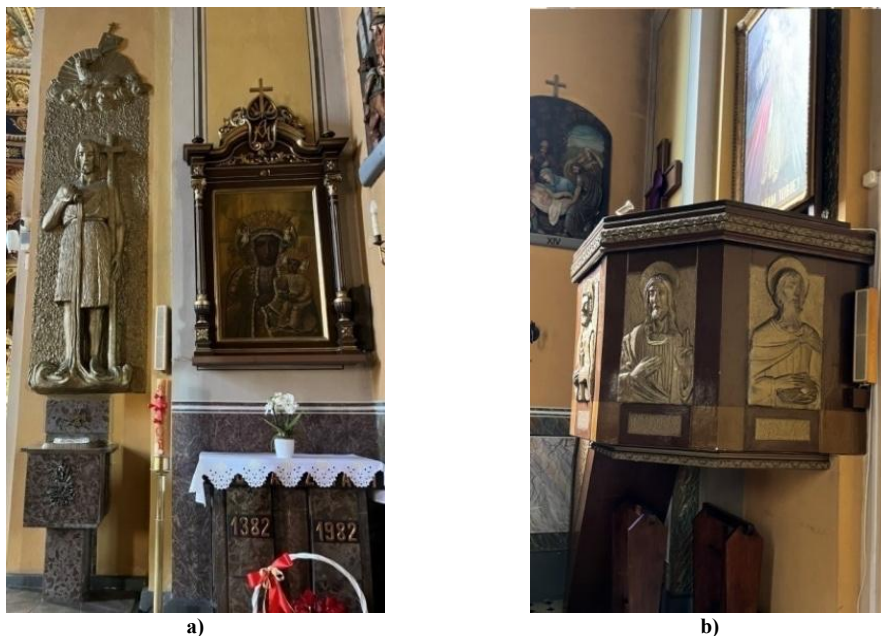
Fig. 12. View from the interior of the church in Kaleja: a) the baptismal font on the right, b) the pulpit on the left

were purchased. A reinforced concrete pulpit was built, decorated with bas-reliefs of Christ and the apostles Peter and Paul (Fig. 12). Directly above the pulpit, the text of the Ten Commandments was placed, along with a sculpture of a dove [11, 14].

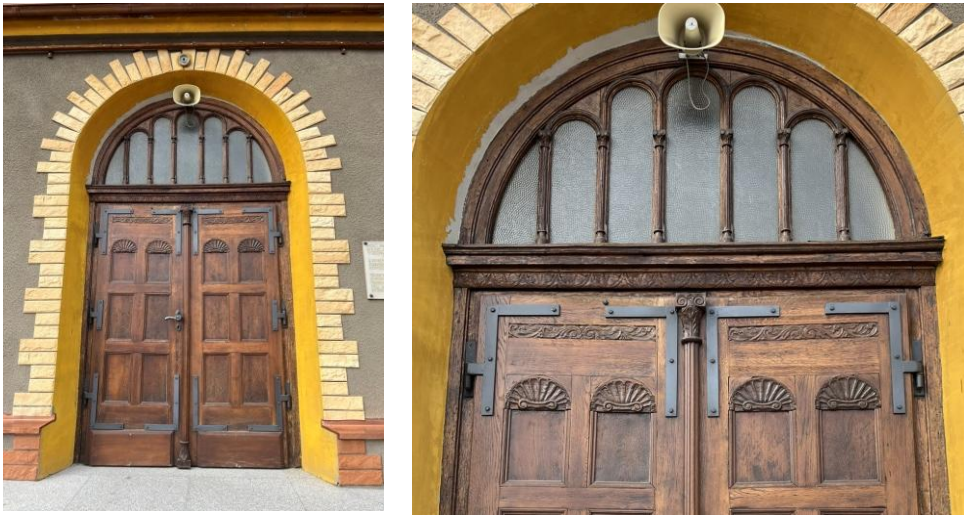
**Fig. 14.** A contemporary view of the main door in the church in Kaleja

Since 2016, the parish priest has been Father Mariusz Foltyński, who is renovating and modernizing subsequent elements of the church building. In order to prevent dampness of the external walls of the church building, he is performing drainage around the building and draining rainwater from the roof. A year later, an alarm system was installed, monitoring was also installed, and additional grounding was made. In order to increase the safety of both the parishioners and the church building itself, a lightning protection system was installed. In the same year, the almost 100-year-old wooden entrance door of the church was renovated (Fig. 14) [11, 14].

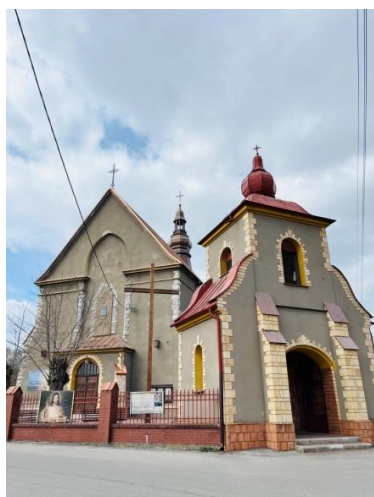
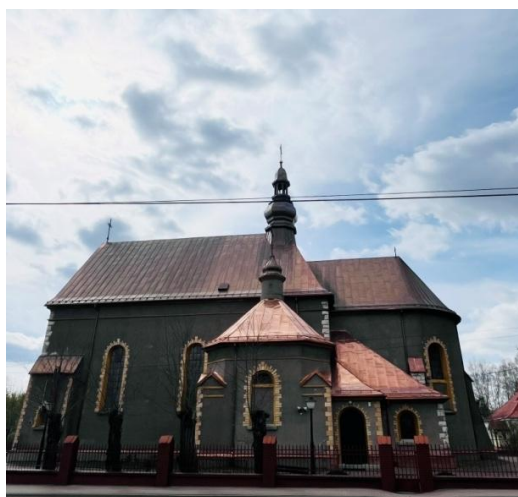
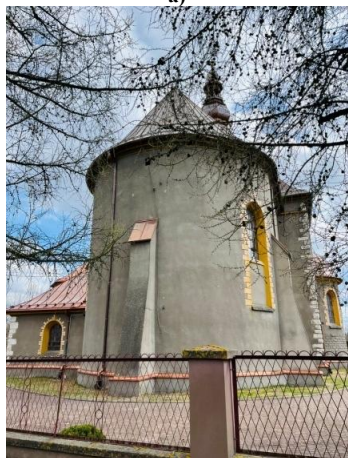
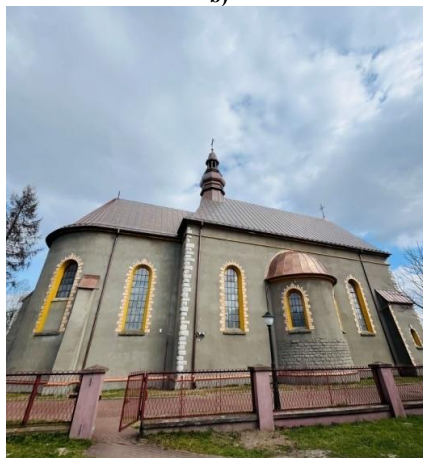
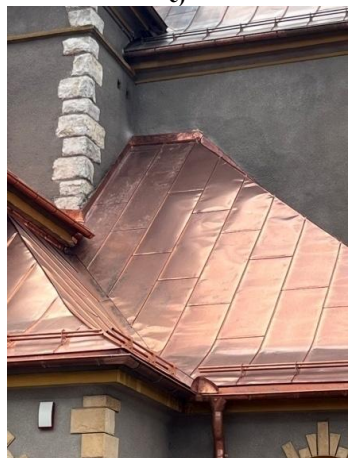
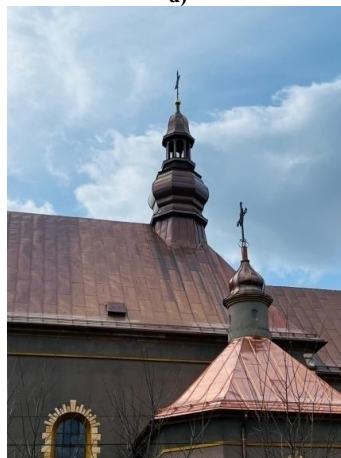
**Fig. 15.** Contemporary view of the Church of the Blessed Virgin Mary Queen of Angels in Kaleja: a) front elevation and view of the bell tower, b) elevation from the right side, c) elevation from the back, d) elevation from the left side, e) view of the new roof slope on the right side of the church, f) view of the renovated turrets

In 2020, the process of adapting the church building for people with mobility disabilities began, and a ramp to the main entrance was built for this purpose, and new stairs were built, secured with railings. In the same year, efforts began to renovate the roof of the church building and the tower. The roof renovation consisted of cleaning and impregnating the roof truss, replacing its worn-out elements, and then replacing the entire roof covering from galvanized sheet metal with copper roofing along with gutters. These works were completed in March 2025. Additional finishing touches were made in the form of copper fittings on plinths protruding from the face of the wall around the building and on the upper part of all buttresses placed outside the building, which were intended to protect the walls from moisture, and additionally, the downpipes were replaced with copper ones (Fig. 15).
