## REVITALISATION OF THE CZEPURKA MANOR HOUSE: BALANCING LEGAL, TECHNICAL AND FUNCTIONAL CHALLENGES

### Abstract

*The paper analyzes the conservation (legal), functional, and technical challenges of the revitalization of the Czepurka Manor House located in Poland. The conservator's requirements were verified against the possibility of revitalizing the manor house, an analysis was made of currently available building materials and the possibility of their use in the restoration of the structure, and the architectural work carried out to date was reviewed. The aim was to adapt the historic manor house to contemporary requirements while considering the design and legal challenges associated with entering the structure on the Register of Historic Monuments.*

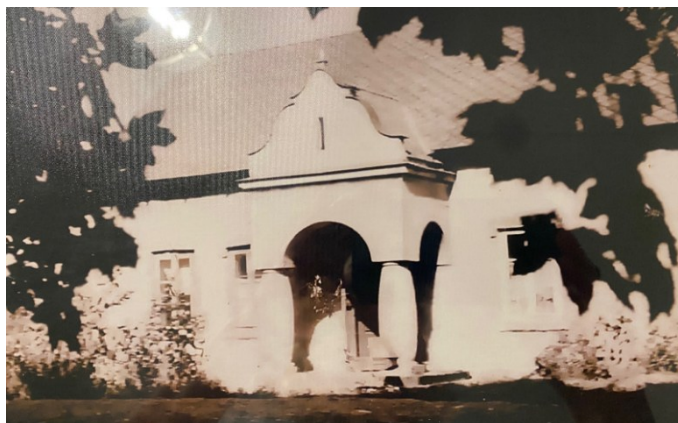
**Fig. 2.** Historical appearance of the manor house; photograph shows the Czepurka Manor House in the first half of the 20<sup>th</sup> century Photo – author unknown, ownership – structure owner

According to the structure's registration card, the Czepurka Manor House construction dates back to the turn of the 18<sup>th</sup> and 19<sup>th</sup> centuries, when it was erected as a manor building. The structure is located on a nearly 2-hectare plot of land where remains of other manor buildings can also be found. The building was listed on the Register of Historic Monuments in 1898. Figure 2 shows a photograph depicting the historical appearance of the manor house.

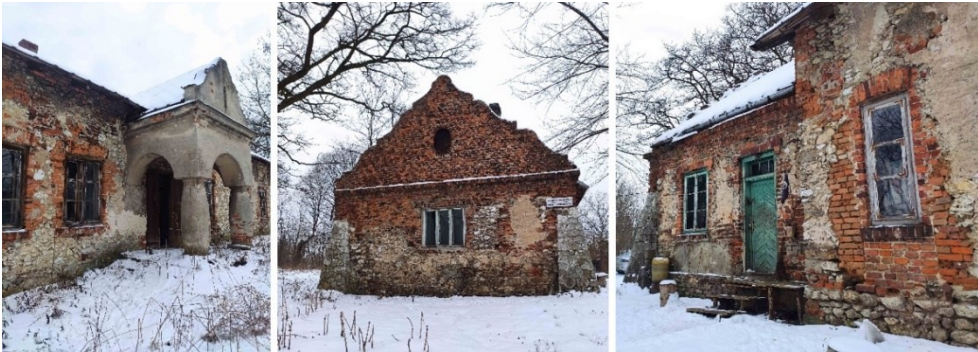
**Fig. 3.** Contemporary condition of the manor house - 22/02/2022, from the left: front elevation (west), north elevation, kitchen annex view; own photographs

Little evidence survives on the history of the building to describe its original form or exact functions. However, architectural research and material analyses show that the individual floors of the structure date to different time periods. This proves the building's multi-stage development and adaptation [5] to the changing needs of its users. The oldest part of the building is the basement with its barrel vault made of solid brick. This space served as a granary. Above the vault, the ground floor and roof void were built a few decades or hundreds of years later, with the newest part being the kitchen annex. Figure 3 shows a view of the front elevation in sequence, followed by a photograph of the north elevation and a view of the kitchen annex (east elevation).

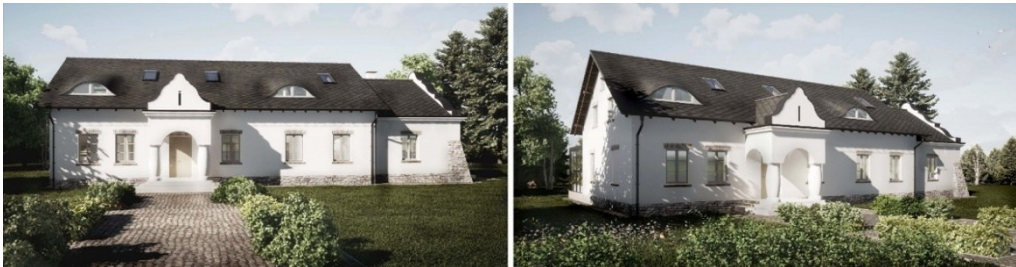
**Fig. 4.** Visualisations of the Czepurka Manor House, front elevation view [6]

Despite the difficulties, the process was successfully completed as both the conservation permit and the permit for renovation and all other necessary works on the monument were obtained. At the concept design stage, the design unit developed visualizations of what the building would ultimately look like. Figure 4 presents selected visualizations of the final appearance of the manor house – view of the front elevation.

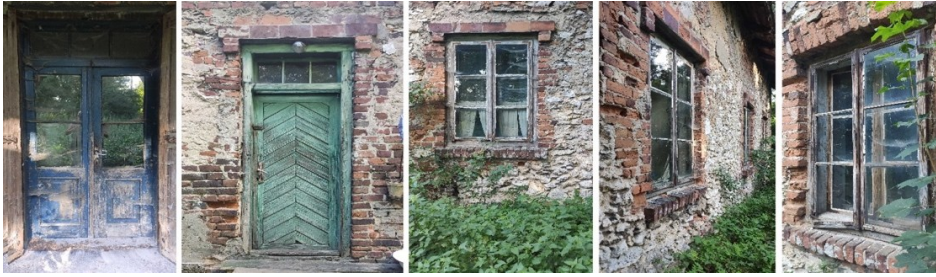
Fig. 6. Window and door woodwork, selected examples, 23/08/2022;

All conservation guidelines were taken into account. The window and door woodwork that could not be renovated was carefully inventoried and planned for restoration, the elevations were designed in their original colors, and natural materials were used to maintain the authenticity of the manor house. Figure 6 shows photographs of the appearance of the door and window woodwork before the restoration construction work was undertaken. Figure 7 shows a selected part of the manor house elevation design, which was approved by the Voivodship Conservator of Monuments and granted a building permit.

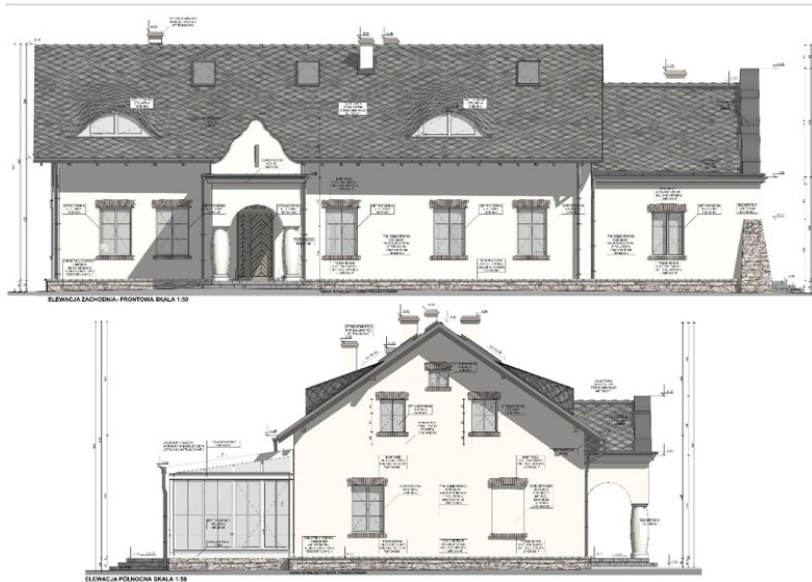
Fig. 7. Front elevation (west) and north elevation [16]
